**Prepared For: Confidential Client  
South Florida Condominium**

**Year Built: 1982 Sq. Footage 991  
Weather: 86° & Rainy  
Home Inspection  
Wind Mitigation Inspection  
4 Point Inspection**

**William Scott**

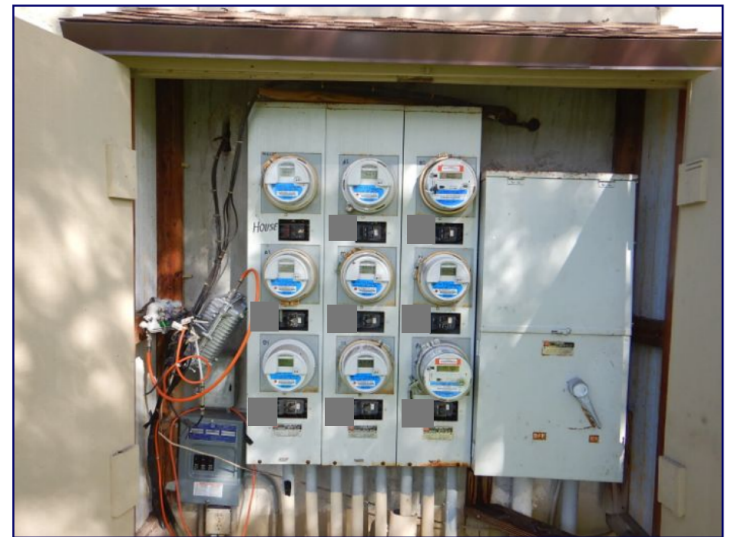
Exterior main disconnect panel was inaccessible at the time of inspection. Age and condition could not be determined. Check with your HOA for accessibility.

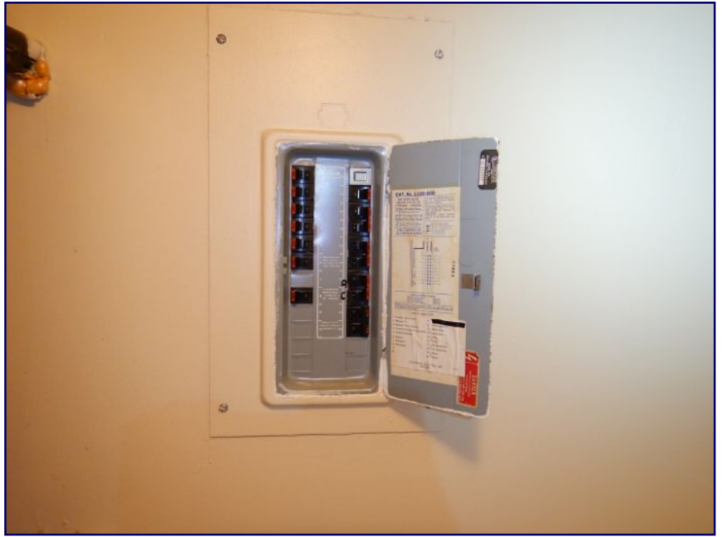
A Federal Pacific Electric (FPE) main panel was observed. Studies have shown that some FPE circuit breakers may fail to trip properly, which can result in lack of circuit protection and create potential fire and electrocution hazards. Although the U.S. Consumer Product Safety Commission (CPSC) has not issued a formal product recall, the company is no longer in business, the panels are aged, and replacement parts are limited.

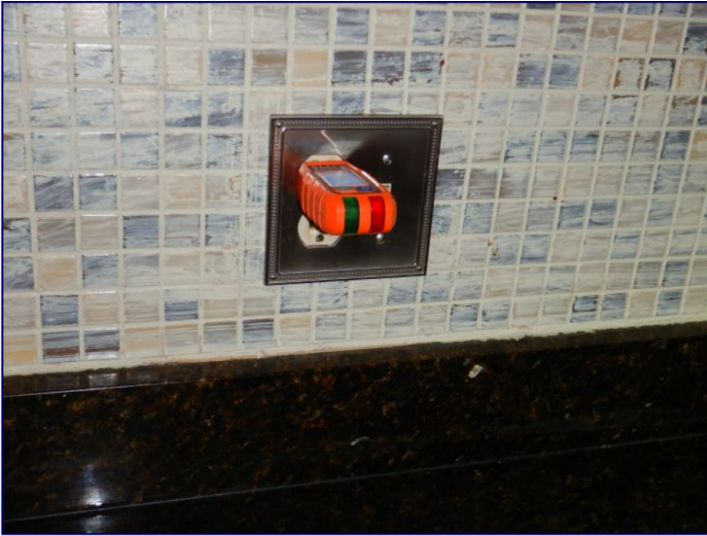
There are no GFCIs located at the kitchen area. I would recommend upgrading outlets to GFCI outlets (especially under the kitchen sink) to provide an extra measure of protection against electrocution.

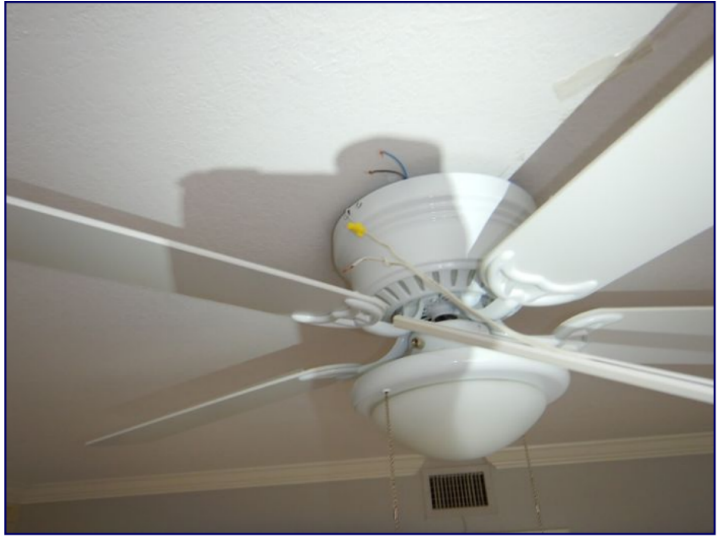
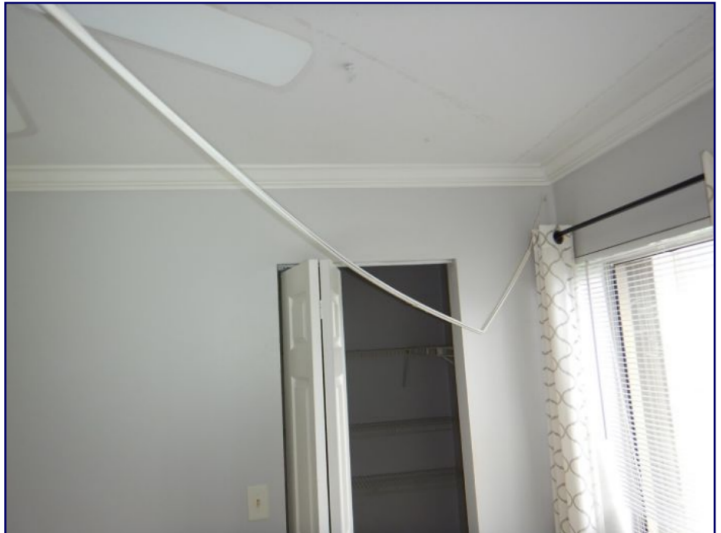
Ceiling fan at master bedroom is disconnected and exposed wiring is noted at the ceiling. Swag kit has detached from the ceiling. Recommend removal or replacement. Ceiling fan could not be evaluated for operations.

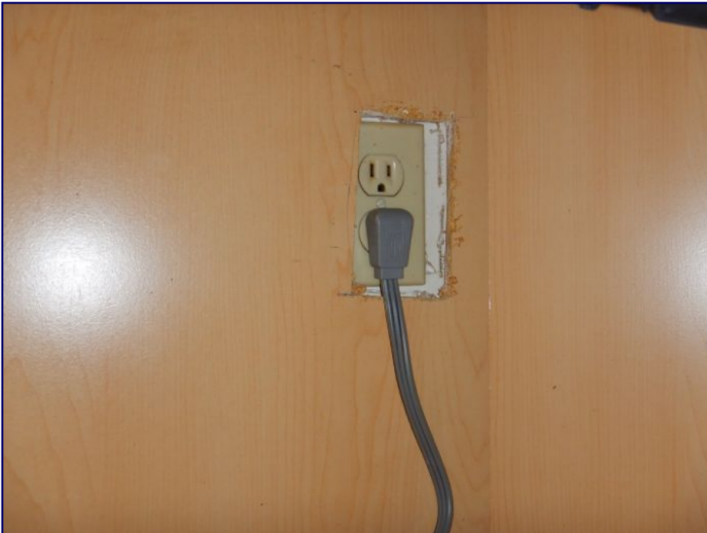
Outlet under the kitchen sink is not GFCI protected. Installation of a GFCI at this location should be considered to add an extra measure of protection against electrocution.

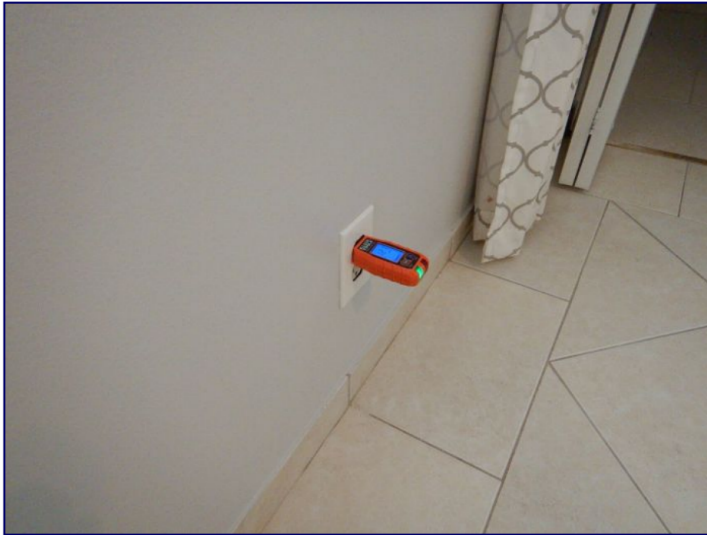
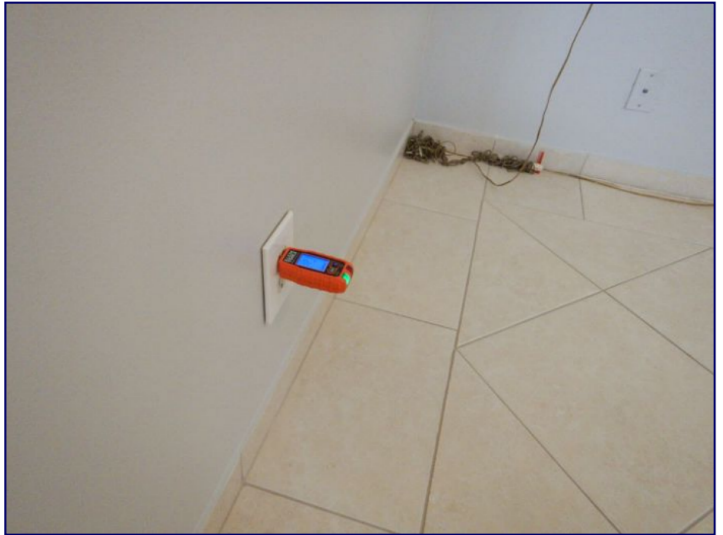
Loose or improperly secured outlet(s) noted at 2nd Bedroom I would recommend corrections by a licensed electrician as over time use can cause connections to become loose and may cause arcing, overheating and may be a potential electrocution/ fire hazard.

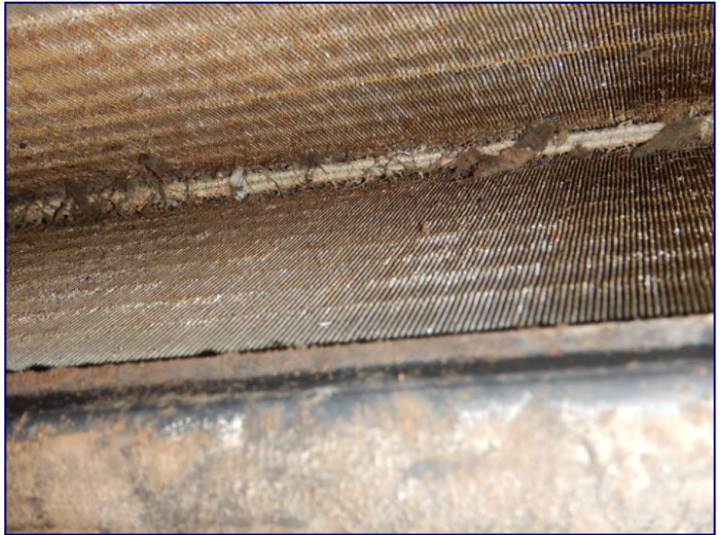
The HVAC coils are extremely dirty which may require them to be removed in order to be properly cleaned. I would recommend further evaluation by a licensed HVAC company and that you obtain an estimate for coil cleaning prior to closing. Aside from loss of cooling and efficiency, dirty coils can also lead to water damage from iced up evaporator coils and build up which may allow condensation to divert outside the drain pan. Visual inspection does not establish microbial identity, exposure, or health outcomes.

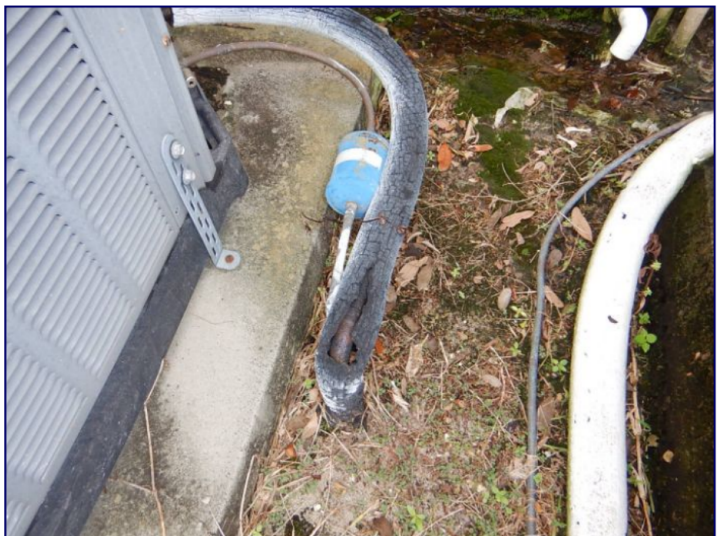
Low side line coming out of the condenser unit needs to be re-insulated. I would recommend having the low side line re-insulated with a newer, more UV resistant type insulation to improve energy efficiency.

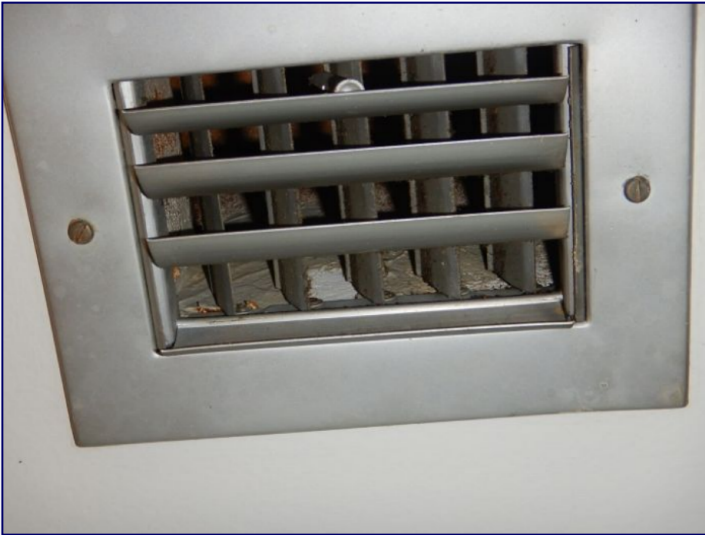
Duct work appears to be dirty. I would recommend having the duct work cleaned to improve indoor air quality.

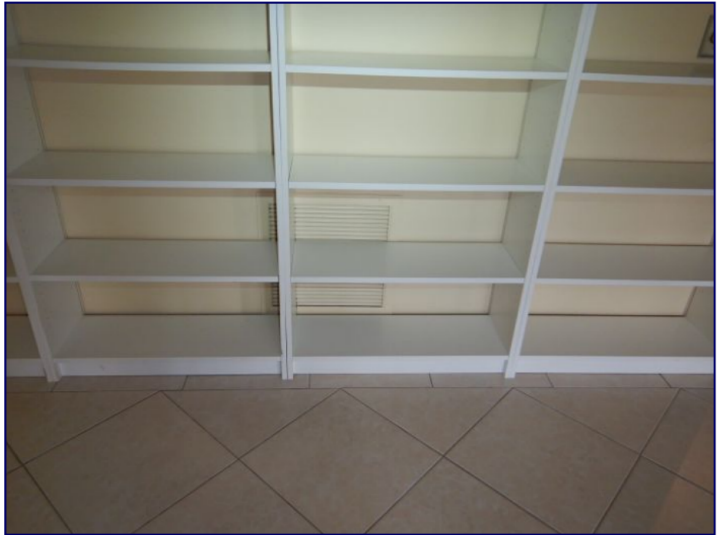
The HVAC return is located behind built-in shelving. Maintain adequate clearance around the return opening and avoid placing items or materials where they may restrict airflow. Proper return airflow is important for normal HVAC operation and system efficiency.

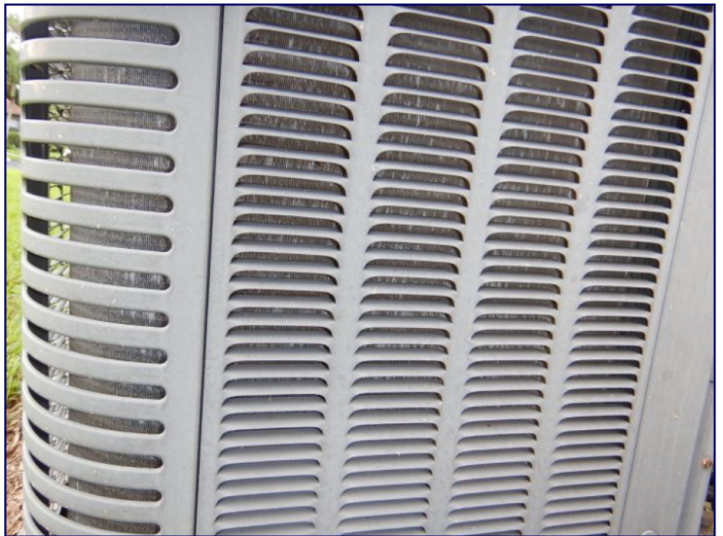
Condenser coils appear to be dirty. I would recommend having the coils cleaned by a licensed HVAC company to ensure peak efficiency and to avoid costly repairs. Call Joseph Donahue with AQ AC Air Conditioning and Electrical at (561) 294-2316 for all of your HVAC needs.

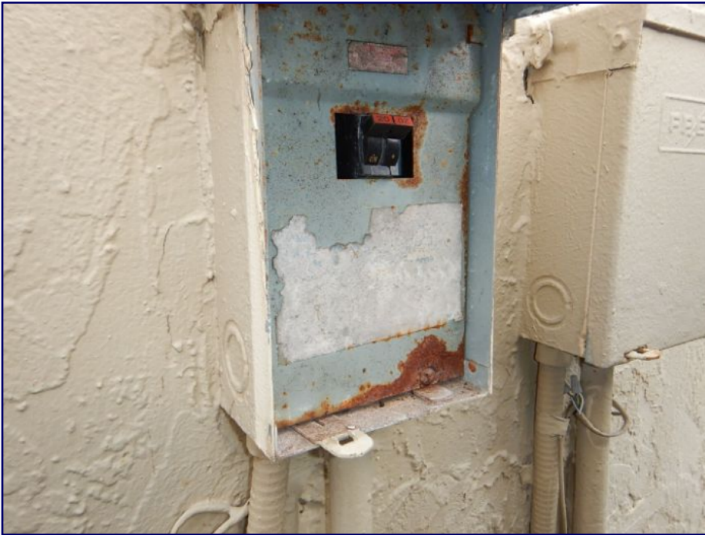
Condenser disconnect is dated and appears to be at or past its serviceable life expectancy. I would recommend replacement at the next HVAC change out. Interior is inaccessible due to rust/ corrosion.

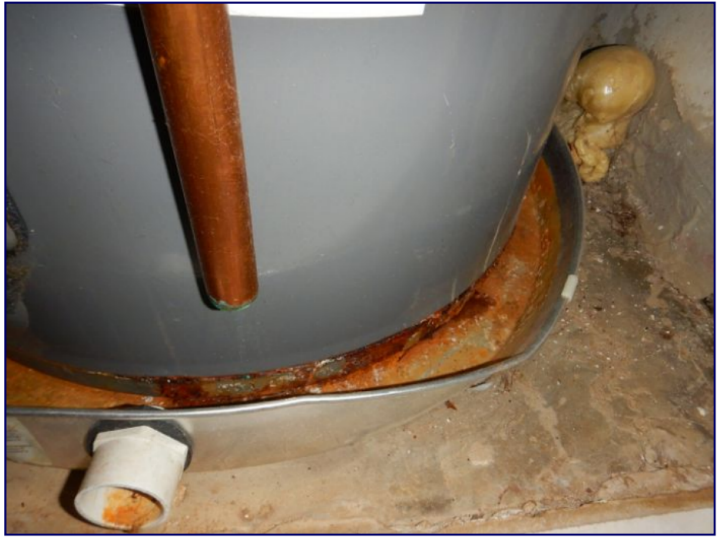
Rust/ corrosion noted at the water heater enclosure. Monitor for further deterioration or leaks. No leaks observed at the time of inspection.

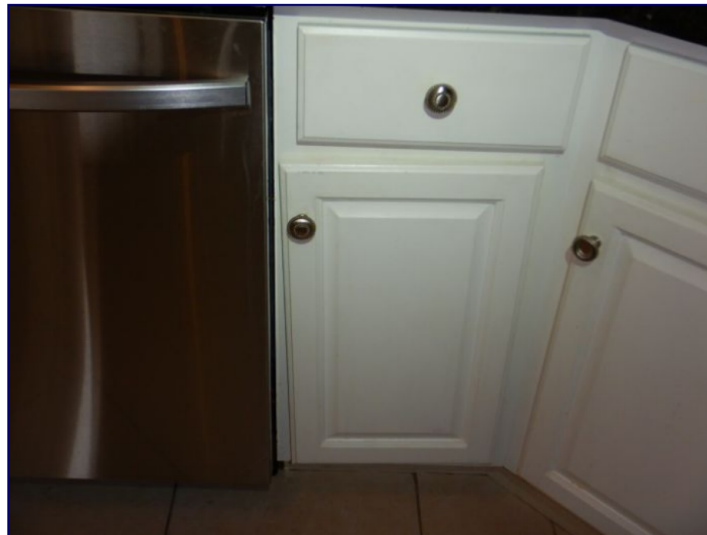
Trash bin needs minor adjustments for proper operations.

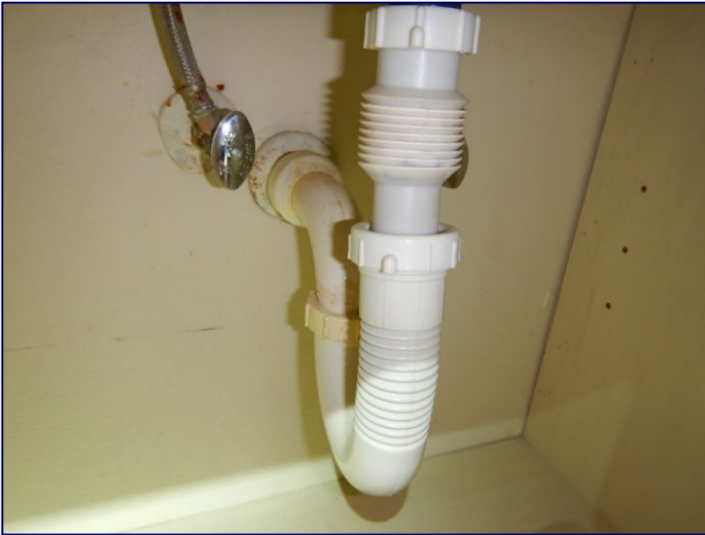
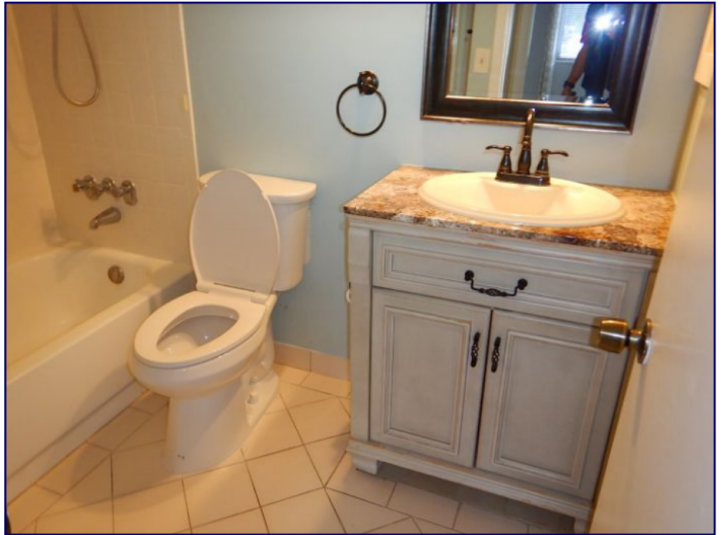
Corrugated P-trap and/or tail piece noted at the sink(s). This type of plumbing is considered to be substandard due to the ease in which they clog, smell and the difficulty in clearing clogged drain lines. Replacement(s) with smooth plumbing lines are highly recommended.

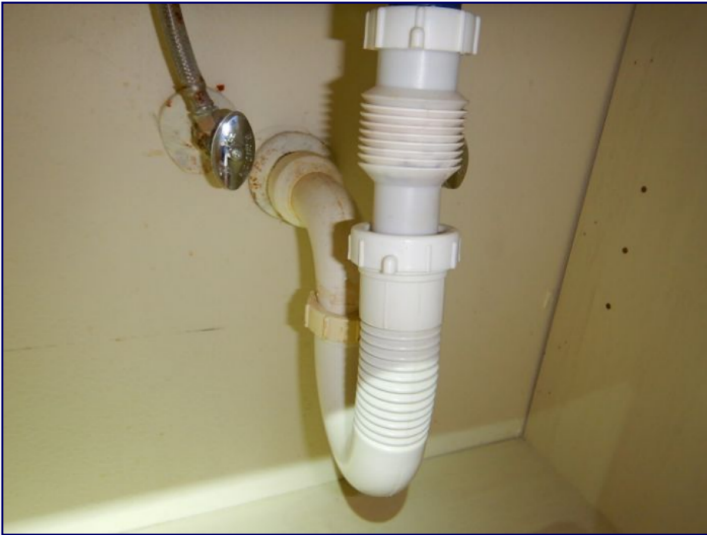
Corrugated P-trap and/or tail piece noted at the sink(s). This type of plumbing is considered to be substandard due to the ease in which they clog, smell and the difficulty in clearing clogged drain lines. Replacement(s) with smooth plumbing lines are highly recommended.

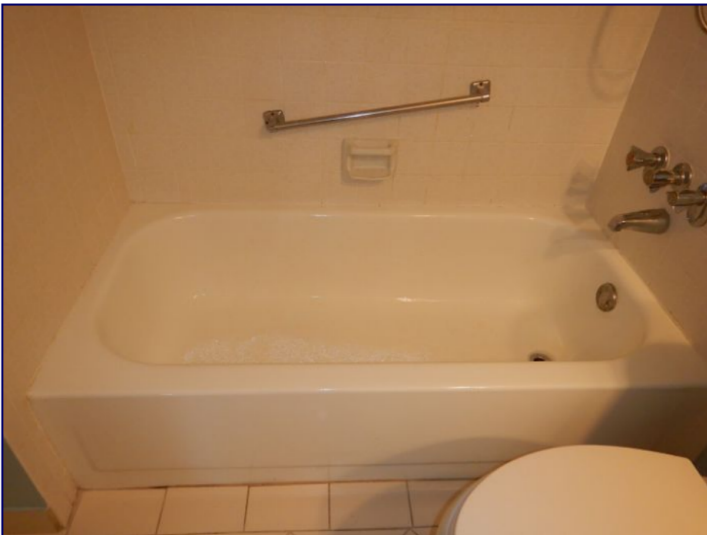
Tub and/or shower area needs caulk/ grout. This is especially critical for bathrooms located over living spaces, as this can cause leaking into the floor cavity causing ceiling staining below, development of mold and in extreme cases structural damage.

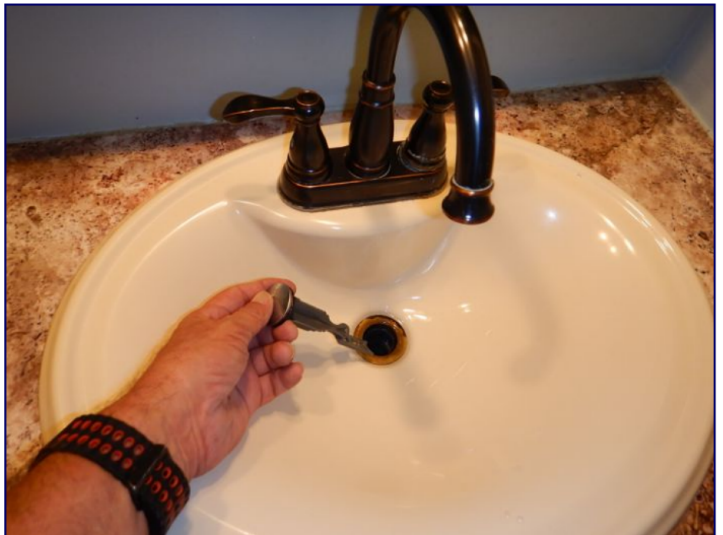
Sink drain stopper assembly will need adjustments for proper/ smoother operation.

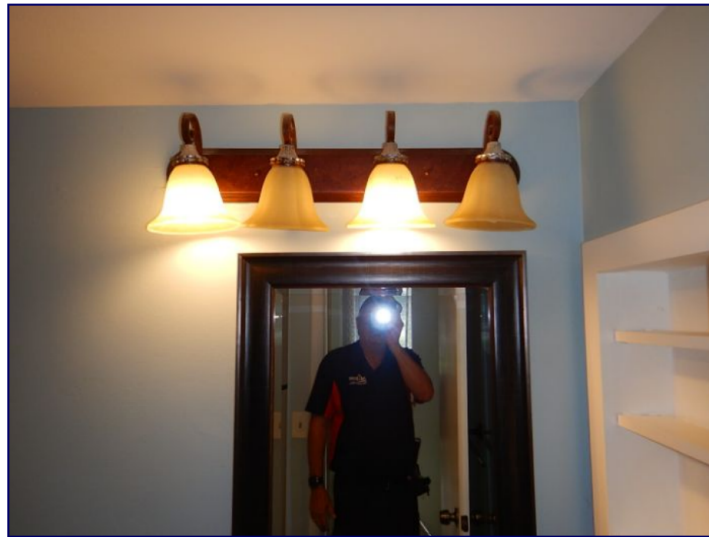
Bulb or bulbs unlit and need to be replaced.

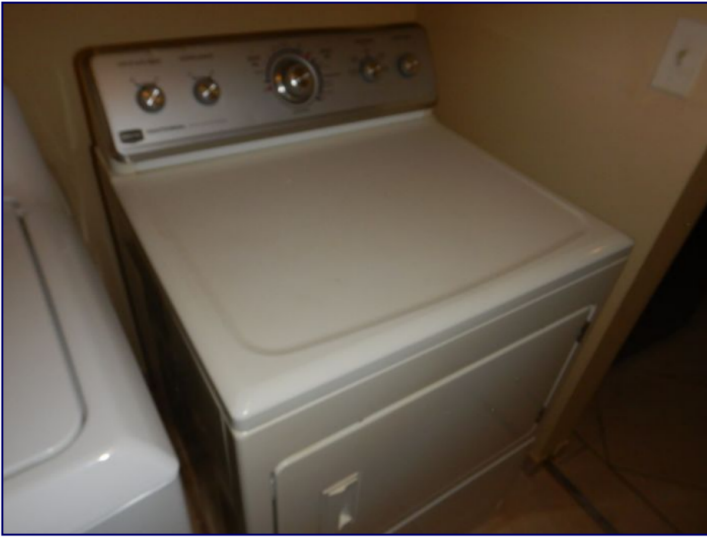
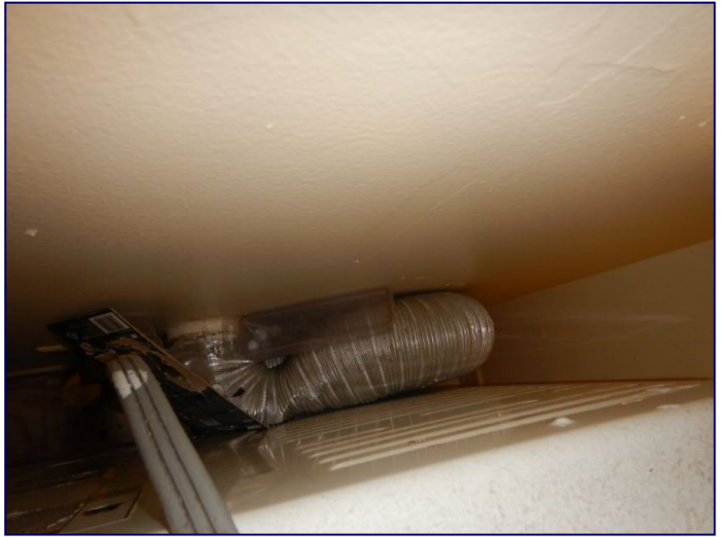
Operating conditions were consistent with restricted dryer exhaust airflow. Excessive heat was noted at the upper dryer cabinet with inadequate heat/air movement at the lint-filter area. Recommend professional inspection and cleaning of the dryer vent system. Restricted dryer venting may create a fire hazard.

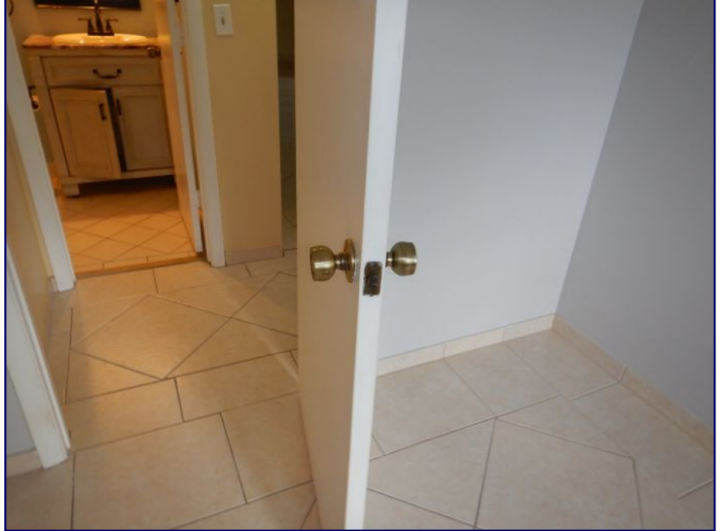
Privacy lock set at the master bedroom is inoperable. Recommend replacement for proper operations.

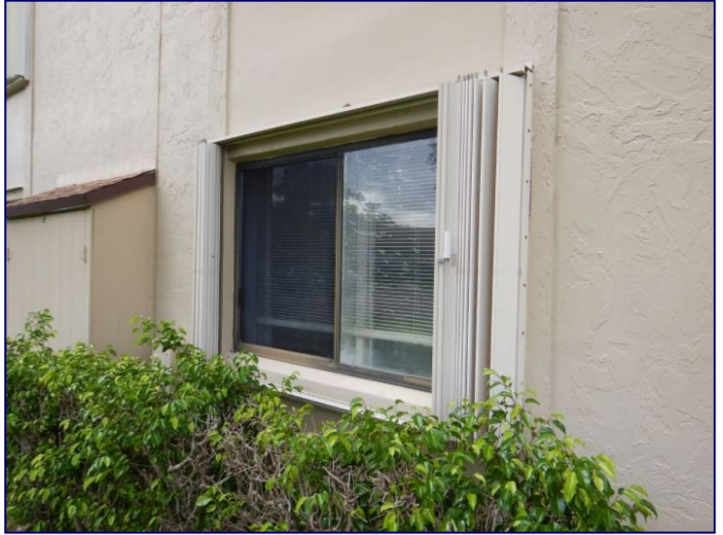
Glider window(s) are dated and hard to operate. Clean slider tracks, lubricate or replace glides or rollers for smoother operation.

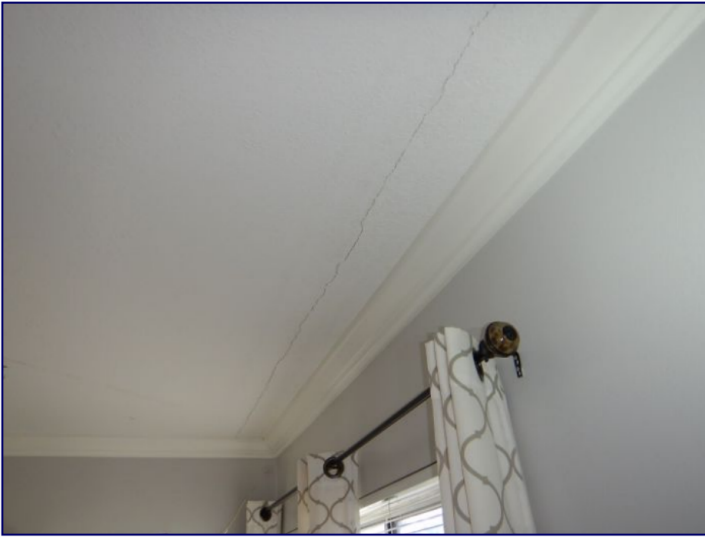
Cracking was noted through the reinforced concrete decking at the master bedroom and extending into the master bedroom closet. The condition appears consistent with possible settlement; however, the cause cannot be confirmed by visual inspection alone.

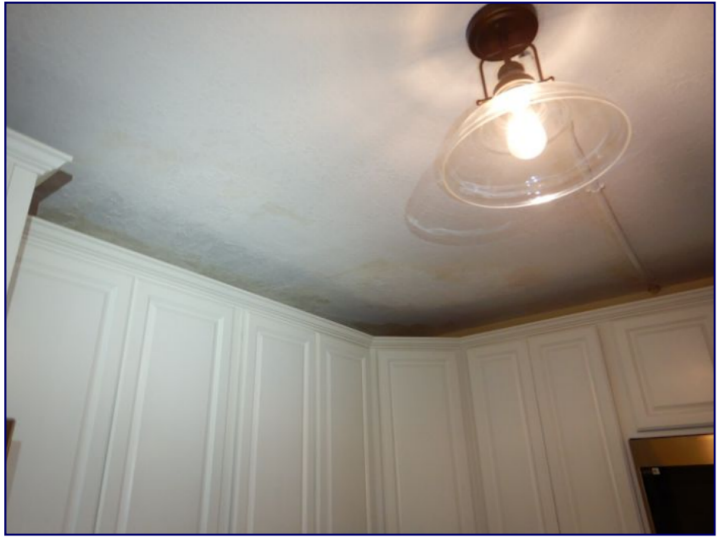
Previous ceiling repairs noted at: Kitchen. These areas were scanned with infrared technology. No moisture was detected in the ceilings at the time of inspection. I would recommend speaking to the seller regarding these repairs and that you obtain in writing any repairs/mold remediation that have been performed and any related warranties that may exist. If the seller cannot provide this information in writing, further evaluation and possible repairs and/or mold remediation by a licensed contractor is recommended. Monitor for the redevelopment of leaks.

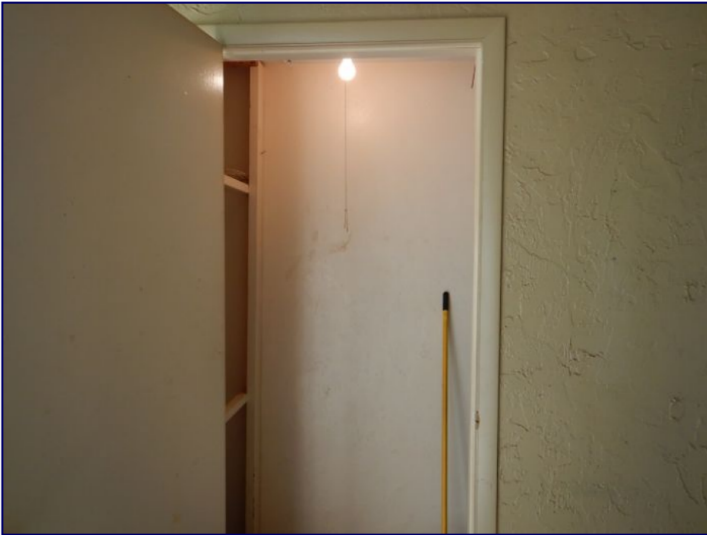
A musty odor was noted in the exterior storage closet. No air conditioning is present in the closet. Odor alone does not identify mold or establish its extent. Evaluate and correct moisture sources and clean based on the conditions found. Avoid storing moisture-sensitive clothing or personal belongings in damp, unconditioned spaces. Persistent odor or suspected concealed involvement warrants further professional evaluation.

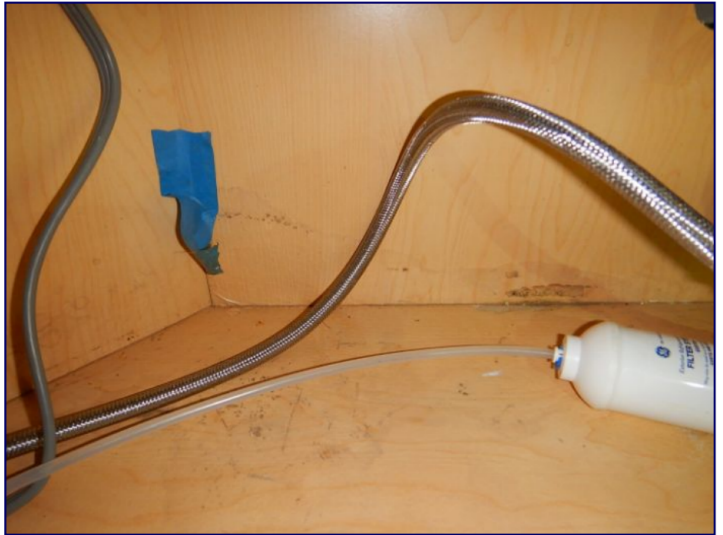
Material that appears to be biological growth was observed on or around cabinetry at: Kitchen. Clean the affected area in accordance with current EPA mold-cleanup guidance and correct the moisture source.

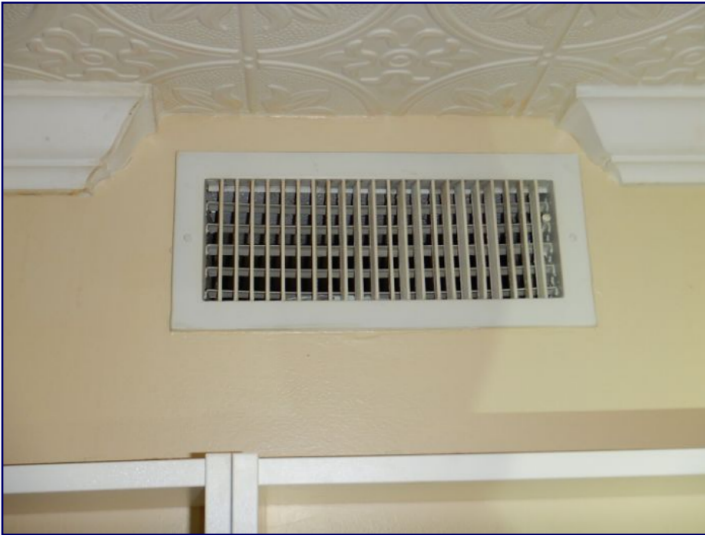
The ductwork is old, and its interior could not be fully inspected. Dust, debris, moisture damage, or biological growth may be present in inaccessible areas but was not verified. Further evaluation and appropriate cleaning as necessary by a licensed HVAC contractor experienced with this type of cleaning is recommended. Cleaning methods should be based on the actual conditions and the equipment manufacturer's instructions. If the growth is significant or widespread, affects building materials or substantial concealed areas, exceeds approximately 10 square feet, or extends beyond HVAC service scope, evaluation and remediation by a Florida-licensed mold remediator should be considered.

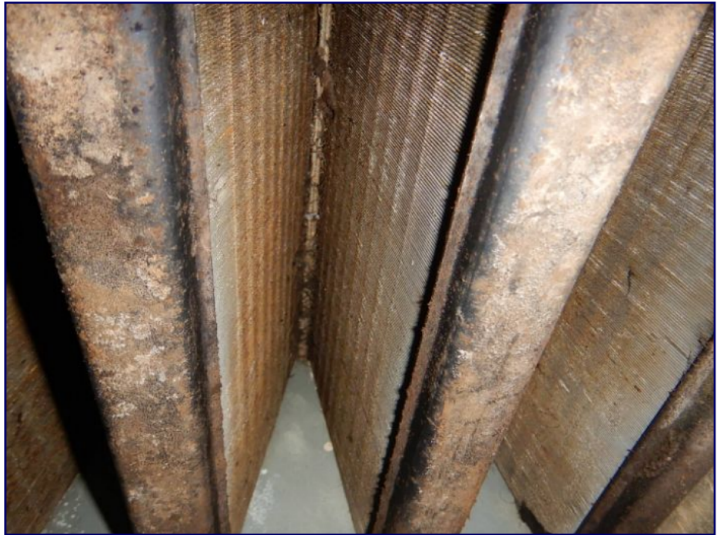
Moderate amounts of material that appears to be biological growth were observed in and/or around accessible portions of the HVAC air handler. Further evaluation and appropriate cleaning as necessary by a licensed HVAC contractor experienced with this type of cleaning is recommended. Cleaning methods should be based on the actual conditions and the equipment manufacturer's instructions. If the growth is significant or widespread, affects building materials or substantial concealed areas, exceeds approximately 10 square feet, or extends beyond HVAC service scope, evaluation and remediation by a Florida-licensed mold remediator should be considered. Visual inspection alone does not establish the identity of the material, airborne concentrations, or its effect on indoor air quality or occupant health.

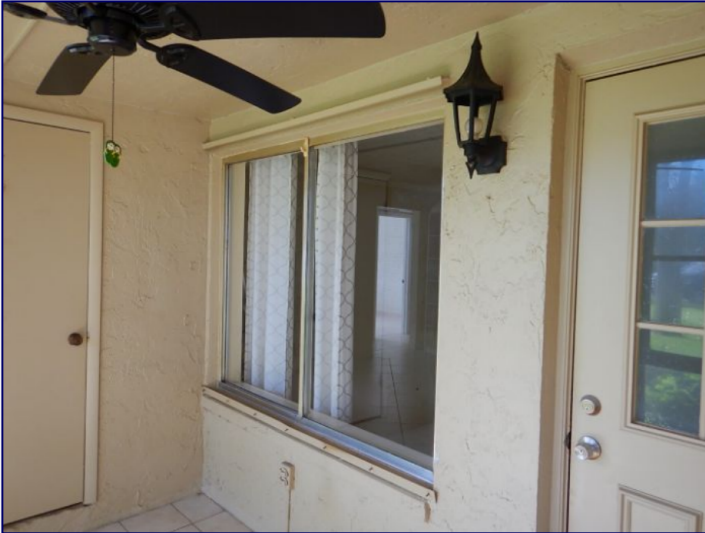
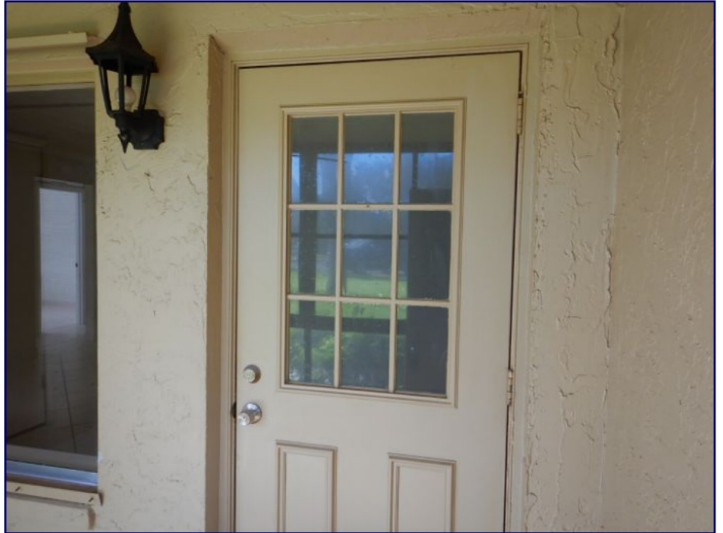
One or more of your glazed openings are not protected and/or do not meet standards under the 2002 South Florida Building Code. To qualify for these credits all glazed openings including side lights, glass block, garage door with glazed opening, etc, will need to be updated with large impact products or coverings.
