**123 Main Street**

**Date: 6/30/2026**

**Year Built: 1959 Square Ft. 1232**

**Home Inspection**

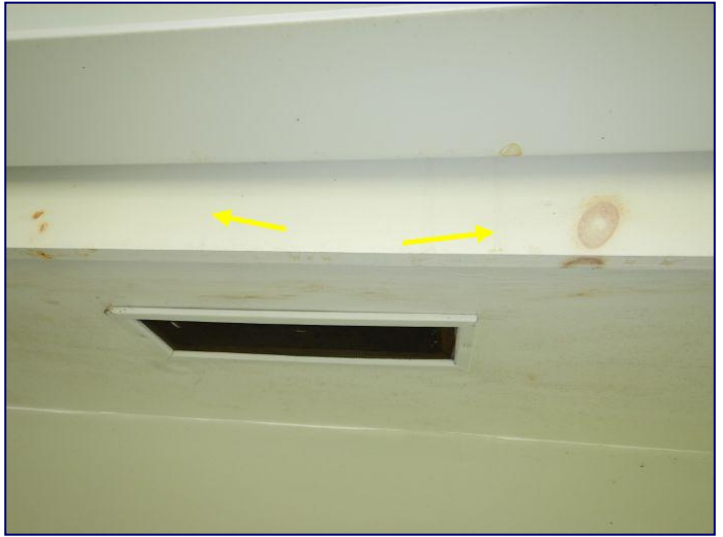
Seep staining deterioration of the underlayment noted on fascia at multiple locations throughout the exterior.

Monitor these areas at the interior of the home for leaks.

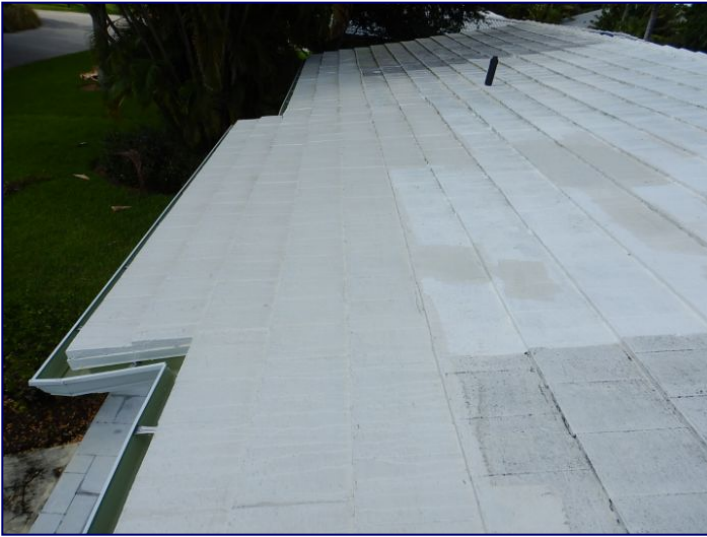
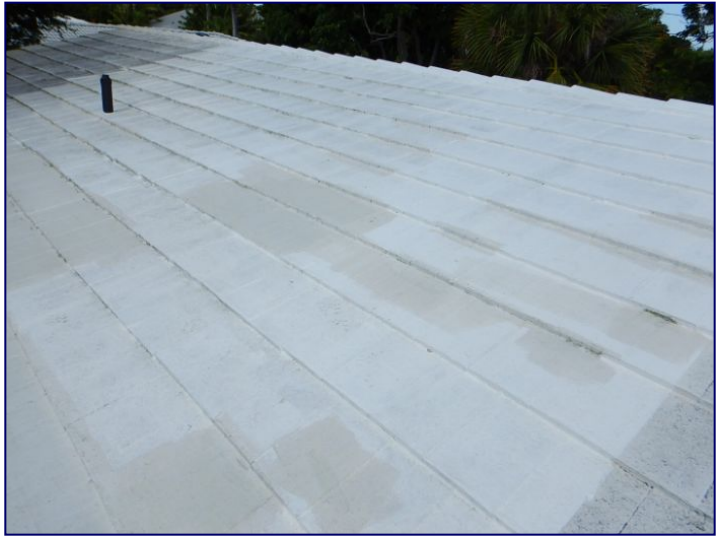
Serviceability of the roof is questionable; further more invasive evaluation by a licensed roofing contractor is recommended.

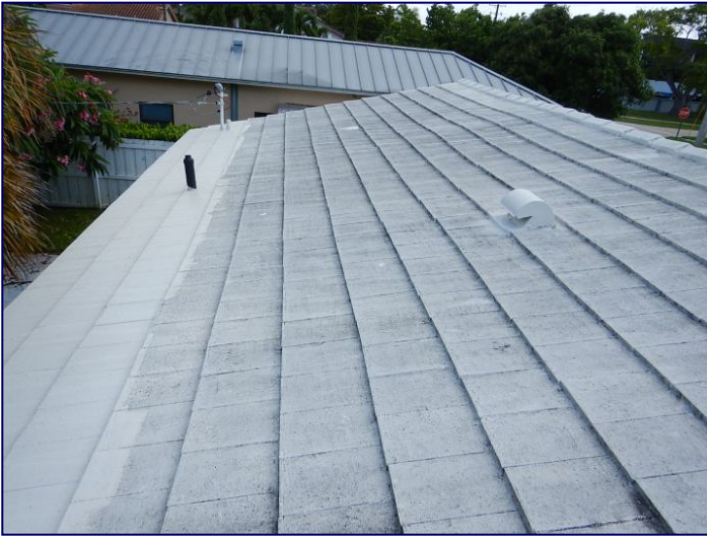
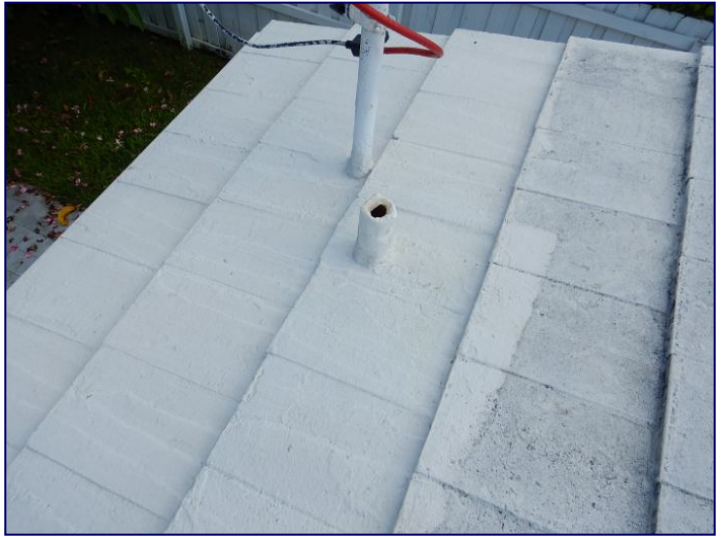
\*Cast iron vent pipe noted. See Interior/Exterior plumbing section for more information on cast iron plumbing.

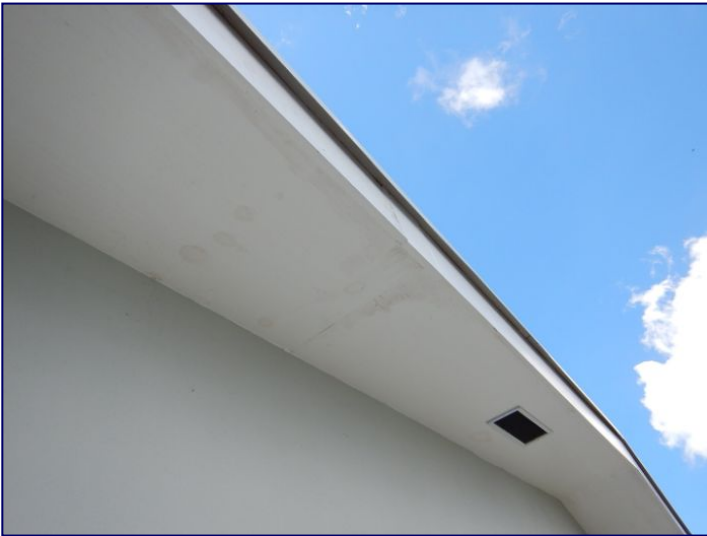
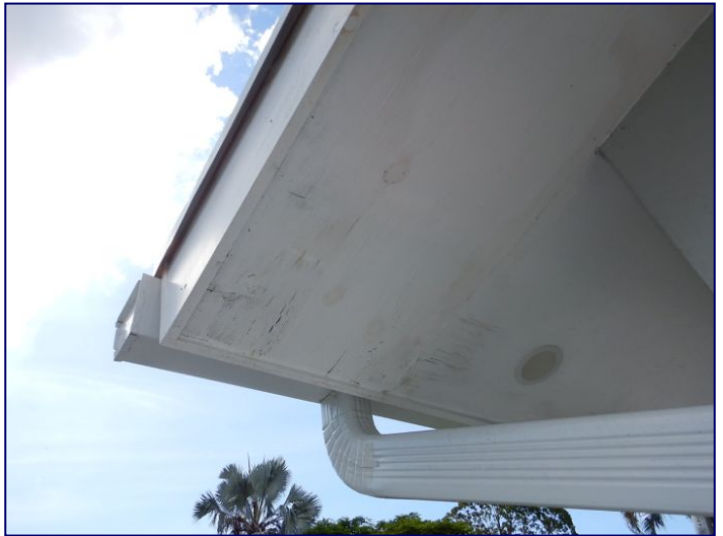
| | | <ul style="list-style-type: none"> <li>• <b>Minor wood rot or deterioration noted at some soffit areas. This may be an indication of active or previous leaks. Check with the seller to determine exact cause and if these issues have been addressed.</b></li> </ul> |

Minor wood rot or deterioration noted at some soffit areas. This may be an indication of active or previous leaks. Check with the seller to determine exact cause and if these issues have been addressed.

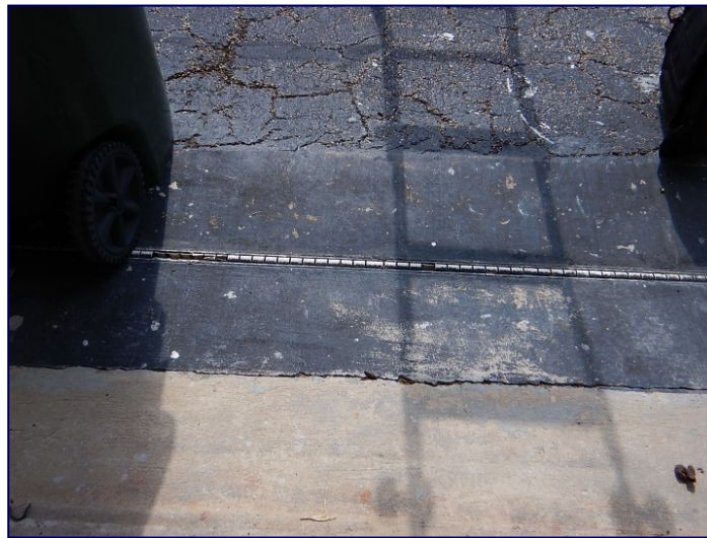
Clean channel drains and replace channel drain cover at the front of the garage area.

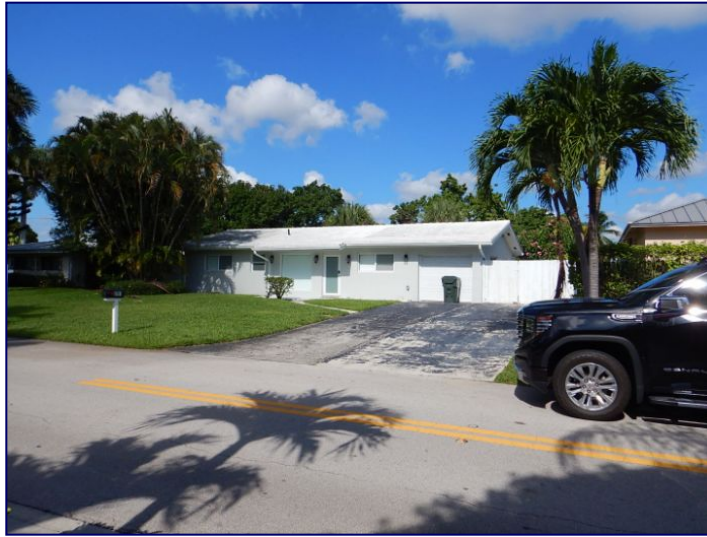
Moderate cracks in the asphalt driveway. This is not uncommon for asphalt driveways. Reseal or repair as necessary.

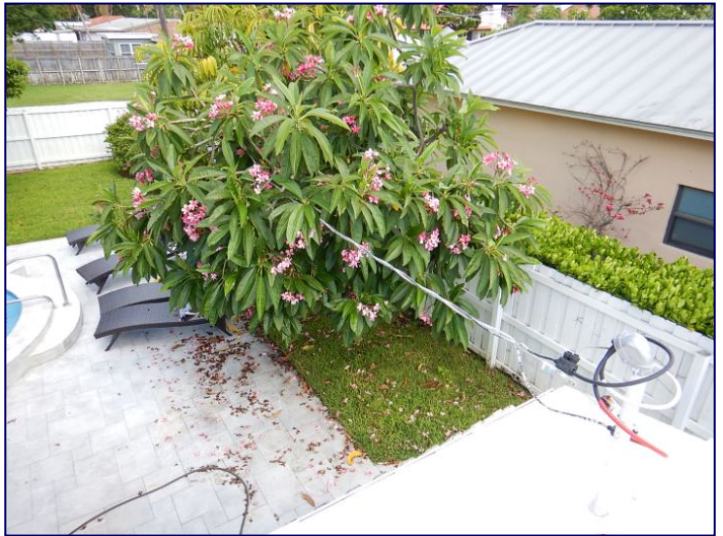
| Page 33 Item: 1 | Main Electrical Observations | <ul style="list-style-type: none"> <li>• <b>SERVICE ENTRANCE:</b></li> <li>• <b>Clear vegetation from service entrance. Windstorm hazard, Electrical service interruptions may occur during windstorms.</b></li> </ul> |

Clear vegetation from service entrance. Windstorm hazard, Electrical service interruptions may occur during windstorms.

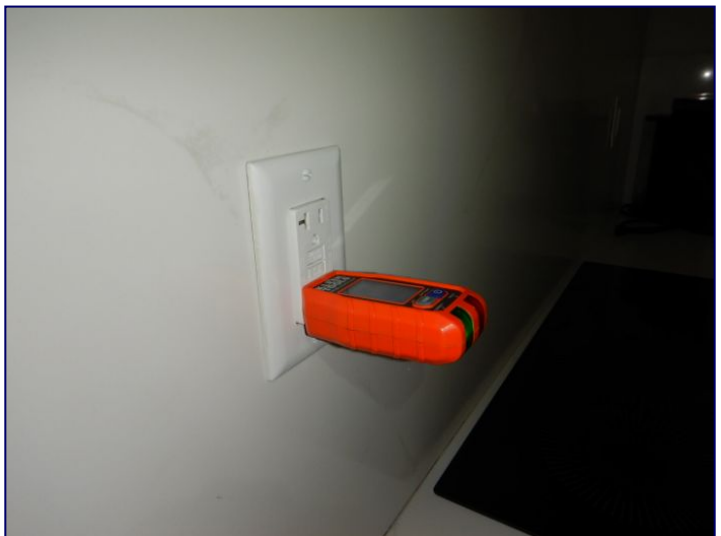
Loose or improperly secured outlet(s) noted at Kitchen  
I would recommend corrections by a licensed electrician as over time use can cause connections to become loose and may cause arcing, overheating and may be a potential electrocution/ fire hazard.

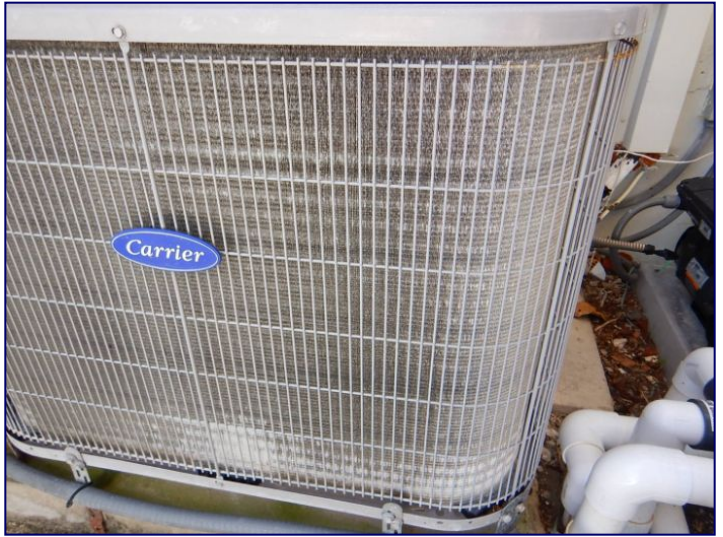
Condenser coils appear to be dirty. I would recommend having the coils cleaned by a licensed HVAC company to ensure peak efficiency and to avoid costly repairs. Call Joseph Donahue with AQ AC Air Conditioning and Electrical at (561) 294-2316 for all of your HVAC needs.

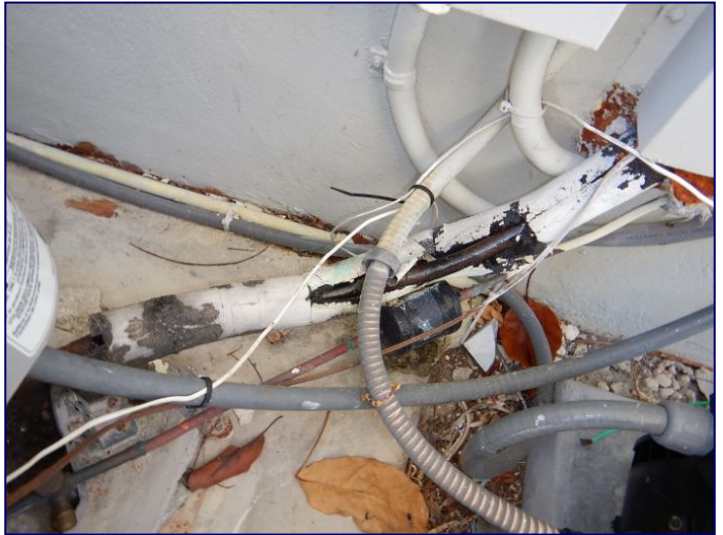
Low side line coming out of the condenser unit needs to be re-insulated. I would recommend having the low side line re-insulated with a newer, more UV resistant type insulation to improve energy efficiency.

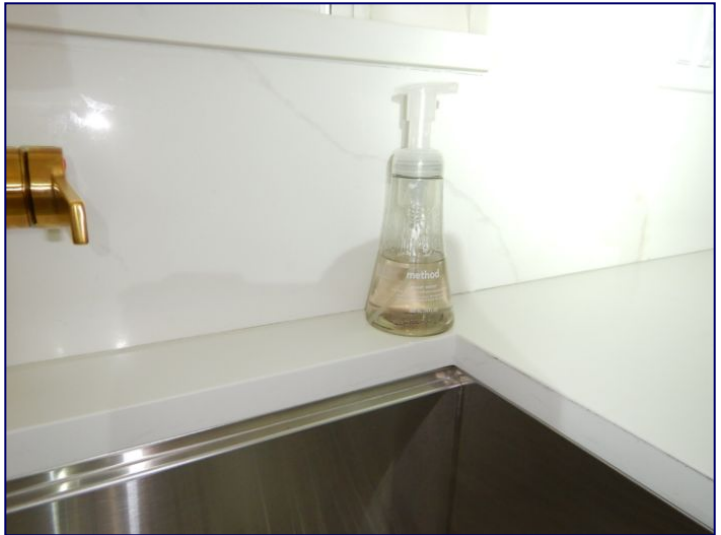
Back splash needs Minorcaulking/ rerouting to prevent water intrusion into or behind the cabinetry below which can cause damage to the cabinetry and the potential development of mold and indoor air quality issues.

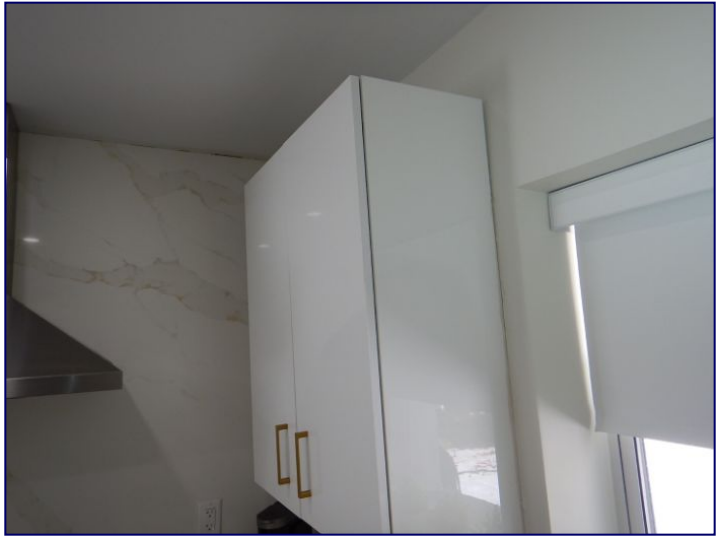
Loose upper cabinet noted at the kitchen area, I recommend tightening and caulking around all upper cabinets

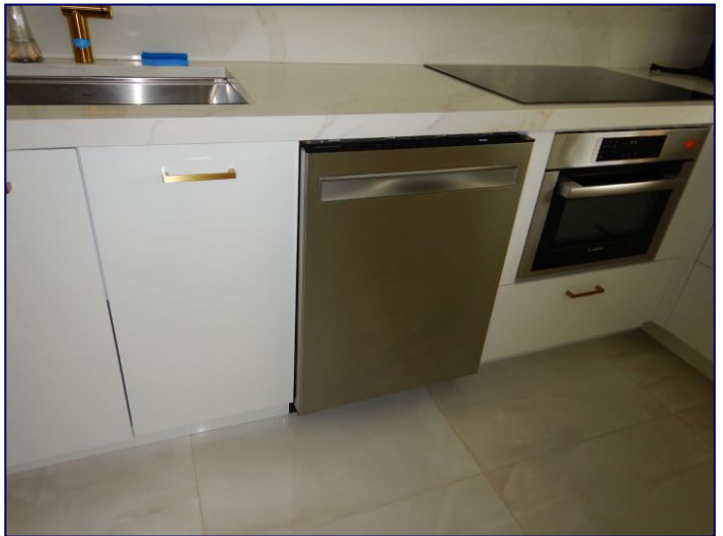
Minor cosmetic damage noted at the brand-new dishwasher. These are cosmetic in nature only and do not affect function.

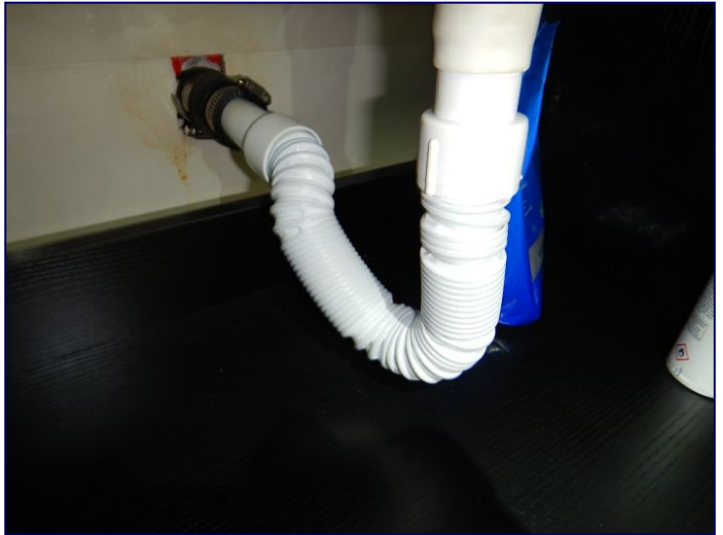
| Page 51 Item: 2 | Guest Bath Observations | <ul style="list-style-type: none"> <li>• <b>SINK DRAINS:</b></li> <li>• Corrugated P-trap and or tail piece noted at the sink(s). This type of plumbing is considered to be substandard due to the ease in which they clog, smell and the difficulty in clearing clogged drain lines. Replacement(s) with smooth plumbing lines are highly recommended.</li> </ul> |

Corrugated P-trap and or tail piece noted at the sink(s). This type of plumbing is considered to be substandard due to the ease in which they clog, smell and the difficulty in clearing clogged drain lines. Replacement(s) with smooth plumbing lines are highly recommended.

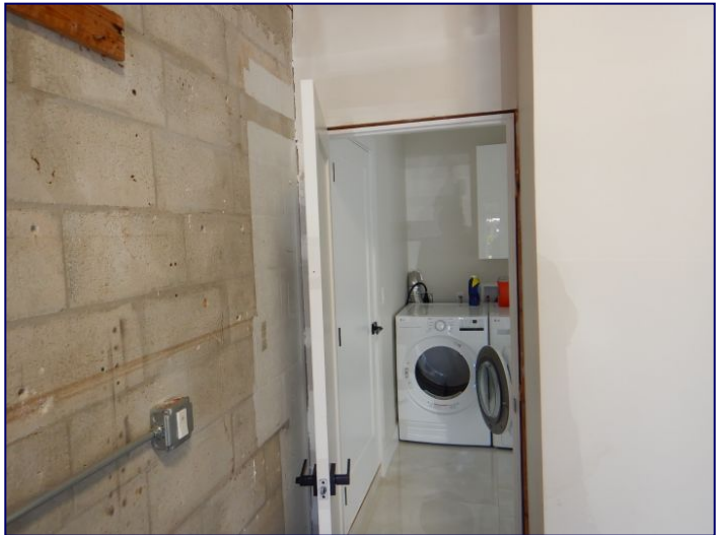
Auto closing hinges need to be added or adjusted for self closure. This is to prevent excess CO2 from entering the home. House to garage doors also act as a fire block to prevent fire and smoke from spreading so quickly into the living area of the home should a fire occur.

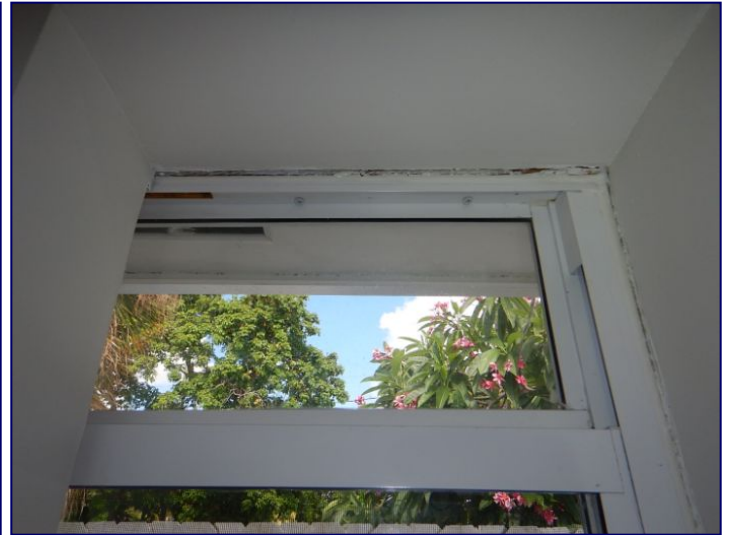
| Page 59 Item: 2 | Windows Observations | <ul style="list-style-type: none"> <li>• <b>CAULKING AND SEALANT:</b></li> <li>• Maintenance Tip: Caulk around the interior of the window at the half bath area. Some areas around the windows are missing caulking and there are minor gaps that need to be filled in with caulk or drywall mud to help energy efficiency and to reduce conditions that are conducive to mold growth.</li> </ul> |

Maintenance Tip: Caulk around the interior of the window at the half bath area. Some areas around the windows are missing caulking and there are minor gaps that need to be filled in with caulk or drywall mud to help energy efficiency and to reduce conditions that are conducive to mold growth.

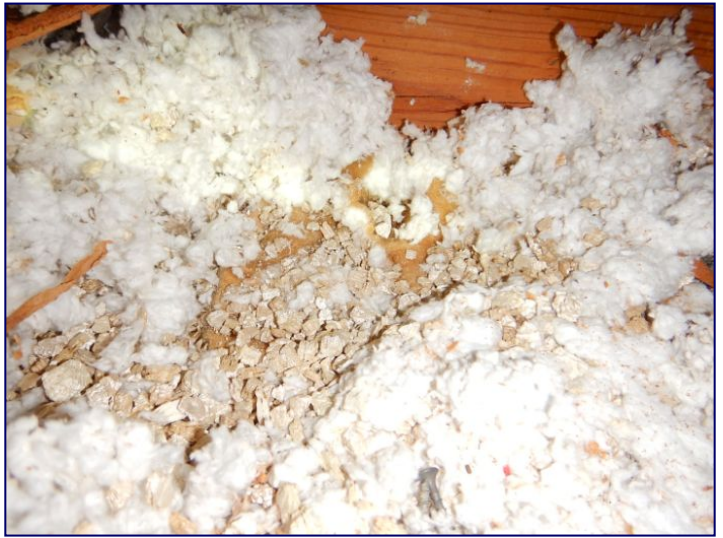
• Attic Insulation: A mixture of potential vermiculite insulation, identified by its visual appearance, and blown-in loose-fill fiberglass insulation was observed throughout the attic. The material has not been tested, and the presence of asbestos cannot be determined by visual inspection alone. Some vermiculite insulation installed prior to the early 1990s may contain asbestos fibers. Evidence of prior work within the attic, including electrical modifications and HVAC ductwork replacement, was observed. If renovation, remodeling, or additional work requiring disturbance of the insulation is planned, the material should be evaluated and, if appropriate, sampled by a qualified asbestos inspector or environmental testing laboratory before it is disturbed.

Attic Insulation: A mixture of potential vermiculite insulation, identified by its visual appearance, and blown-in loose-fill fiberglass insulation was observed throughout the attic. The material has not been tested, and the presence of asbestos cannot be determined by visual inspection alone. Some vermiculite insulation installed prior to the early 1990s may contain asbestos fibers. Evidence of prior work within the attic, including electrical modifications and HVAC ductwork replacement, was observed. If renovation, remodeling, or additional work requiring disturbance of the insulation is planned, the material should be evaluated and, if appropriate, sampled by a qualified asbestos inspector or environmental testing laboratory before it is disturbed.

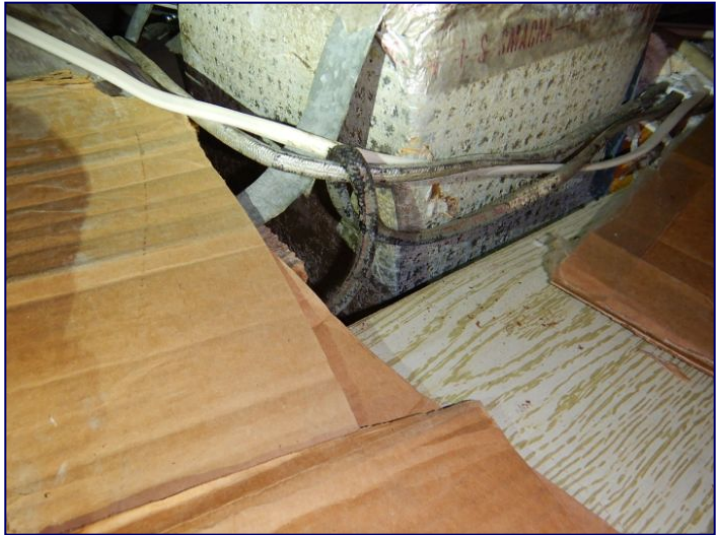
• **Cloth wiring noted in the attic.** Cloth wiring was used between the 1920s through the 1960s. Cloth covered wire conductors will either be copper, tinned copper or aluminum. Aluminum wiring was used in homes between the early 1960s through the mid 70s due to a worldwide copper shortage between these years. Aluminum wiring is considered to be unsafe due to the fact that as aluminum expands and contracts as the wiring heats and cools under load. Over time expansion and contractions may cause connections to become loose. Loose connections can lead to overheating and arcing and create fire hazards at these connections. At Beacon Home inspection Services you and your family's health and safety as well as protection of your investment is our top priority, and we make every effort to determine and identify unsafe conditions. Due to conditions of limited accessibility, safety and or liability concerns as well as techniques that fall well outside the scope of a home inspection, if cloth covered wiring is observed whether copper, tinned copper or aluminum wiring is or is not identified a further more invasive inspection by a licensed electrician is highly recommended as all cloth wiring is now considered to be nearing or past its serviceable life expectancy of 50 years. Cracks/ deterioration of the cloth insulator which cannot be seen during a visual inspection can also be an electrocution/ fire hazard. For homes built between 1960 and 1976 aluminum wiring or remnants of aluminum wiring may be present in the home that can not be visually detected. Identification of the types of conductors is limited to the main electrical panel inspection only and all types of conductors observed at the main panel will be listed under the main electrical section of the report.

• **Electrical Wiring:** Although the main electrical service equipment appears to have been updated, live cloth-insulated branch circuit wiring was observed within the attic serving portions of the home's electrical system. Due to the finished wall and ceiling coverings, the type and condition of the concealed branch circuit wiring throughout the remainder of the home could not be determined. Additional cloth-insulated wiring may exist within the concealed wall and ceiling cavities. The presence of cloth-insulated wiring may affect the insurability of the home and could result in additional underwriting requirements by some insurance carriers.

Cloth wiring noted in the attic. Cloth wiring was used between the 1920s through the 1960s. Cloth covered wire conductors will either be copper, tinned copper or aluminum. Aluminum wiring was used in homes between the early 1960s through the mid 70s due to a worldwide copper shortage between these years. Aluminum wiring is considered to be unsafe due to the fact that as aluminum expands and contracts as the wiring heats and cools under load. Over time expansion and contractions may cause connections to become loose. Loose connections can lead to overheating and arcing and create fire hazards at these connections. At Beacon Home inspection Services you and your family's health and safety as well as protection of your investment is our top priority, and we make every effort to determine and identify unsafe conditions. Due to conditions of limited accessibility, safety and or liability concerns as well as techniques that fall well outside the scope of a home inspection, if cloth covered wiring is observed whether copper, tinned copper or aluminum wiring is or is not identified a further more invasive inspection by a licensed electrician is highly recommended as all cloth wiring is now considered to be nearing or past its serviceable life expectancy of 50 years. Cracks/ deterioration of the cloth insulator which cannot be seen during a visual inspection can also be an electrocution/ fire hazard. For homes built between 1960 and 1976 aluminum wiring or remnants of aluminum wiring may be present in the home that can not be visually detected. Identification of the types of conductors is limited to the main electrical panel inspection only and all types of conductors observed at the main panel will be listed under the main electrical section of the report.

**Recommendation:** Evaluation by a qualified licensed electrical contractor is recommended to determine the extent of the remaining cloth-insulated wiring and to discuss repair or replacement as needed.

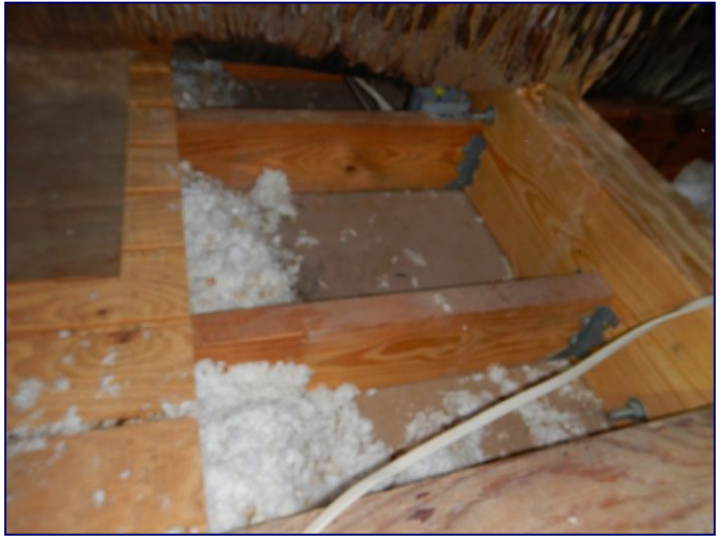
Some areas of insulation have been disturbed or removed by tradesmen. Redistribution or installation of more insulation is recommended to improve energy efficiency and prevent deterioration of indoor air quality.

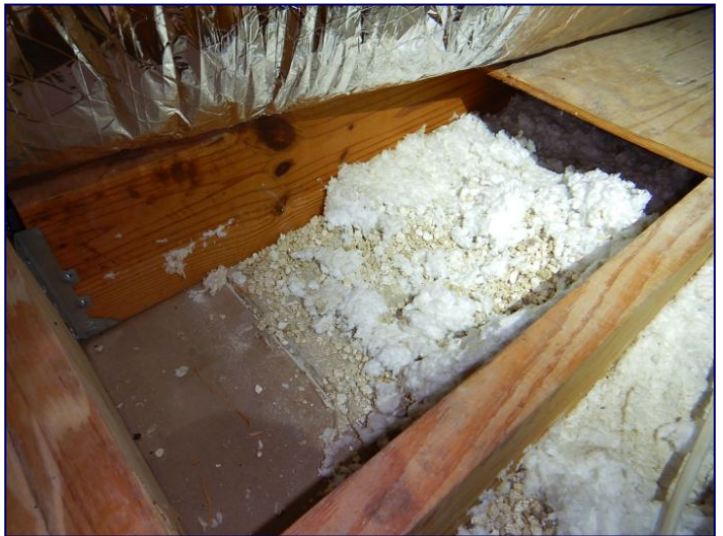
Some areas of insulation have been disturbed or removed by tradesmen. Redistribution or installation of more insulation is recommended to improve energy efficiency and prevent deterioration of indoor air quality.

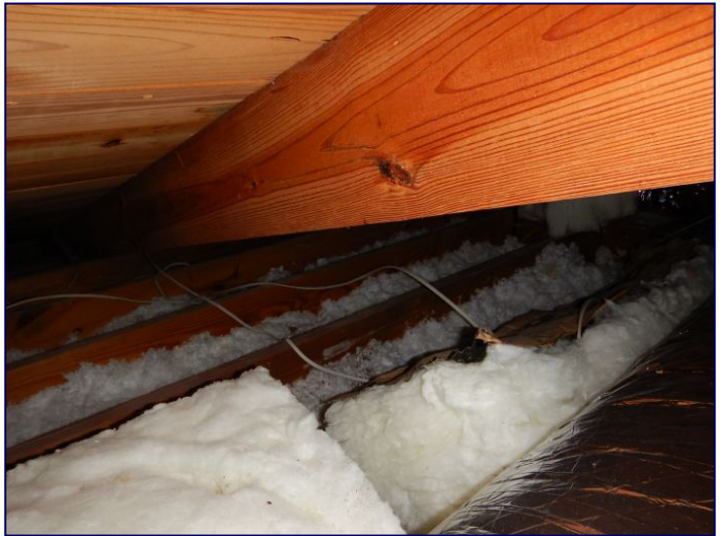
\*Not enough insulation. Insulation throughout the attic is aged, degraded, matted down or disturbed to the point where insulation should be added or replaced. Contact FP&L, they sometimes perform free energy audits and will add insulation at no cost to the owner. 1-800-DIAL-FPL (1-800-342-5375).

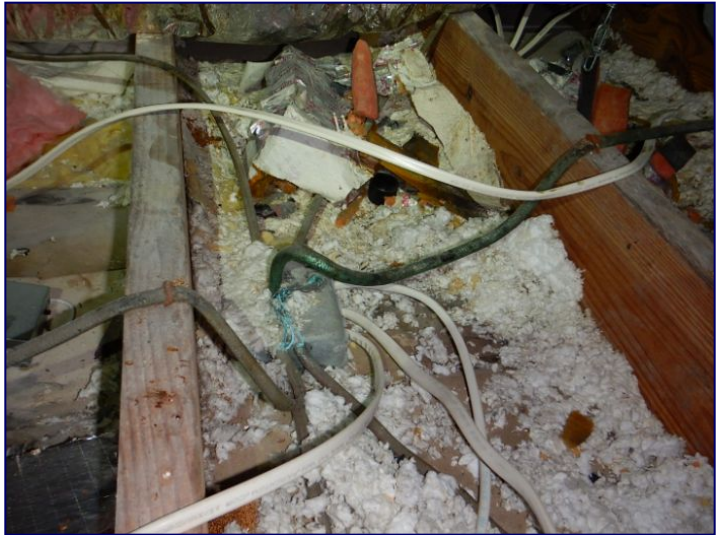
| | | <ul style="list-style-type: none"><li>• Insect damage or activity noted in the form of <b>drywood termite pellets</b>, galleries and or shed wings. I would highly recommend checking with the seller to see when the last termite inspection/ treatment was performed and if there are any warranties or termite bonds on the property. If no proof can be provided in writing that service was performed within the last six months further evaluation and treatment options by a licensed pest control company is highly recommended. See environmental section of the report for more information on termites.</li></ul> |

Insect damage or activity noted in the form of drywood termite pellets, galleries and or shed wings. I would highly recommend checking with the seller to see when the last termite inspection/ treatment was performed and if there are any warranties or termite bonds on the property. If no proof can be provided in writing that service was performed within the last six months further evaluation and treatment options by a licensed pest control company is highly recommended. See environmental section of the report for more information on termites.

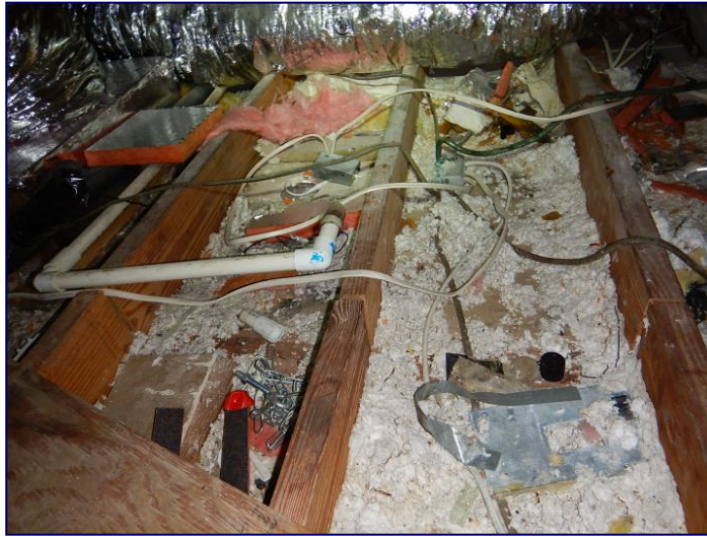
\*Not enough insulation. Insulation throughout the attic is aged, degraded, matted down or disturbed to the point where insulation should be added or replaced. Contact FP&L, they sometimes perform free energy audits and will add insulation at no cost to the owner. 1-800-DIAL-FPL (1-800-342-5375).

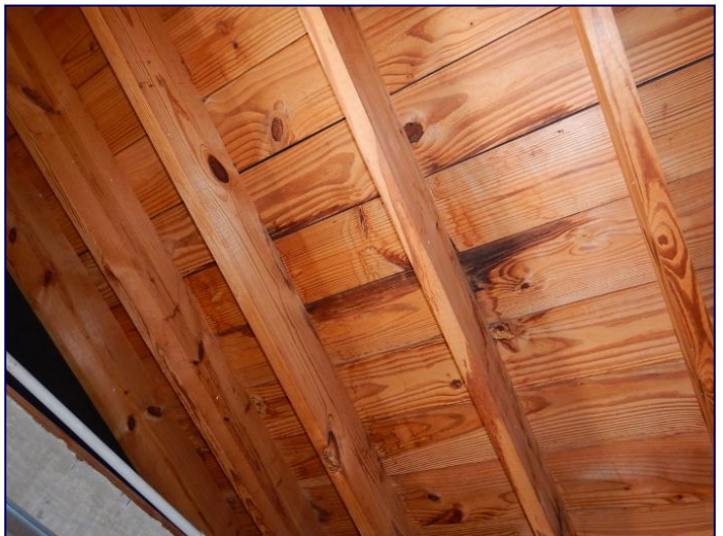
| Page 70 Item: 2 | Garage Observations | <ul style="list-style-type: none"><li>• <b>GARAGE CEILING:</b></li><li>• Water stains or previous repairs noted at garage ceiling. See Photo(s) These areas were scanned with infrared technology and found to be dry at the time of inspection. I would recommend speaking to the seller regarding these repairs and their origins. Any roof repairs should be documented in writing and you should check to see if there are any transferable warranties for the repairs. Monitor for the redevelopment of leaks.</li></ul> |

Water stains or previous repairs noted at garage ceiling. See Photo(s) These areas were scanned with infrared technology and found to be dry at the time of inspection. I would recommend speaking to the seller regarding these repairs and their origins. Any roof repairs should be documented in writing and you should check to see if there are any transferable warranties for the repairs. Monitor for the redevelopment of leaks.

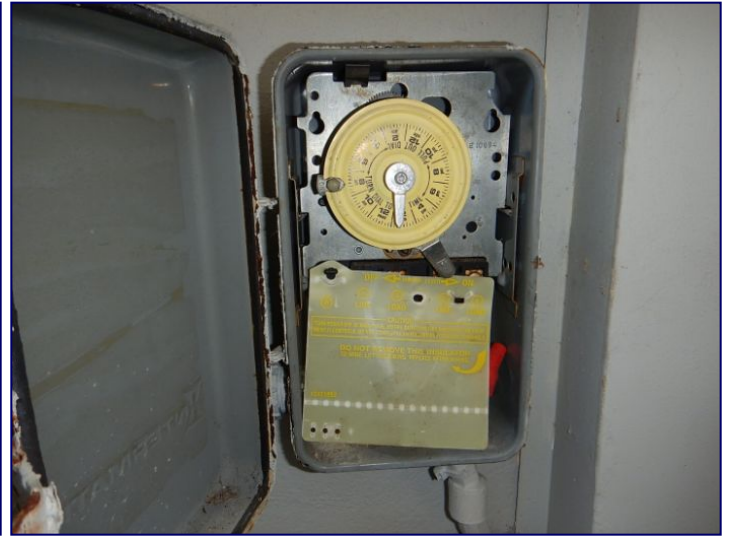
The timer is functional but aged and / or rusted. Replacement may soon be needed.

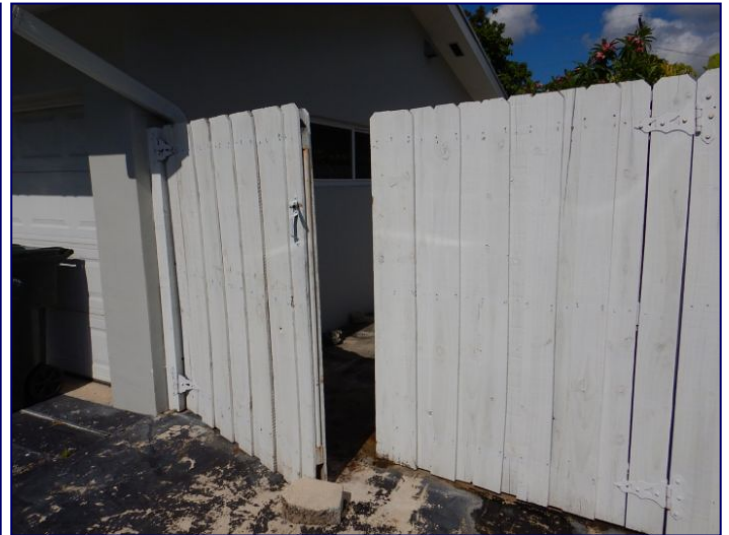
The pool is not properly enclosed to prevent unauthorized access of small children. This is a significant safety issue and liability. I would highly recommend correcting this issue immediately. Fencing, gates and gate latches must be 48" above grade at minimum and gate(s) or pool enclosure screen door(s) must self close and latch when held and released from any position. See photos of deficiency or deficiencies. Adjust gates or pool screen enclosure doors for proper closure prior to closing. The gates and or latching system for the pool enclosure need to be adjusted for proper closure. If proper adjustments or repairs cannot be made in a timely manner, installation of padlocks or safety screening is highly recommended.

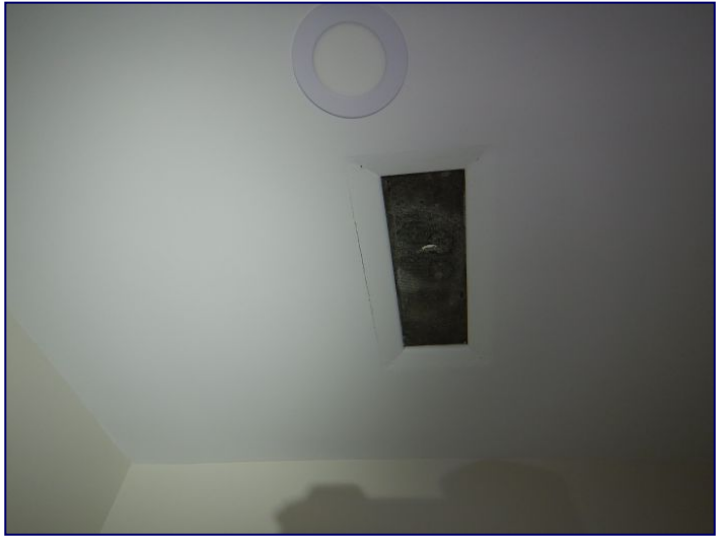
| Page 85 Item: 1 | Mold Observations | <p>• <b>Conditions Conducive to Mold Growth:</b></p> <p>• <b>CLOSETS:</b></p> <p>• <b>Potential Conditions Conducive to Mold Growth:</b> Attic ventilation openings were observed in the ceilings of multiple interior closets, creating a direct pathway between the attic and the closet spaces. The attic contains potential vermiculite insulation and loose-fill fiberglass insulation, while the closets are not directly conditioned and are equipped with solid doors, limiting air circulation. This configuration may allow heat, humidity, and insulation particulates to enter the closets, creating conditions conducive to microbial growth.</p> <p>Although no visible organic or biological growth was observed during the inspection or under UV light, the freshly painted surfaces may conceal evidence of previous moisture intrusion or microbial growth.</p> <p><b>Recommendation:</b> Seal the attic ventilation openings and improve closet ventilation by installing louvered doors or providing conditioned air through the HVAC system.</p> <p>• <b>LAUNDRY:</b></p> <p>• <b>Potential Conditions Conducive to Mold Growth:</b> The laundry room, adjacent half bathroom, and three linen closets are not served by the home's HVAC system and are therefore unconditioned spaces.</p> <p>Moisture content testing of the accessible wall surfaces within the laundry room was performed and found to be within the normal range at the time of the inspection.</p> <p>Although no visible organic or biological growth was observed during the inspection or under UV light, the freshly painted surfaces may conceal evidence of previous moisture intrusion or microbial growth.</p> <p><b>Recommendation:</b> Consider extending the home's HVAC system to condition the laundry room and adjoining closet areas to improve temperature and humidity control and reduce conditions conducive to future microbial growth.</p> |

Potential Conditions Conducive to Mold Growth: Attic ventilation openings were observed in the ceilings of multiple interior closets, creating a direct pathway between the attic and the closet spaces. The attic contains potential vermiculite insulation and loose-fill fiberglass insulation, while the closets are not directly conditioned and are equipped with solid doors, limiting air circulation. This configuration may allow heat, humidity, and insulation particulates to enter the closets, creating conditions conducive to microbial growth.

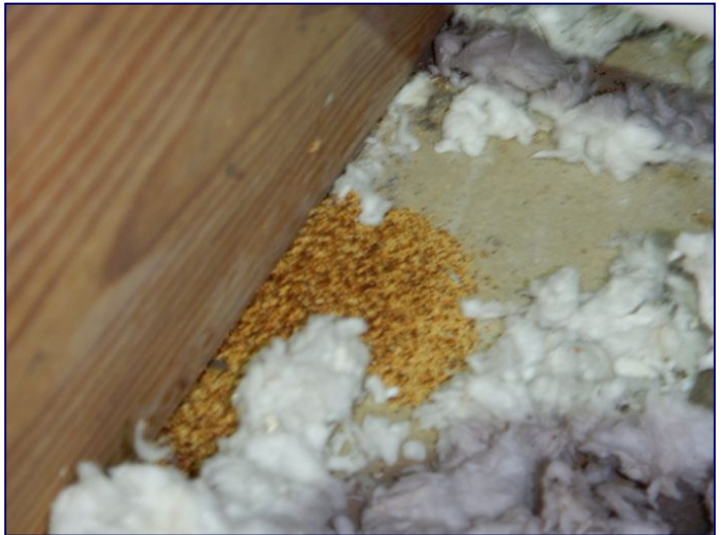
| Page 89 Item: 2 | WDO Observations | <p>• <b>Insect activity noted in the form of Drywood termite pellets noted at Attic. Further evaluation in the form of a full WDO inspection by a licensed pest control company is recommended.</b></p> |

**Insect activity noted in the form of Drywood termite pellets noted at Attic. Further evaluation in the form of a full WDO inspection by a licensed pest control company is recommended.**

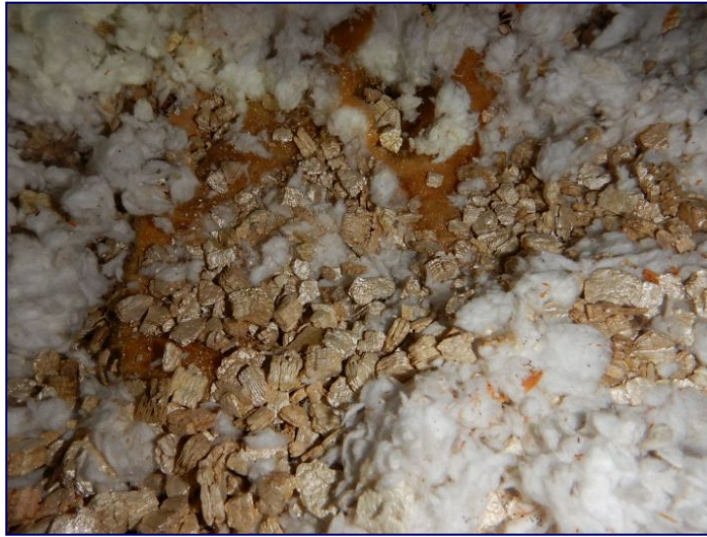
| Page 90 Item: 3 | Lead Paint/ Asbestos Observations | <ul style="list-style-type: none"><li>• <b>ASBESTOS:</b></li><li>• <b>Insulation:</b></li><li>• Apparent vermiculite insulation present; this type of insulation may contain asbestos, which has been linked to cancer (mesothelioma). The EPA makes the following recommendation at <a href="http://www.epa.gov/asbestos/pubs/insulation.html">http://www.epa.gov/asbestos/pubs/insulation.html</a> :</li></ul> <p>"What should I do if I have vermiculite attic insulation? <b>DO NOT DISTURB IT.</b> Any disturbance has the potential to release asbestos fibers into the air. Limiting the number of trips you make to your attic and shortening the length of those trips can help limit your potential exposure. EPA and ATSDR strongly recommend that:<br/>Vermiculite insulation be left undisturbed in your attic. Due to the uncertainties with existing testing techniques, it is best to assume that the material may contain asbestos.<br/>You should not store boxes or other items in your attic if retrieving the material will disturb the insulation.<br/>Children should not be allowed to play in an attic with open areas of vermiculite insulation.<br/>If you plan to remodel or conduct renovations that would disturb the vermiculite, hire professionals trained and certified to handle asbestos to safely remove the material.<br/>You should never attempt to remove the insulation yourself.<br/>Hire professionals trained and certified to safely remove the material."</p> |

Apparent vermiculite insulation present; this type of insulation may contain asbestos, which has been linked to cancer (mesothelioma). The EPA makes the following recommendation at <http://www.epa.gov/asbestos/pubs/insulation.html> :
