South Florida Condominium

# COMPARATIVE HOME INSPECTION REPORT

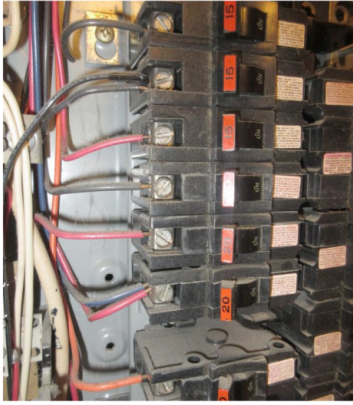
## 1.1 MAIN PANEL

Double tap is present in the breaker.

During the inspection of the electrical main panel, it was observed that there is a double tap present at the breaker. This condition occurs when two conductors are connected to a breaker meant for only one, which can lead to overheating and potential fire hazards. It is recommended to have a licensed electrician evaluate the situation further and correct the wiring by either installing a breaker designed for double taps or providing separate breakers for each conductor if needed.

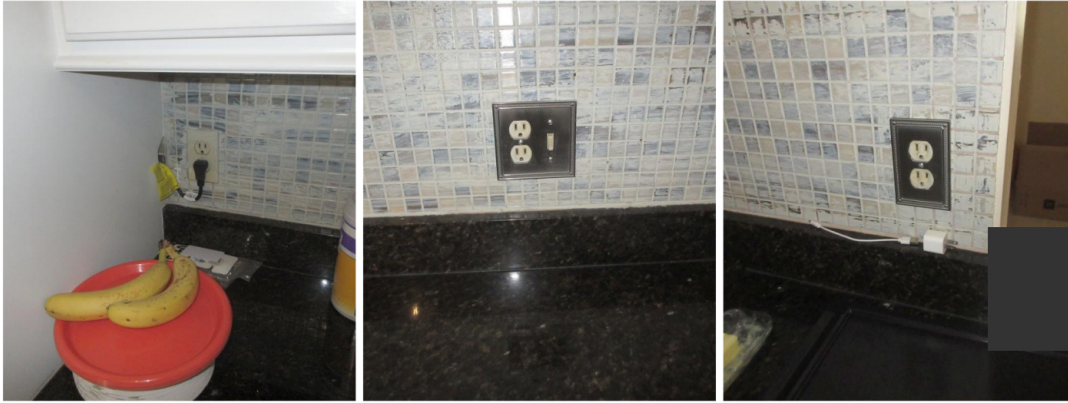
## 1.2 GFCI/AFCI

Not present in the kitchen where they are required

During the inspection, it was noted that Ground Fault Circuit Interrupter (GFCI) protection is not present in the kitchen, where it is required for safety. It is recommended to have a licensed electrician install GFCI outlets in the kitchen to ensure compliance with electrical safety standards and enhance protection against electrical shock.

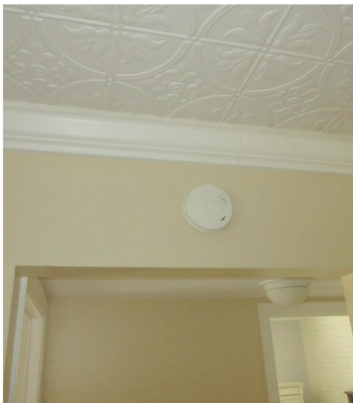
### 1.3 SMOKE DETECTORS

The smoke/carbon monoxide detector is old/outdated.

The smoke/carbon monoxide detector is outdated, which may compromise its effectiveness in detecting smoke or carbon monoxide. It's recommended to replace it with a new, dual-function detector that meets current safety standards to ensure proper functionality and occupant safety.

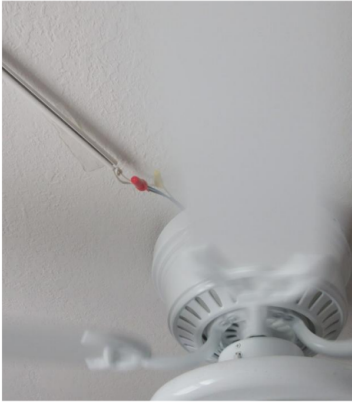
### 1.4 WIRING

Exposed

Exposed electrical wiring was observed, creating a potential shock and fire hazard; recommend evaluation and repair by a qualified electrician.

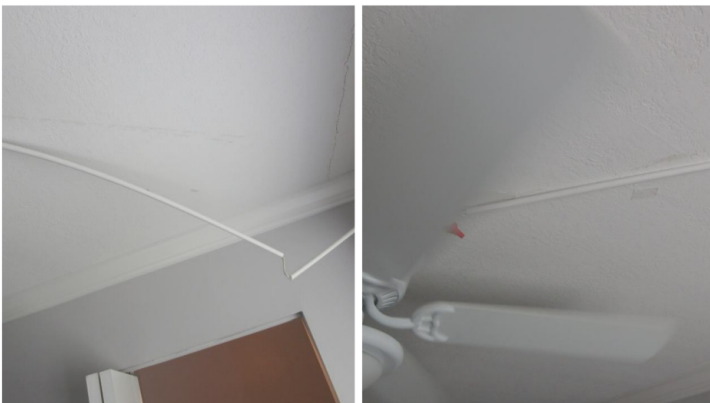
Wire is not properly attached to house structure.

Electrical wiring was not properly secured to the house structure, and a qualified electrician should evaluate and properly fasten the wiring as needed for safety and code compliance.

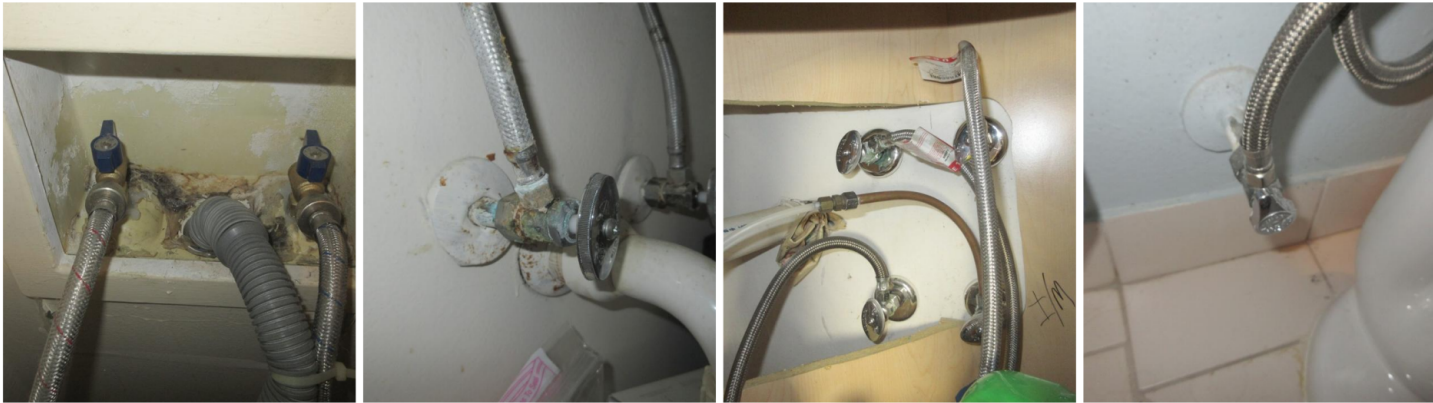
### 2.1 WATER LINES

Water inlet Shut-Off valves shows moderate corrosion, no leakage visible

During the inspection, moderate corrosion was observed on the water inlet shut-off valves; however, no leakage is currently visible. It is recommended to monitor these valves regularly for any signs of leakage or worsening corrosion. Consider consulting a licensed plumber to assess the need for maintenance or replacement to prevent future issues. Regular maintenance can help ensure the reliability and longevity of the plumbing system.

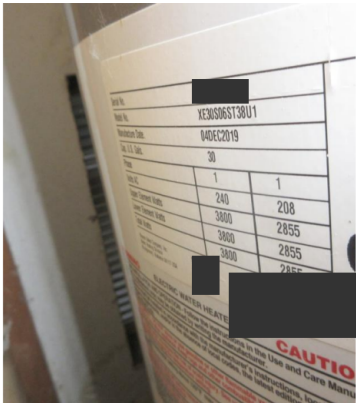
NAMEPLATE:

Rusted

The water heater shows signs of rust, which can indicate potential internal corrosion and may lead to leaks or failure. It is recommended to have a licensed plumber assess the condition promptly and consider replacement to prevent possible water damage.

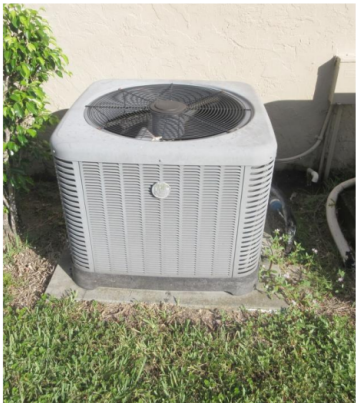
### 3.2 AC-CONDENSER

Unit is nearing the end of its design life

The AC condenser unit is nearing the end of its design life. It is recommended to budget for a replacement in the near future and schedule a professional evaluation to ensure continued performance and efficiency.

11 years old

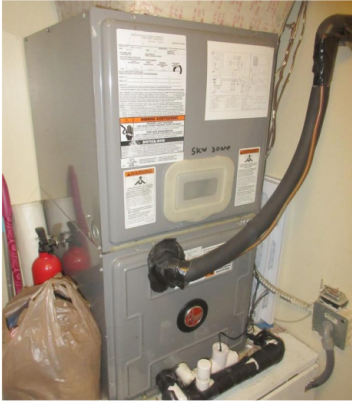
3.3 AIR HANDLER

Nearing the end of its useful life

The Air Handler is nearing the end of its useful life. Consider budgeting for a replacement in the near future to ensure system efficiency and reliability. Regular maintenance and monitoring by a qualified HVAC technician are recommended to extend its functionality until replacement.

11 years old

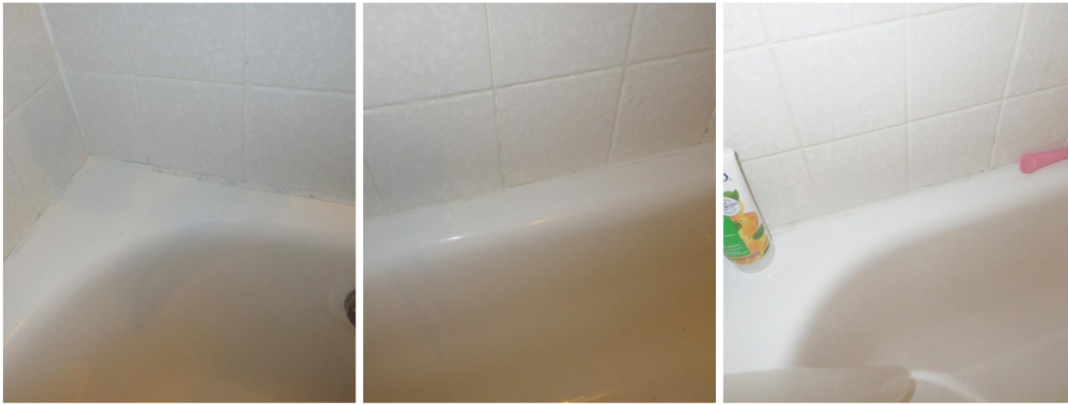
### 4.1 TUB/SHOWER/SURROUND

Caulking and grout around the tub/shower area is deteriorated

The caulking and grout around the tub/shower area are deteriorated, which could lead to moisture intrusion and potential water damage. It is recommended to remove and replace the deteriorated caulking and grout to ensure a watertight seal. Consider consulting a professional to ensure proper application and to prevent any future issues. Regular maintenance will prolong the integrity of the tub/shower surround.

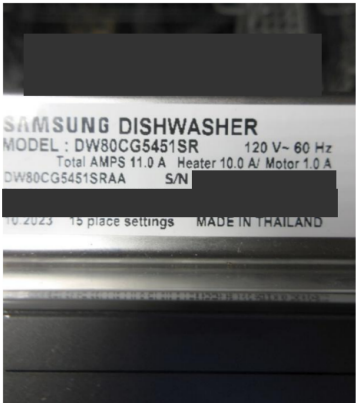
**NAMEPLATE:**

Drain pipe is not properly installation

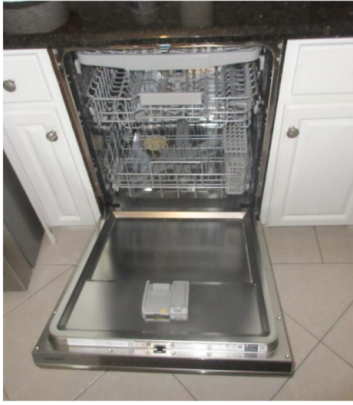
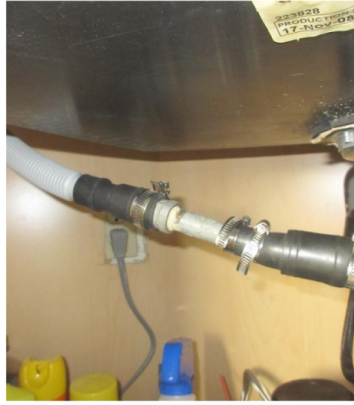
### 5.1 DISHWASHER

The dishwasher drain line was not properly installed, and a qualified plumber should repair or reconfigure it to ensure proper drainage and prevent potential backflow or leaks.

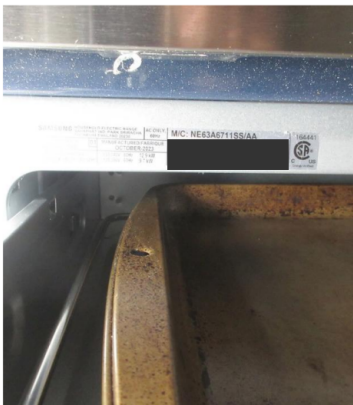
**NAMEPLATE:**

Unit is in good condition at the time of the inspection.

The kitchen range/oven is in good condition at the time of inspection. It functions properly with no visible issues. I recommend regular cleaning and maintenance, including checking connections and ensuring proper ventilation, to sustain performance and efficiency.

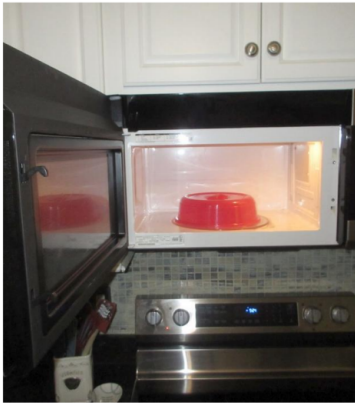
Unit is in good condition at the time of the inspection.

The kitchen microwave was observed to be in good condition at the time of inspection. It is functioning properly with no visible signs of damage or wear. For optimal performance, ensure regular cleaning and follow the manufacturer's maintenance guidelines.

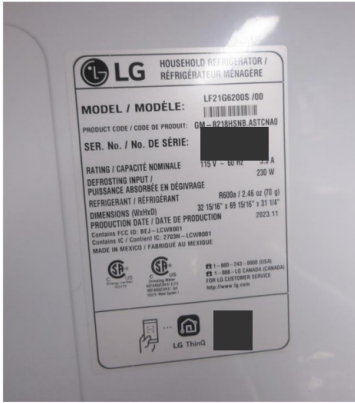
NAMEPLATE:

Unit is in good condition at the time of the inspection.

The kitchen refrigerator is in good condition at the time of inspection. Ensure routine maintenance, including cleaning the coils and checking door seals, to maintain efficiency and longevity. Regularly monitor temperature settings to keep food stored safely.

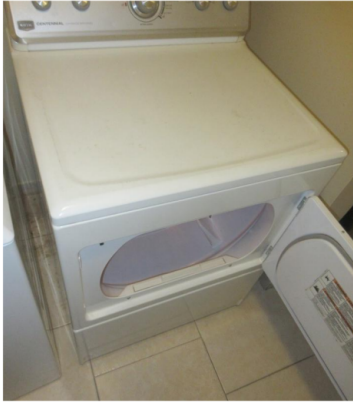
5.5 DRYER

Nearing the end of its useful life

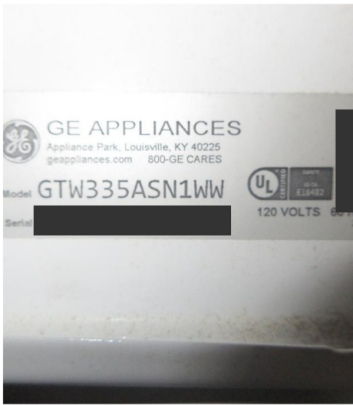
NAMEPLATE:

Unit is in good condition at the time of the inspection.

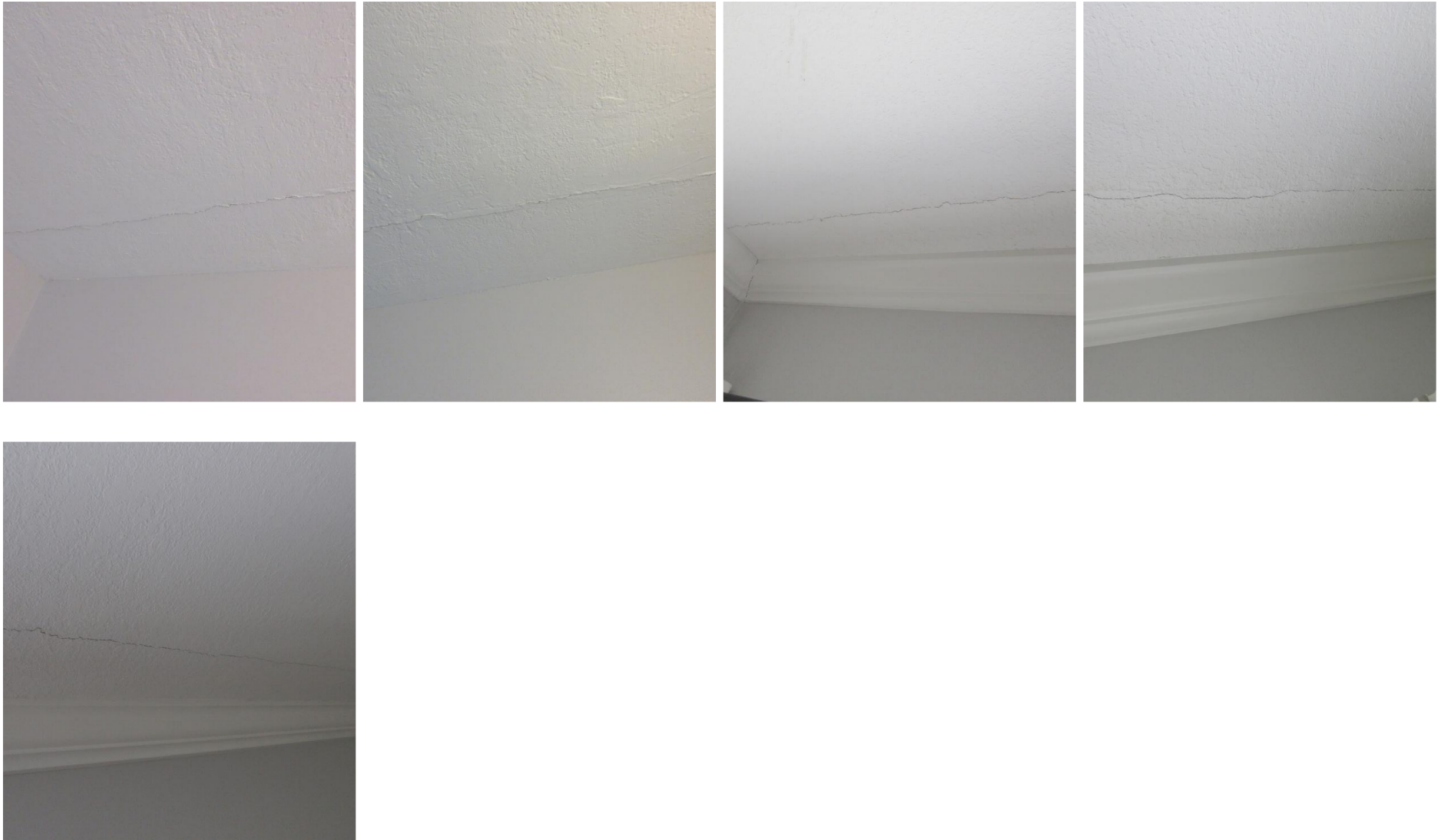
## 6.1 CEILING

Ceiling has crack

A crack was observed in the concrete ceiling, and evaluation by a qualified structural engineer or concrete repair specialist is recommended to determine the cause and make any necessary repairs.

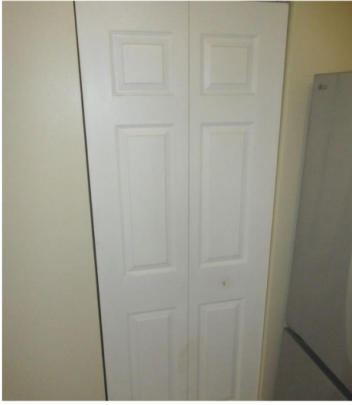
## 6.2 DOORS

Missing door knob.

A door knob was missing and should be replaced to restore proper operation, security, and privacy.

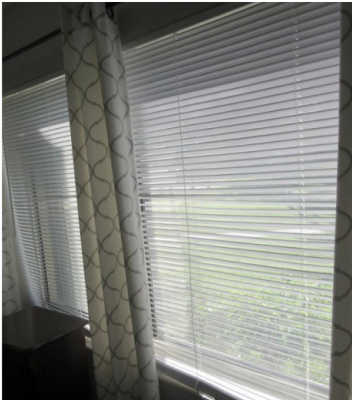
## 6.3 WINDOWS

Sliding window drag wheel in the bottom

The sliding window exhibits an issue with the drag wheel at the bottom, causing difficulty in opening and closing. It is recommended to have a professional adjust or replace the wheel to ensure smooth and proper operation. Regular maintenance can prevent future issues.

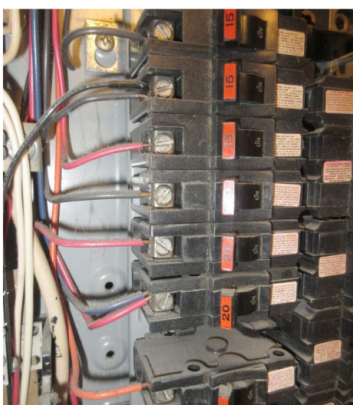
### 1.1 MAIN PANEL

Double tap is present in the breaker.

During the inspection of the electrical main panel, it was observed that there is a double tap present at the breaker. This condition occurs when two conductors are connected to a breaker meant for only one, which can lead to overheating and potential fire hazards. It is recommended to have a licensed electrician evaluate the situation further and correct the wiring by either installing a breaker designed for double taps or providing separate breakers for each conductor if needed.

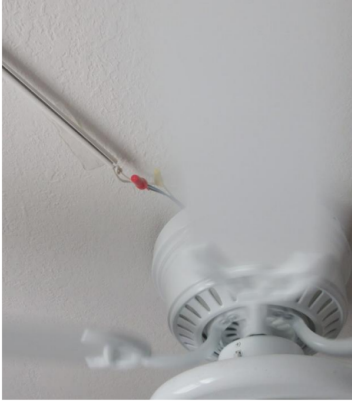
## 1.4 WIRING

Exposed

Exposed electrical wiring was observed, creating a potential shock and fire hazard; recommend evaluation and repair by a qualified electrician.

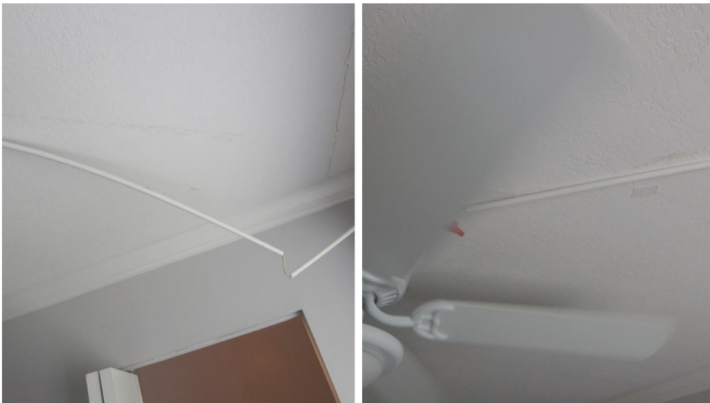
Wire is not properly attached to house structure.

Electrical wiring was not properly secured to the house structure, and a qualified electrician should evaluate and properly fasten the wiring as needed for safety and code compliance.

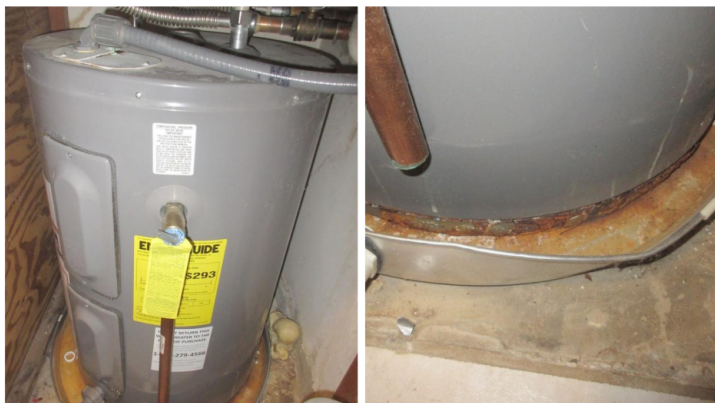
### 2.2 WATER HEATER

Rusted

The water heater shows signs of rust, which can indicate potential internal corrosion and may lead to leaks or failure. It is recommended to have a licensed plumber assess the condition promptly and consider replacement to prevent possible water damage.

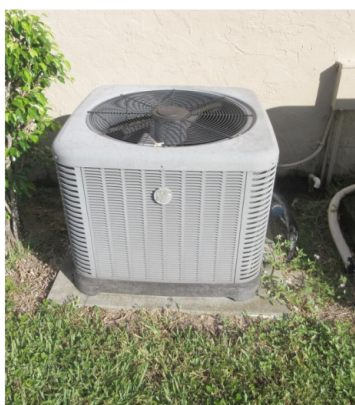
### 3.2 AC-CONDENSER

Unit is nearing the end of its design life

The AC condenser unit is nearing the end of its design life. It is recommended to budget for a replacement in the near future and schedule a professional evaluation to ensure continued performance and efficiency.

11 years old

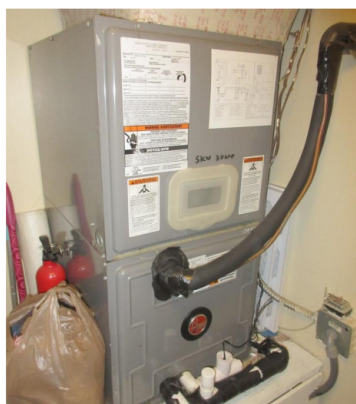
### 3.3 AIR HANDLER

Nearing the end of its useful life

The Air Handler is nearing the end of its useful life. Consider budgeting for a replacement in the near future to ensure system efficiency and reliability. Regular maintenance and

monitoring by a qualified HVAC technician are recommended to extend its functionality until replacement.

11 years old

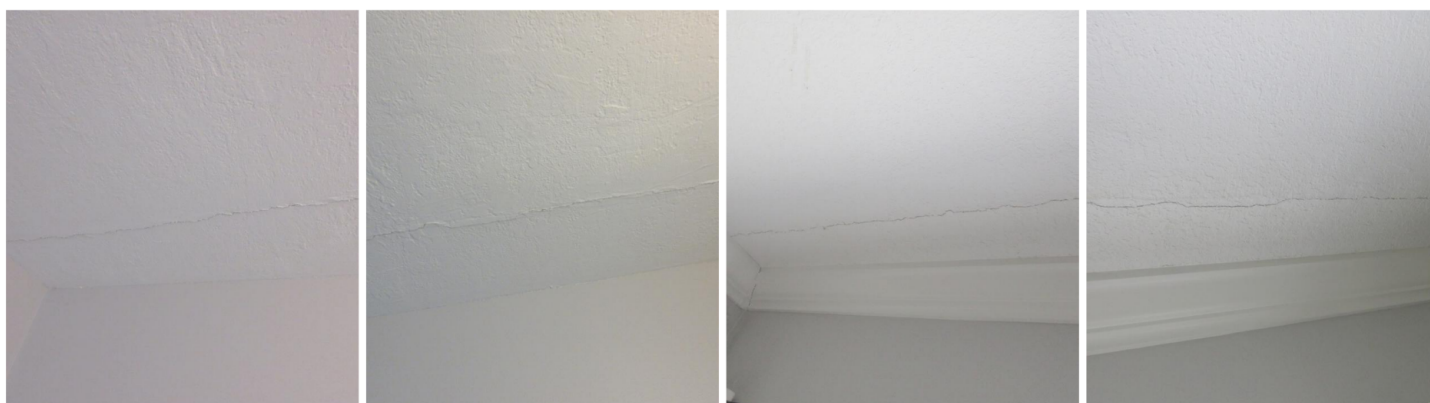
### 6.1 CEILING

Ceiling has crack

A crack was observed in the concrete ceiling, and evaluation by a qualified structural engineer or concrete repair specialist is recommended to determine the cause and make any necessary repairs.
