**Prepared For: Confidential Client  
South Florida Condominium**

**Year Built: 1982 Sq. Footage 991  
Weather: 86° & Rainy  
Home Inspection  
Wind Mitigation Inspection  
4 Point Inspection**

**William Scott**

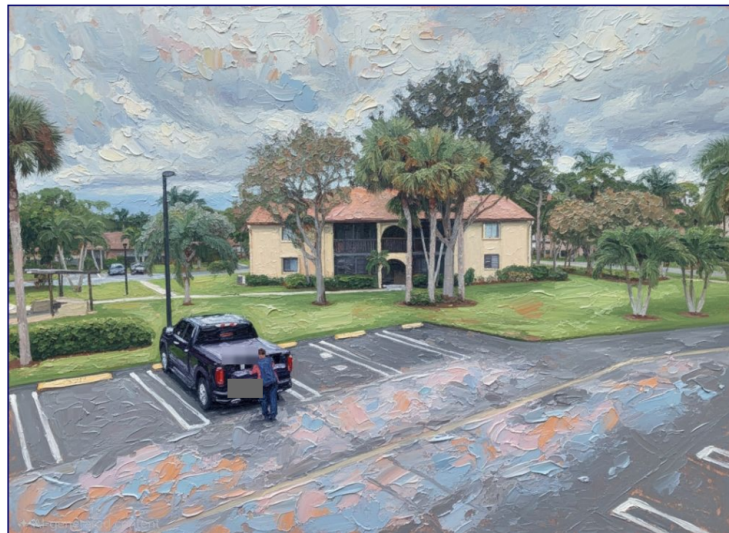
The home appears to be structurally sound but one or more of the components such as but not limited to cabinetry, plumbing fixtures and components, electrical, electrical components, windows & doors are dated. Please read your report carefully and consider all comments regarding the age of the home and its components, as the inspection evaluates serviceable conditions at the time of inspection. Depending on their age, older homes may contain environmental hazards or construction defects that were commonplace when they were built. We make every effort to identify these issues from a visual, non-invasive inspection.

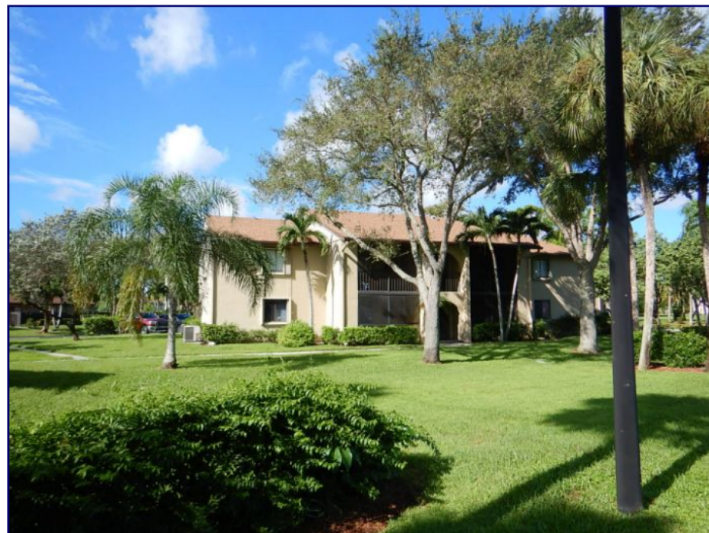
No visible structural concerns noted with the home at the time of inspection. Note: Structural observations for multi-family units (Condominiums, Villas, Apartments, etc...) are for the unit(s) to be inspected only. For high-rise and mid-rise buildings, I would highly recommend checking with the HOA and/or your local municipality for the most recent structural inspections and reports prior to the end of your home inspection period.

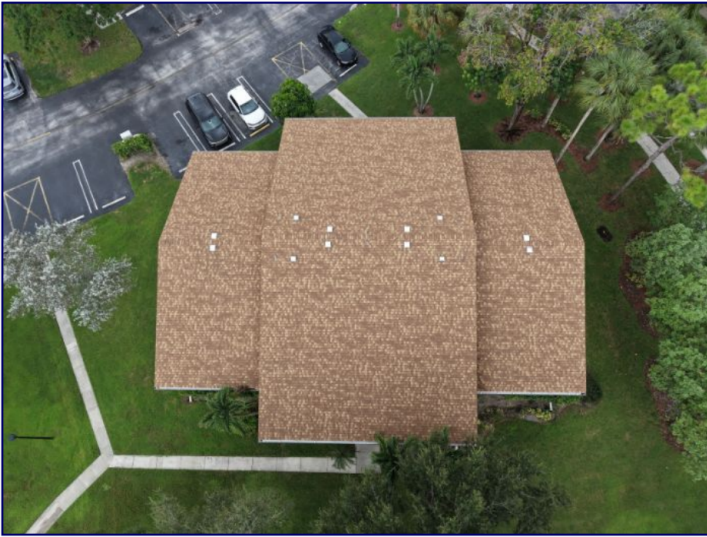
No major system or safety functional concerns with the structure of the roof at the time of inspection.

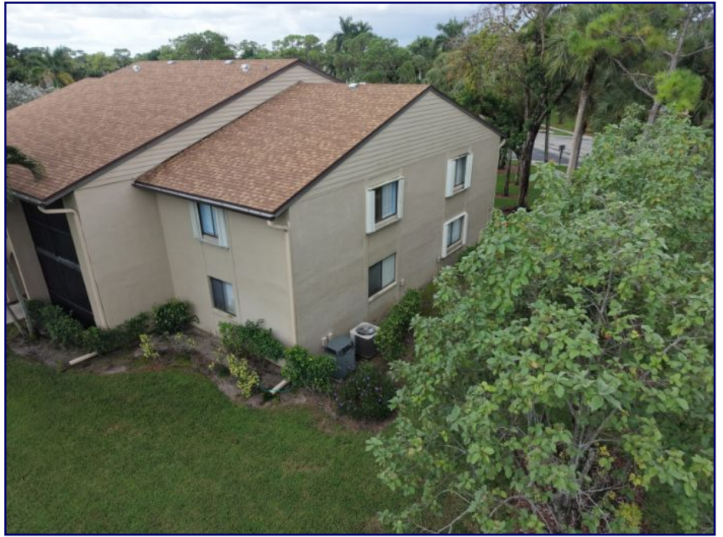
No major system safety or function concerns noted with the asphalt shingles at the time of inspection.

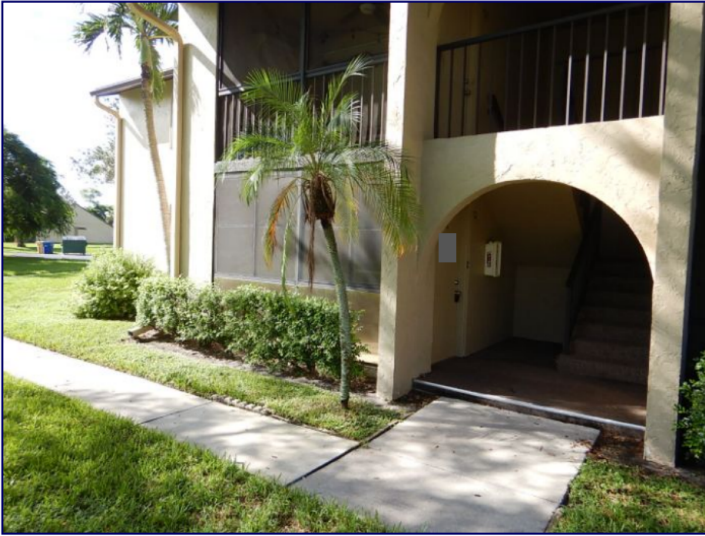
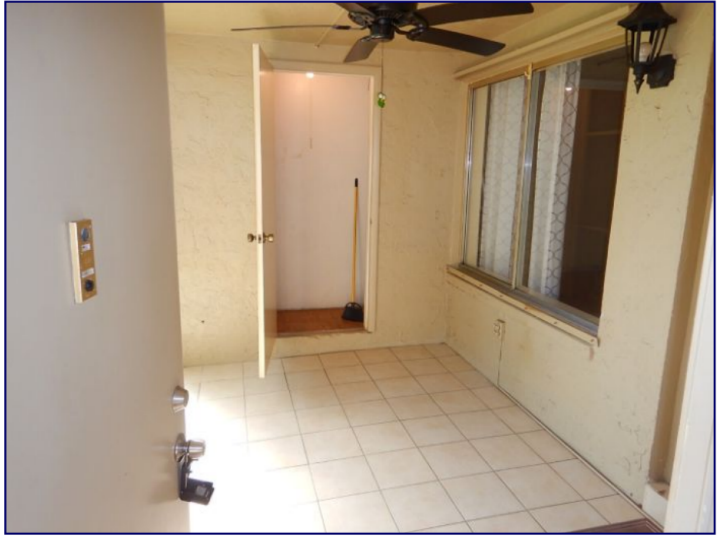
No significant issues noted with the screen enclosure at the time of inspection. The rear screened enclosure is in serviceable condition for its age.

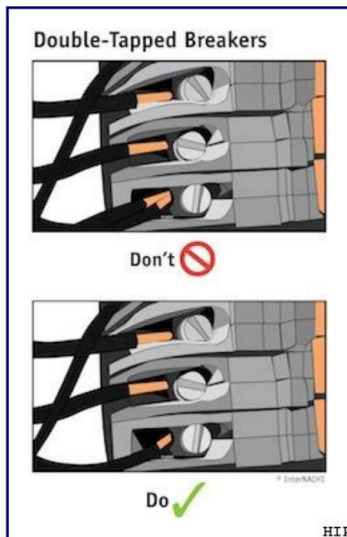
One or more double-tapped breakers were observed (more than one electrical conductor connected to a single breaker). This is considered improper wiring and a potential fire/electrocution hazard.

Corrections by a licensed electrician are recommended. This deficiency must also be noted on a 4-Point Inspection (if performed) and will generally need to be corrected before the home can be insured. See photo(s).

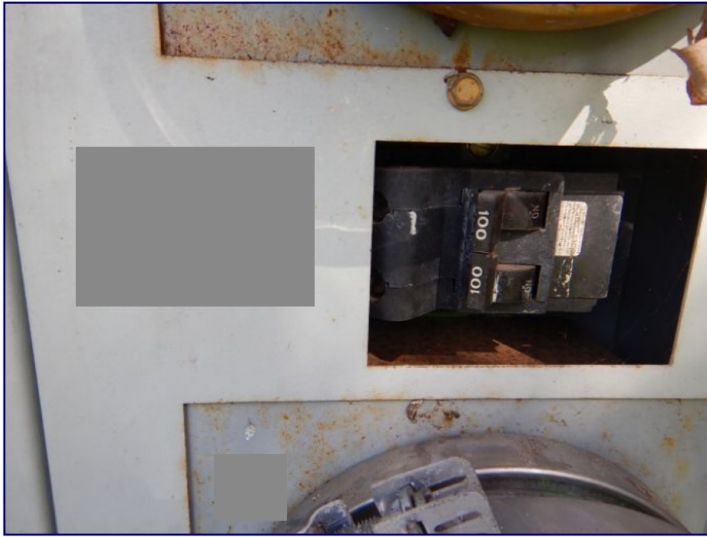
Main amperage coming into the home.

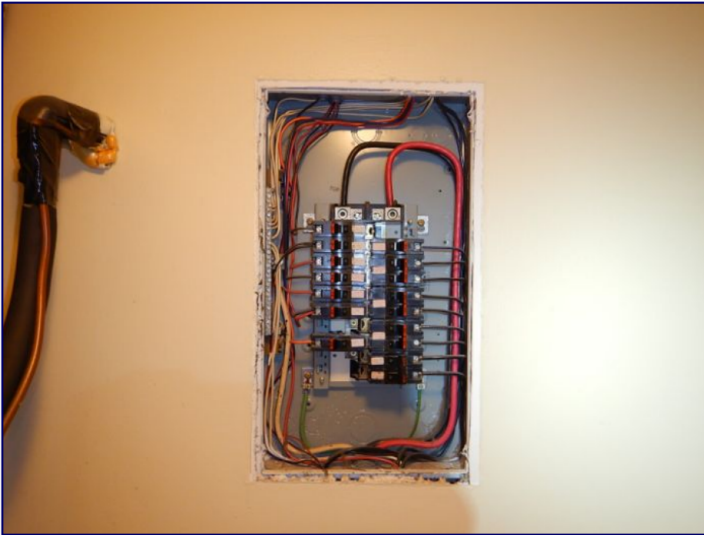
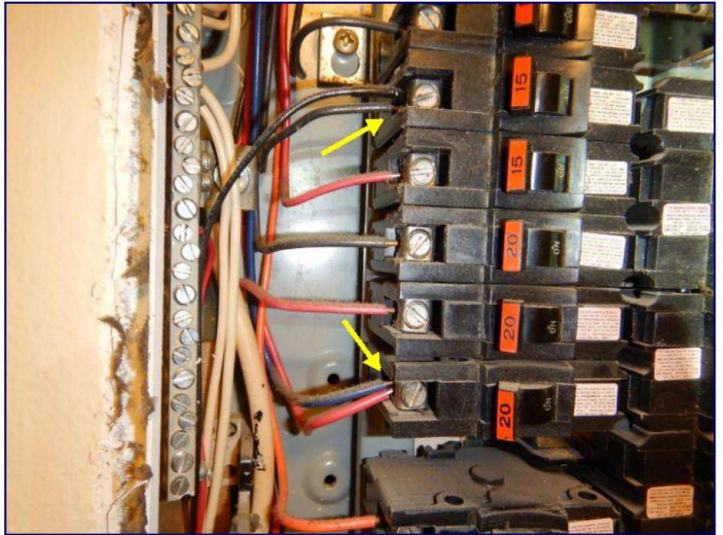
**Double-Tapped Breaker(s)**

One or more double-tapped breakers were observed (more than one electrical conductor connected to a single breaker). This is considered improper wiring and a potential fire/electrocution hazard.

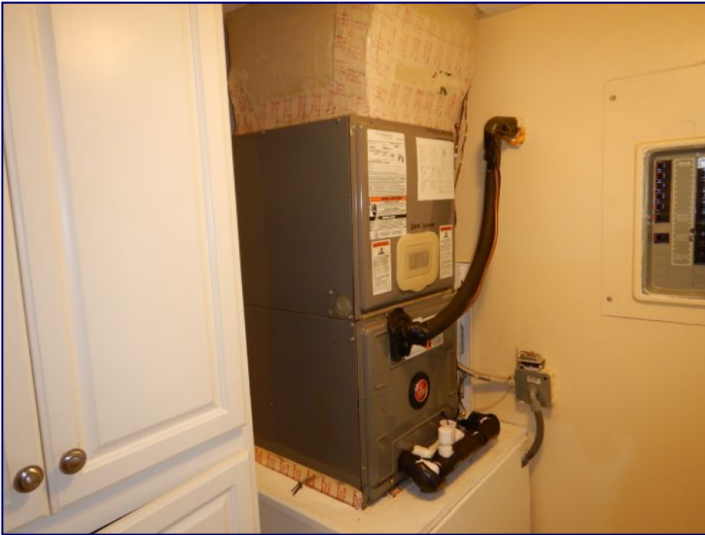
No notable operational concerns with your air handler at the time of inspection.

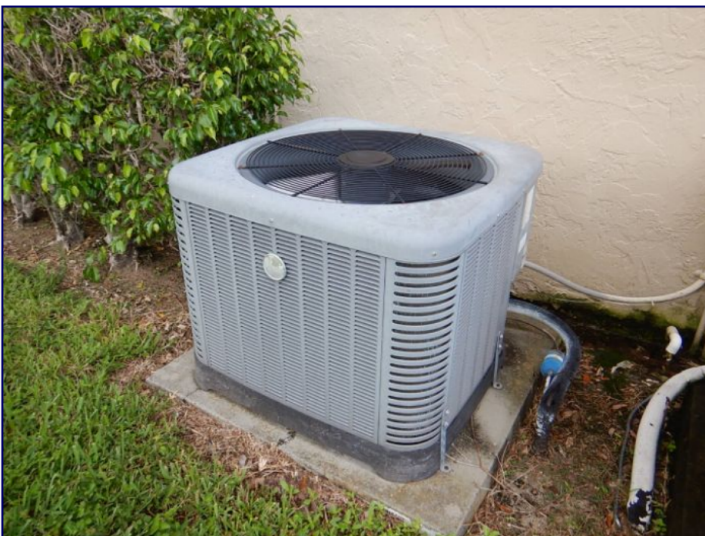
No notable operational concerns with your condenser unit at the time of inspection.

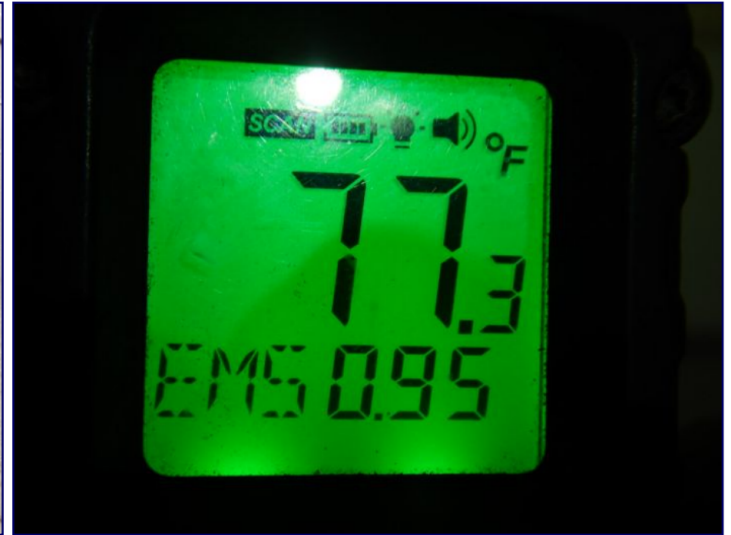
A Temperature Differential Test was performed to determine the efficiency of your HVAC system. (See photos) Temperature around the air return is taken and compared to the temperatures coming out of your air-conditioning registers. There should be a 16° to 20° split between the two. Anything lower than 16 degrees you should consider having your HVAC system serviced by a licensed HVAC company. Service would include but is not limited to cleaning of the air handler/ condenser coils, checking the Freon levels, changing the filter and cleaning your condensate drain line.

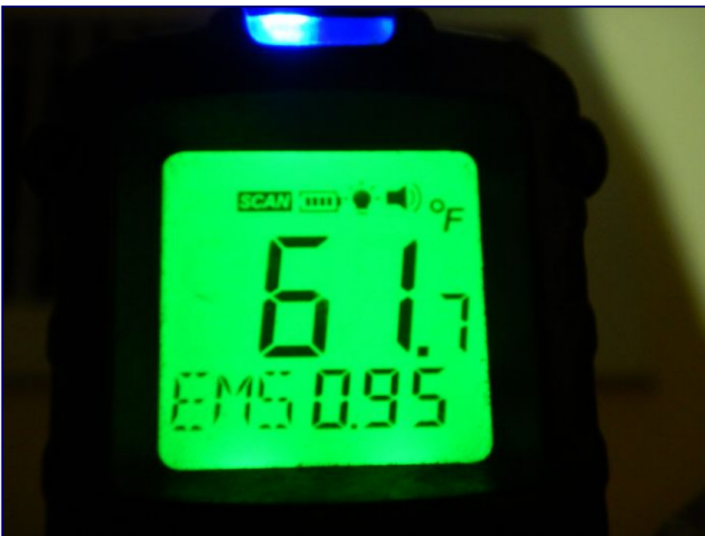
The 2nd part of your HVAC energy efficiency test. The optimum split between the two temperatures is 16° to 20° degrees. If the difference in temperature is not within this range, consider having your HVAC system serviced by a licensed HVAC company to increase energy efficiency.

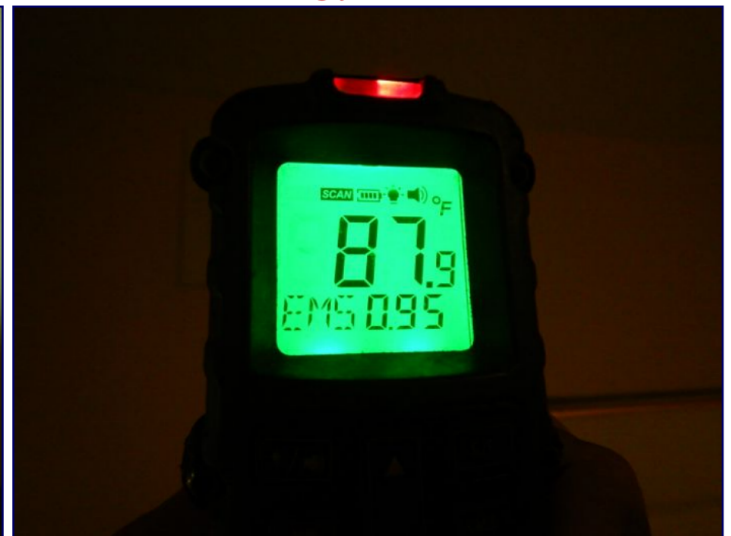
Your heat was tested and temperatures were noted to have reached (see photo) we typically like to see minimum temperature of 85°.

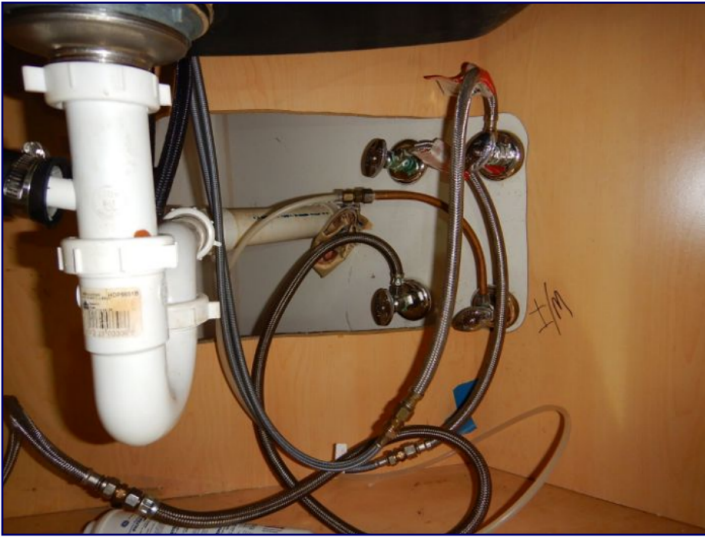
Some or all of the interior plumbing shut off valves and/or plumbing fixtures for the home are dated and/or original to construction. (See Photo(s).) No deficiencies exist other than what is listed throughout this report. Keep in mind that due to the potential for the development of uncontained leaks which may require emergency service from a licensed plumbing company, dated supply shut off valves are not exercised or tested for operations. Expect to find shut off valves at kitchen & baths under sinks, behind toilets, at water heater(s) and at the laundry area that may need service or replacement. All plumbing that is not susceptible to uncontained leaks such as sink faucets/ tub and shower supplies will be inspected for proper operations such as slow drainage, visible leaks, proper water pressure and overall general operational conditions.

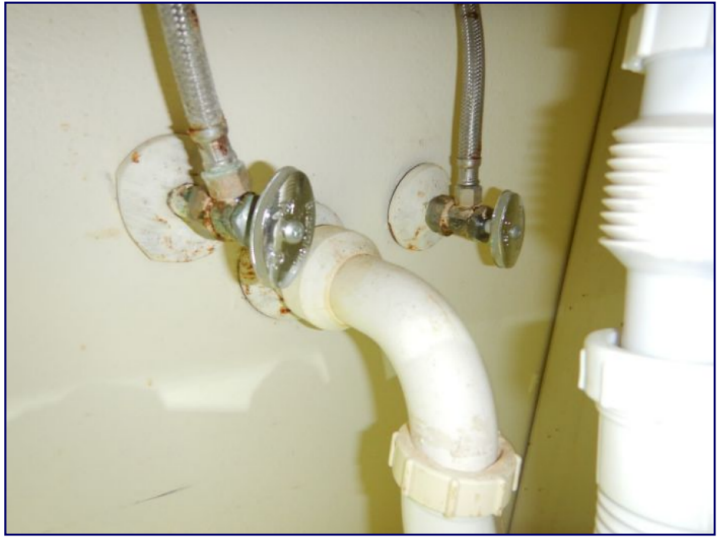
Some or all of the interior plumbing shut off valves and/or plumbing fixtures for the home are dated and/or original to construction. (See Photo(s).) No deficiencies exist other than what is listed throughout this report. Keep in mind that due to the potential for the development of uncontained leaks which may require emergency service from a licensed plumbing company, dated supply shut off valves are not exercised or tested for operations. Expect to find shut off valves at kitchen & baths under sinks, behind toilets, at water heater(s) and at the laundry area that may need service or replacement. All plumbing that is not susceptible to uncontained leaks such as sink faucets/ tub and shower supplies will be inspected for proper operations such as slow drainage, visible leaks, proper water pressure and overall general operational conditions.

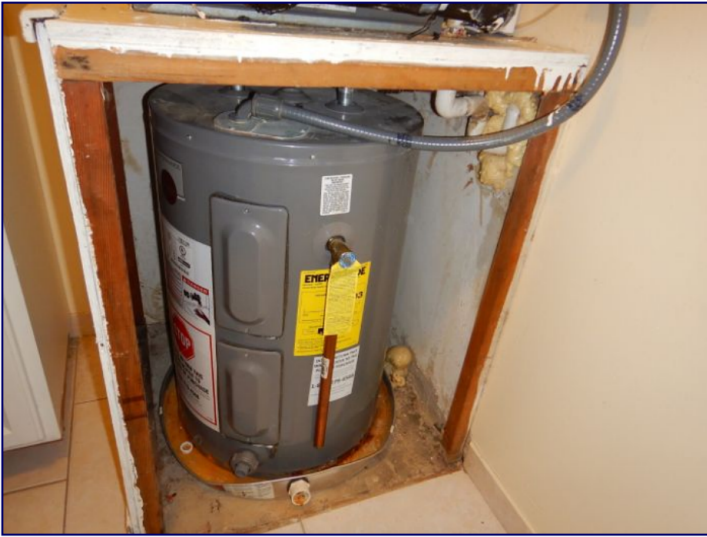
| Page 31 Item: 5 | Water Heater 1<br>Observations | <ul style="list-style-type: none"> <li>• <b>ENCLOSURE:</b></li> <li>• Rust/ corrosion noted at the water heater enclosure. Monitor for further deterioration or leaks. No leaks observed at the time of inspection.</li> </ul> |

- **Rust/ corrosion noted at the water heater enclosure. Monitor for further deterioration or leaks. No leaks observed at the time of inspection.**

Limited access to water heater; not all areas of the enclosure visible for inspection due to confined space, insulation wrap, etc...

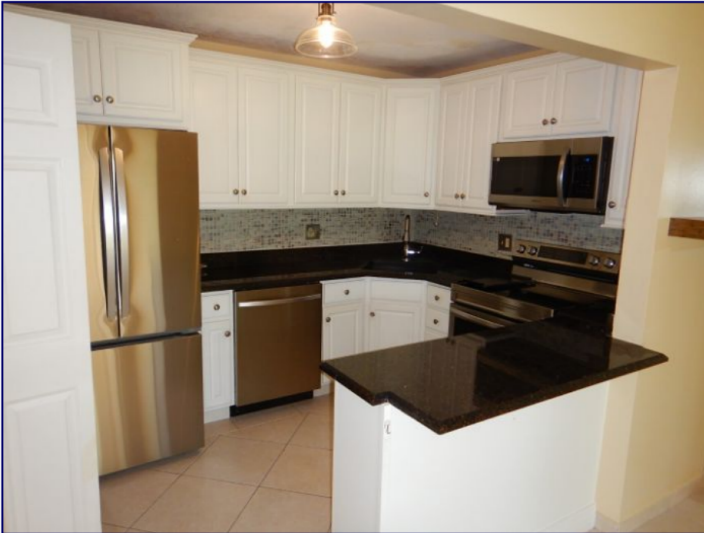
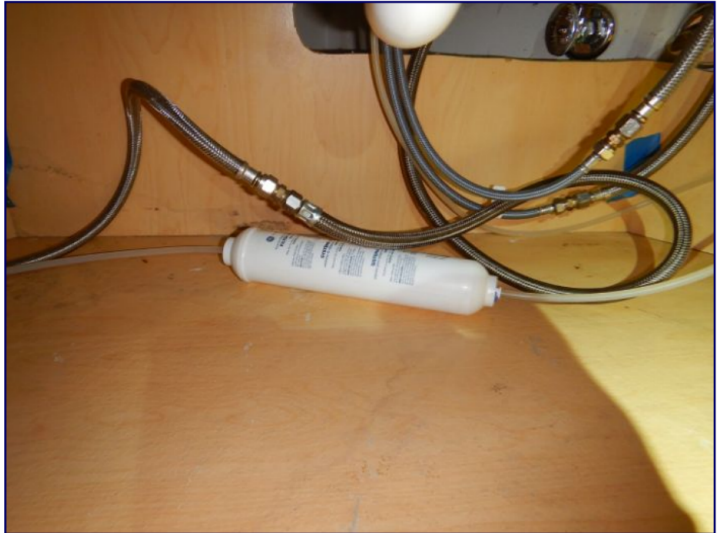
No issues noted with the cabinetry, surfaces, plumbing supply/ drains, general functioning of appliances or lighting other than what is noted.

I would highly recommend replacing your water filters after closing and prior to use.

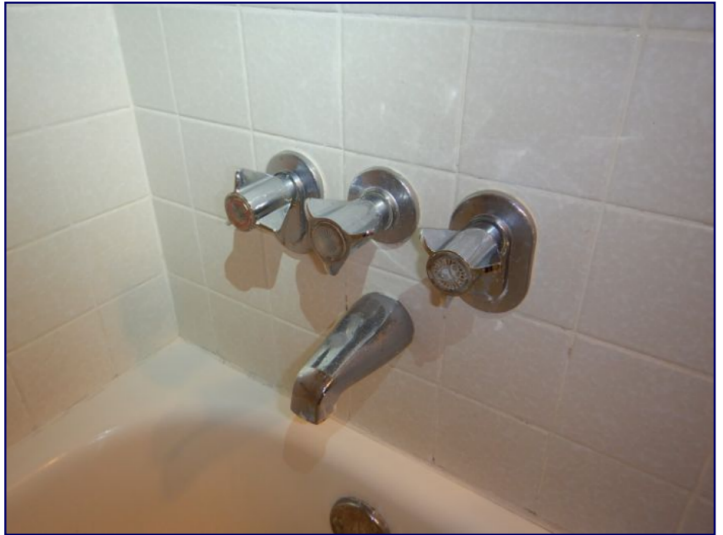
Supply fixtures at the shower/tub are dated but functional. No significant issues noted with the supply fixtures at the time of inspection.

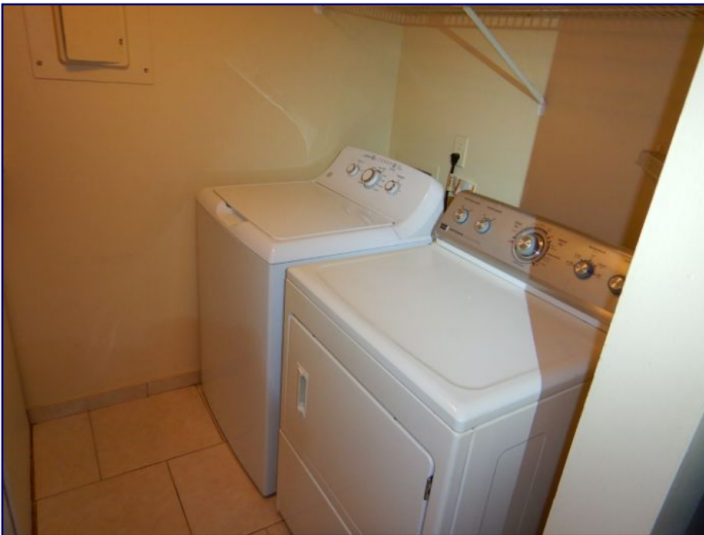
- **Operating conditions were consistent with restricted dryer exhaust airflow. Excessive heat was noted at the upper dryer cabinet with inadequate heat/air movement at the lint-filter area. Recommend professional inspection and cleaning of the dryer vent system. Restricted dryer venting may create a fire hazard.**

No operational deficiencies observed with the washer & dryer at the time of inspection. The washer was operated on the rinse/drain cycle which runs through all cycles (fill, agitate, drain and spin). Operations are noted to be acceptable for the age of the appliances. The dryer was operated at the highest temperature cycle and was noted to be heating properly. Inspection does not include interior dryer vent condition or restrictions. Cleaning of the dryer vent immediately after move in and on an annual basis thereafter is recommended.

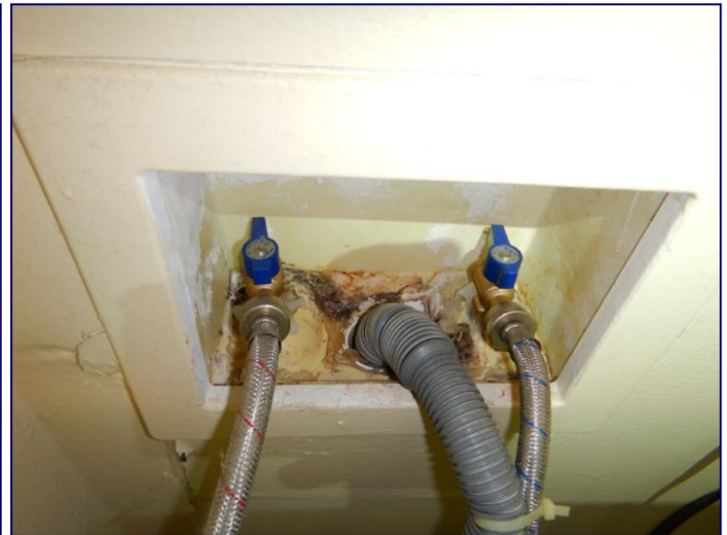
No major safety system or functional concerns for your water supply noted at the time of inspection. Note: Rubber Supply Lines have a finite life expectancy and should be replaced every 5 years, braided stainless steel hoses have a life expectancy of 10 years per manufacturer's recommendations. Check with the seller as to when they were last replaced and replace as necessary.

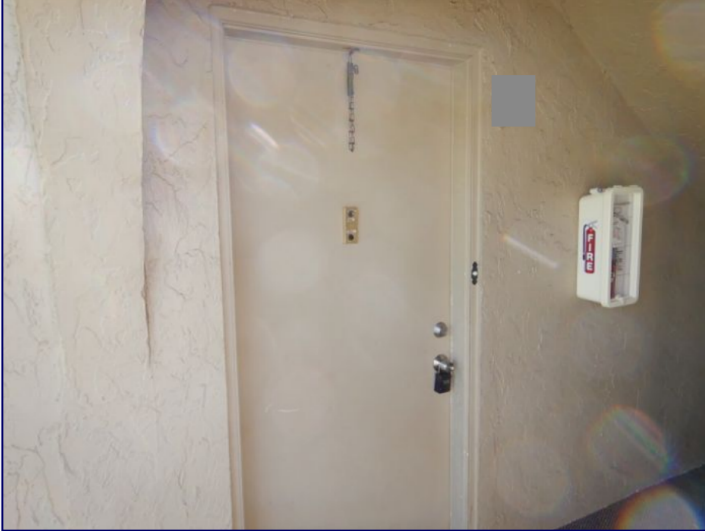
No significant cosmetic or functional concerns noted with the interior/ exterior doors noted at the time of inspection other than what is listed.

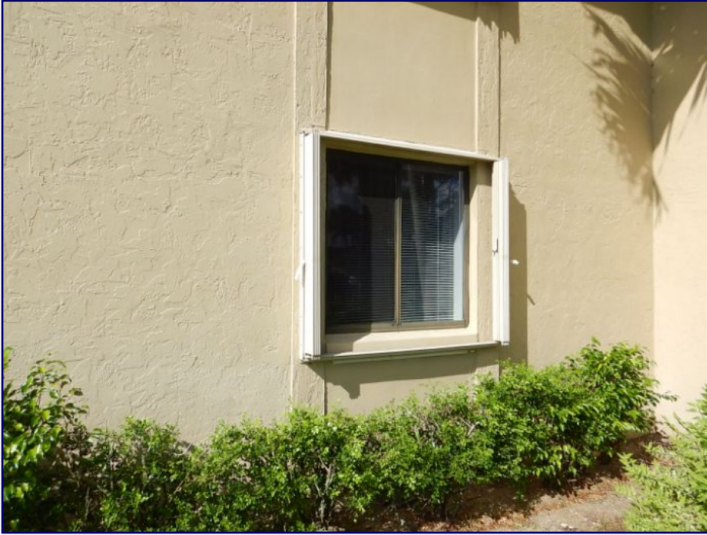
Windows are aged and original to construction but functional. Maintenance as well as ongoing maintenance will be needed such as cleaning of the tracks & weep holes, window glides, lubrication or replacement of balance rods, window locks etc... Contact Larry Lacy at 561-577-6815 for service.

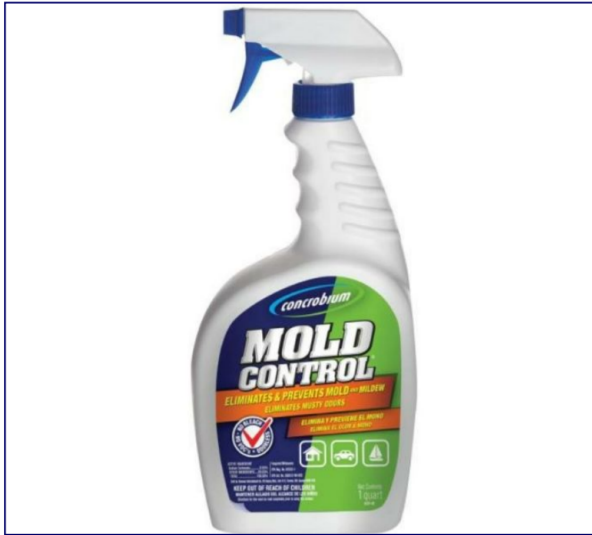
- **Conditions observed during the inspection may contribute to indoor air quality and/or mold-related concerns for certain individuals, particularly the accumulation of dust/debris and other conditions noted within the HVAC system. These observations do not establish airborne contaminant levels or confirm a significant indoor air quality or mold problem. Because individual allergies, respiratory sensitivities, and other health considerations vary, Advanced Indoor Air Quality and/or mold testing should be considered if the client has concerns regarding the indoor environment or the sensitivities of current or future occupants.**

When performing a visual assessment, we identify visible conditions that may suggest biological growth and conditions conducive to mold growth. Visual inspection alone does not establish the identity of the material, airborne concentrations, or its effect on indoor air quality or occupant health. Concealed conditions cannot be determined by visual inspection alone.

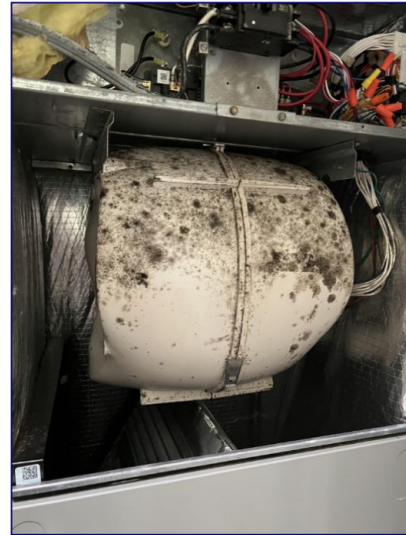
**HVAC SYSTEM:** Stock Photo of conditions that may exist in air handlers over 5 years of age.

Mold development in, on or around HVAC air handlers, plenums and/or duct work is not uncommon.

For air handlers or plenums over approximately five years of age, further evaluation and cleaning as necessary by a licensed HVAC contractor is recommended as preventive maintenance. Inaccessible interior components may contain accumulated dust, debris or biological growth, but no finding in those components is implied. Conditions in unconditioned spaces may warrant more frequent service. Treatment should be based on the contractor's evaluation of actual conditions, not age alone.

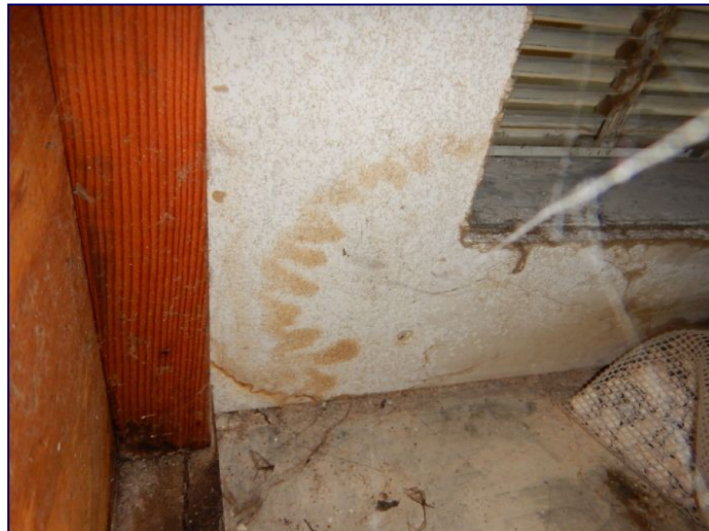
Moderate amounts of material that appears to be biological growth were observed on accessible portions of the HVAC plenum. Further evaluation and appropriate cleaning as necessary by a licensed HVAC contractor experienced with this type of cleaning is recommended. Cleaning methods should be based on the actual conditions and the equipment manufacturer's instructions. Inaccessible interior components were not evaluated as part of this observation. Removal or replacement of affected insulation or building materials should be determined by the appropriate professional. If the growth is significant or widespread, affects building materials or substantial concealed areas, exceeds approximately 10 square feet, or extends beyond HVAC service scope, evaluation and remediation by a Florida-licensed mold remediator should be considered. Visual inspection alone does not establish the identity of the material, airborne concentrations, or its effect on indoor air quality or occupant health.

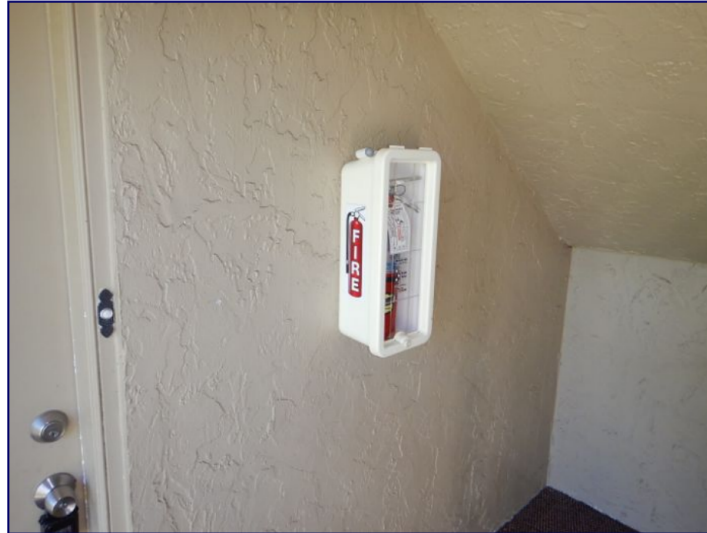
• Fire extinguisher(s) are located outside at front of the home of the home at HOA common area (hallway, breezeway, etc.). I would recommend that you familiarize yourself with this location in case of a fire.

Fire extinguisher(s) are located outside at front of the home of the home at HOA common area (hallway, breezeway, etc.). I would recommend that you familiarize yourself with this location in case of a fire.
