**123 Main Street**

**Date: 6/30/2026**

**Year Built: 1959 Square Ft. 1232**

**Home Inspection**

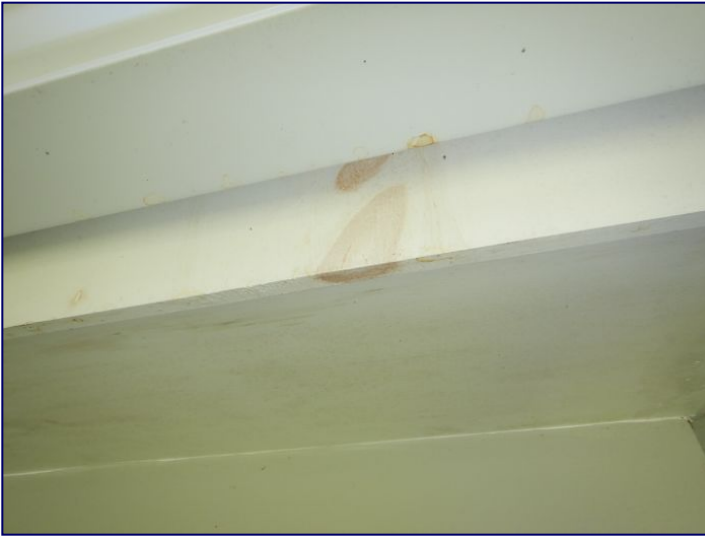
Seep staining deterioration of the underlayment noted on fascia at multiple locations throughout the exterior.

This is an indication of age and deterioration of the underlayment and may be an indication that water is starting to infiltrate the underlayment. Whether active leaks inside the home or attic are noted or not, a further, more invasive evaluation and potential repairs by a licensed roofing contractor is recommended to prevent deterioration, wood rot and potential leaks.

Monitor these areas at the interior of the home for leaks.

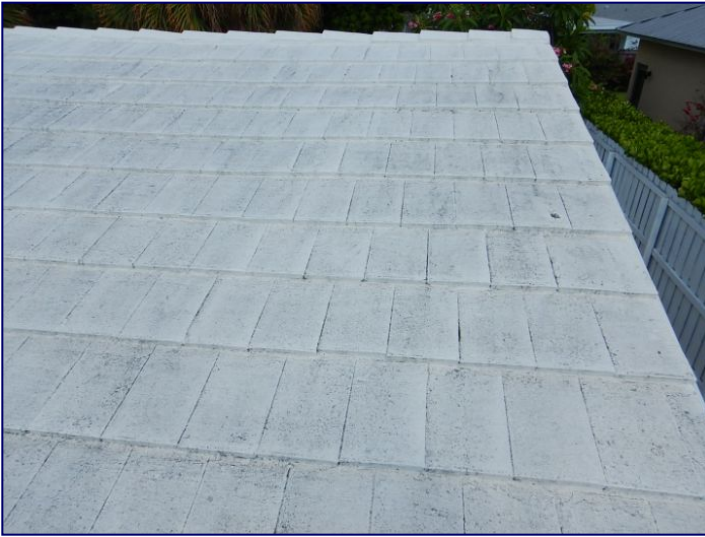
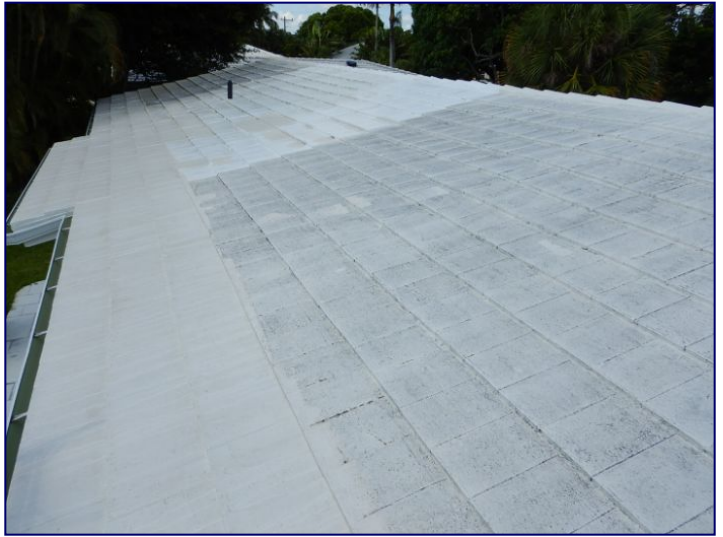
**Roof Covering – Concrete Tile:** The concrete tile roof has been coated with an elastomeric-type roof coating/sealant. Variations in the appearance, weathering, and coating application indicate that portions of the roof appear to have been coated or recoated at different times, possibly as part of previous leak repairs or maintenance. The age of the roof could not be verified, as no roof replacement permit was found during a search of the local building department records. As of December 15, 2022, Citizens Property Insurance Corporation clarified that roof coatings and sealants, including elastomeric coatings, do not constitute a roof replacement and are not accepted in lieu of roof replacement when replacement is otherwise required for insurability.

During the inspection, minor fungal deterioration and potential water intrusion points were observed at multiple soffit locations. Additionally, water seepage staining was noted at multiple areas of the freshly painted fascia, suggesting that cosmetic painting may have concealed or masked previous moisture intrusion. Collectively, the multiple coating applications, apparent maintenance history, fungal deterioration, potential leak points, and seepage staining are strong indicators that the roof underlayment has reached or exceeded the end of its serviceable life expectancy.

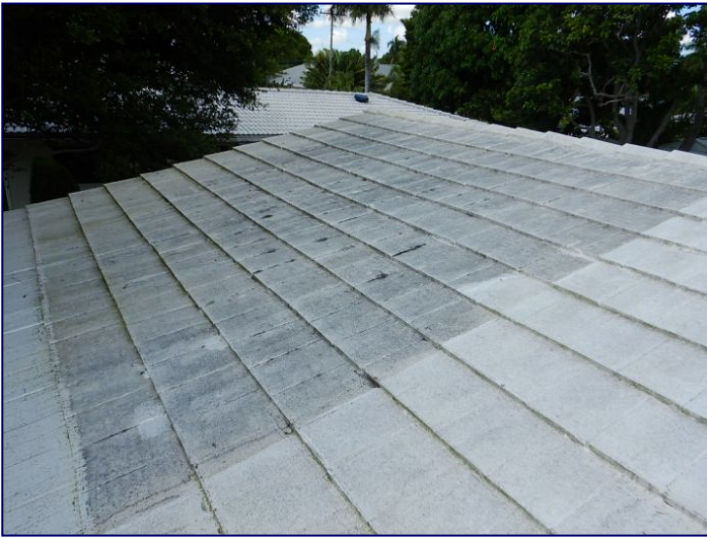
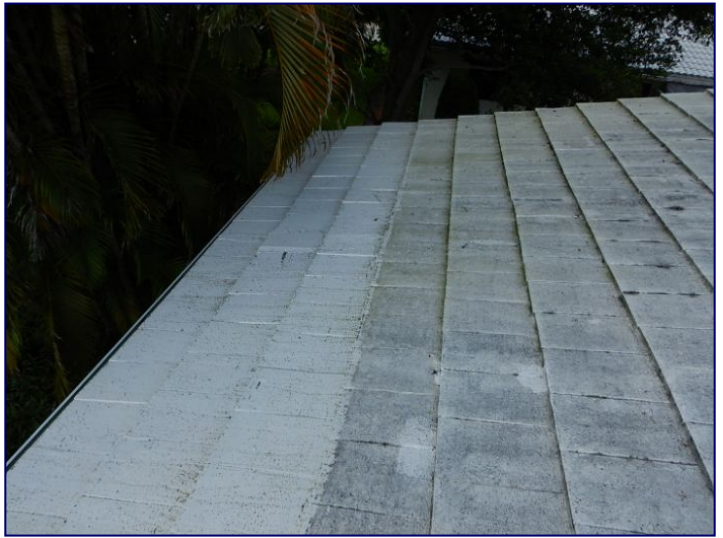
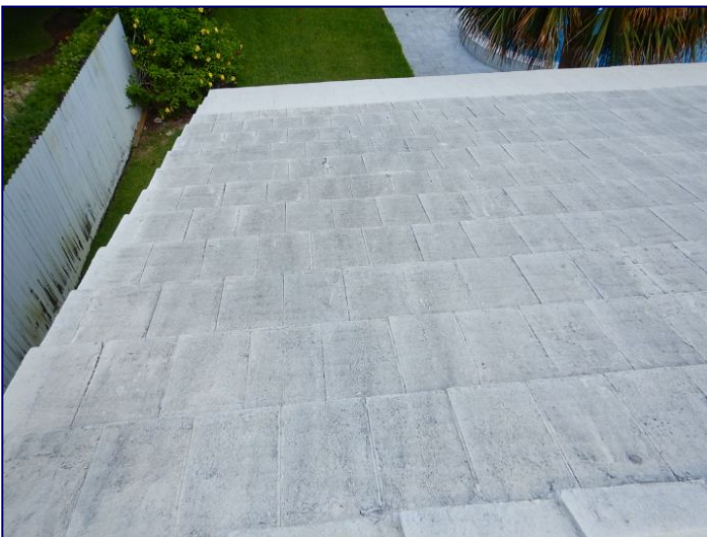
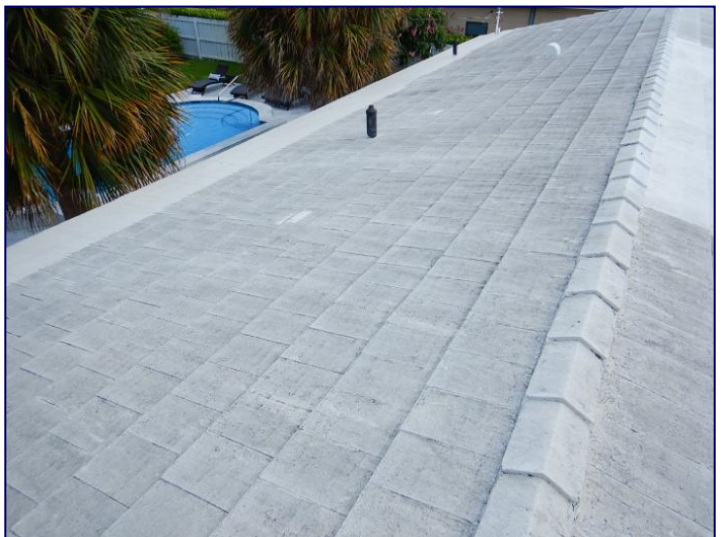
Serviceability of the roof is questionable; further more invasive evaluation by a licensed roofing contractor is recommended.

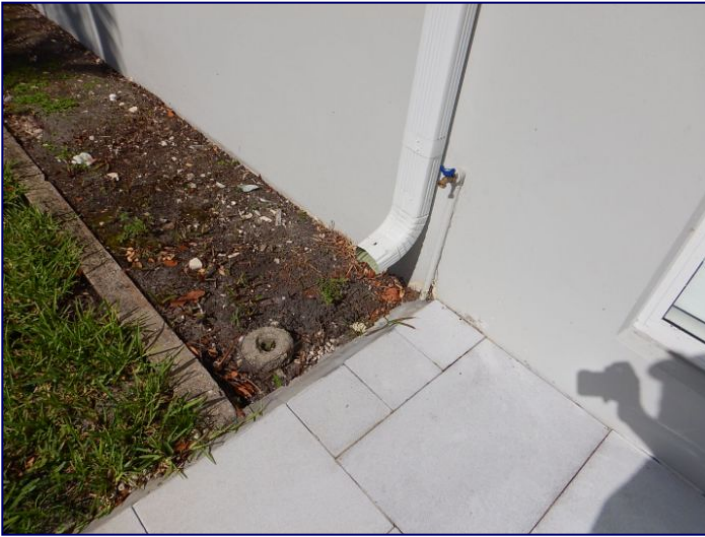
Extensions / Splash blocks missing or insufficient at multiple locations throughout the exterior: Install to divert water away from the foundation.

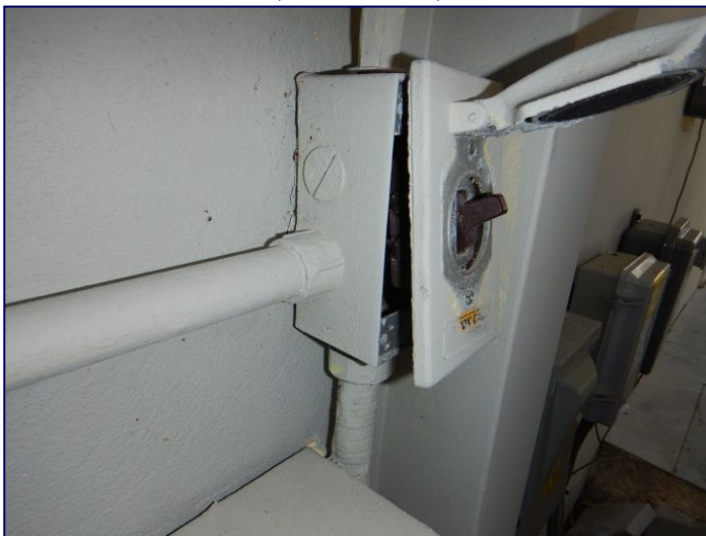
Switch cover(s) at: rear of the home are for interior use, damaged or missing at: I would recommend replacement to prevent water intrusion, rust, deterioration, possible failure or electrocution.

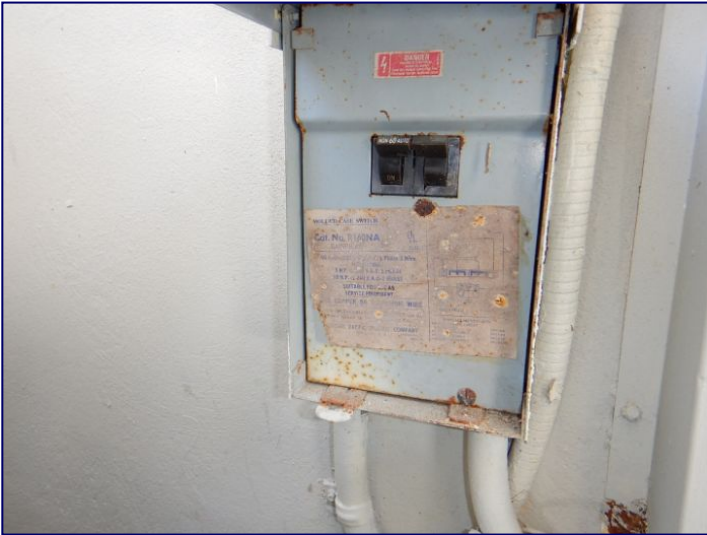
The air handler electrical disconnect is dated and appears to be at or past its serviceable life expectancy. I would recommend replacement at the next HVAC change out.

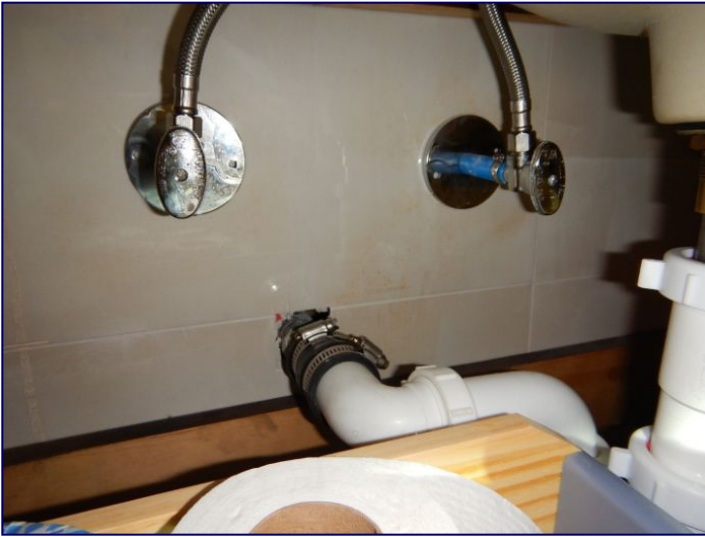
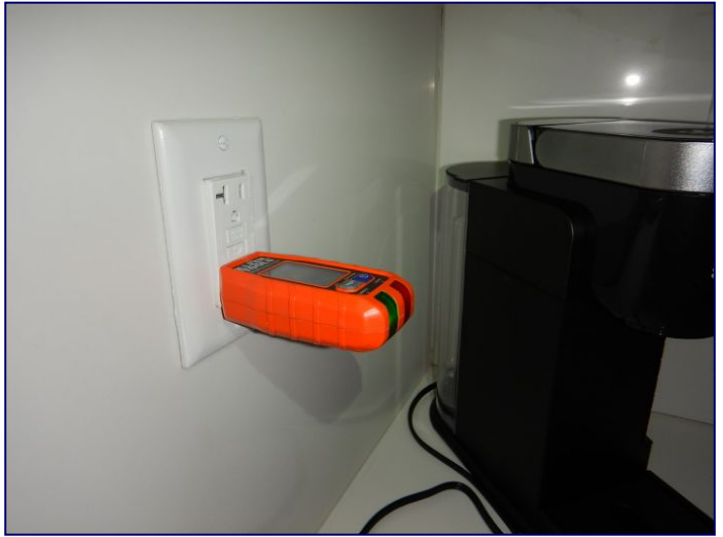
Some or all of the interior plumbing shut off valves and or plumbing fixtures for the home are dated and or original to construction. (See Photo(s) No deficiencies exist other than what is listed throughout this report.

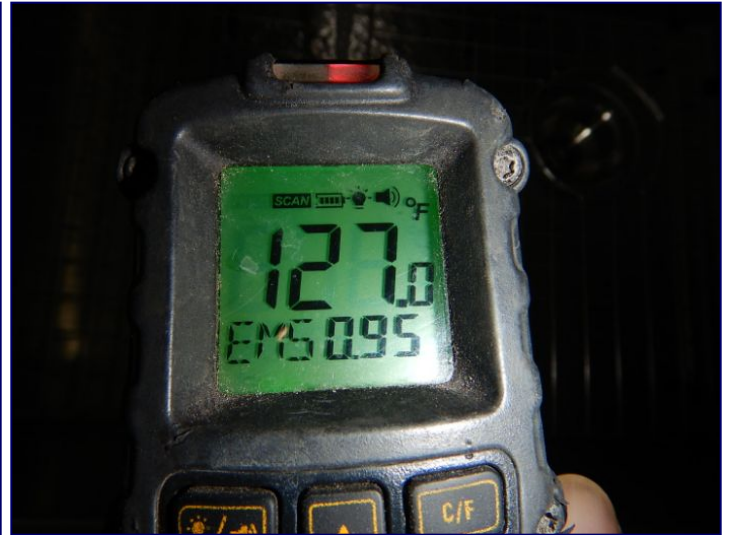
It is recommended that your water temperature not exceed 120° as this can be a scalding hazard to infants and the elderly. I would recommend lowering the temperature below 120°.

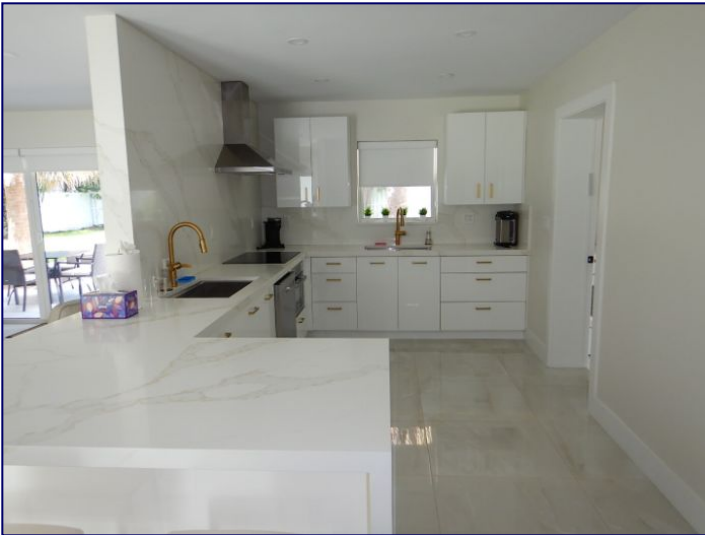
Back splash needs Minorcaulking/ rerouting to prevent water intrusion into or behind the cabinetry below which can cause damage to the cabinetry and the potential development of mold and indoor air quality issues.

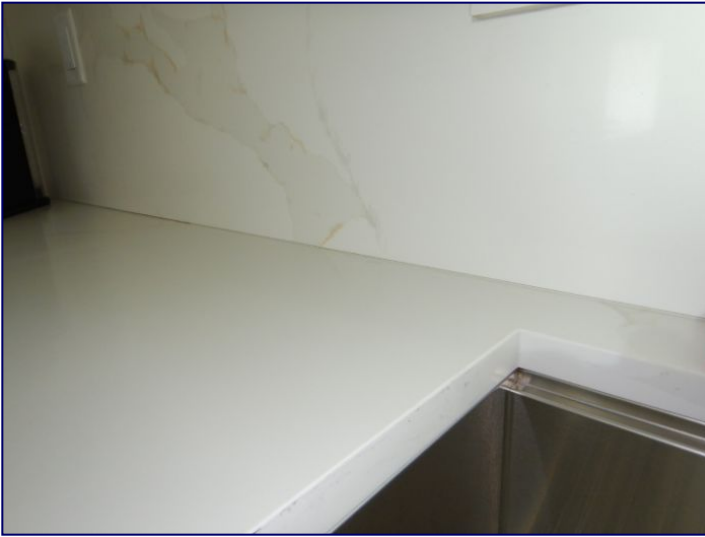
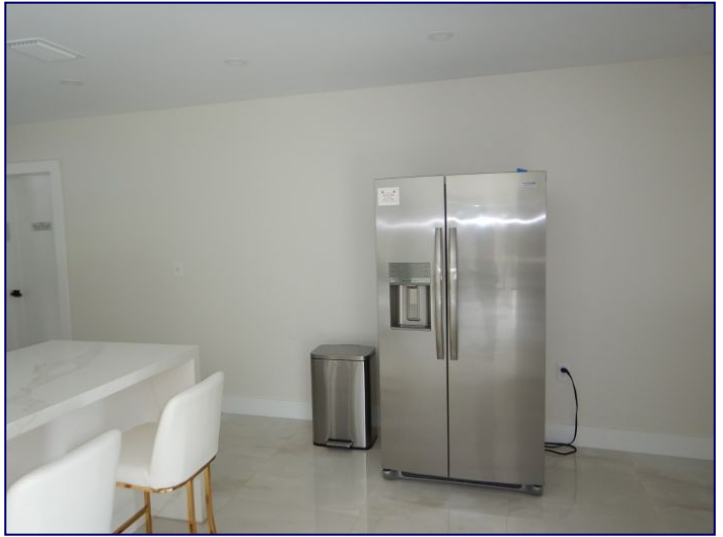
No water line connected to the refrigerator at the time of inspection. Water dispenser and ice maker could not be evaluated for operations.

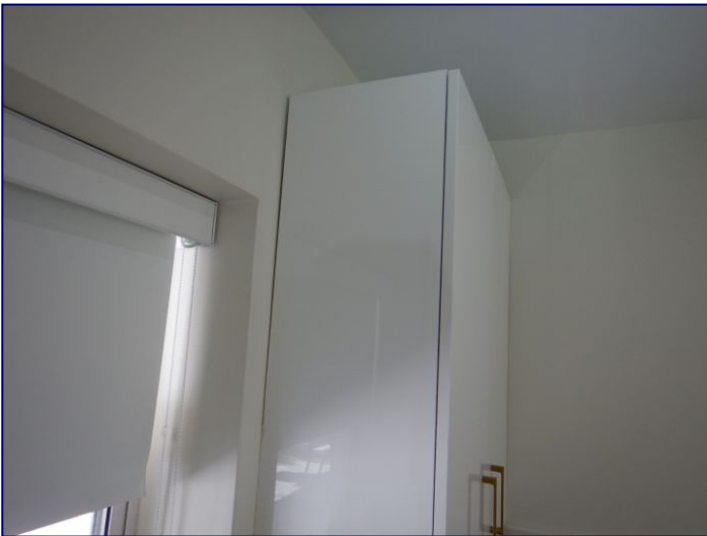
- Loose upper cabinet noted at the kitchen area, I recommend tightening and caulking around all upper cabinets

Loose upper cabinet noted at the kitchen area, I recommend tightening and caulking around all upper cabinets

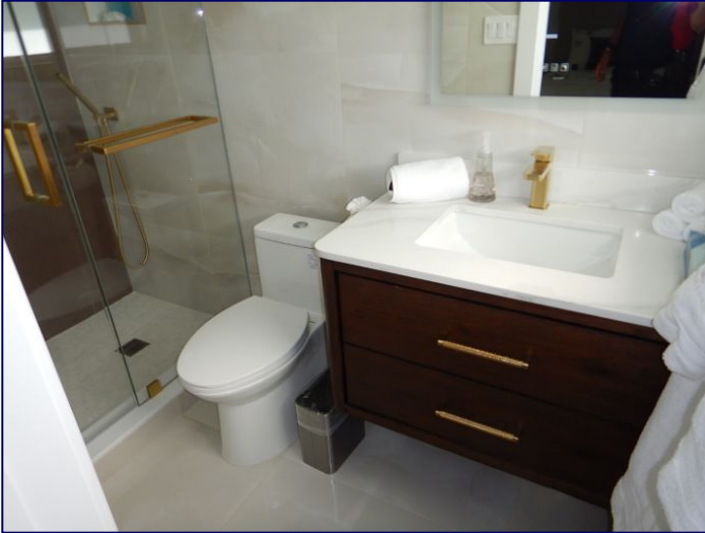
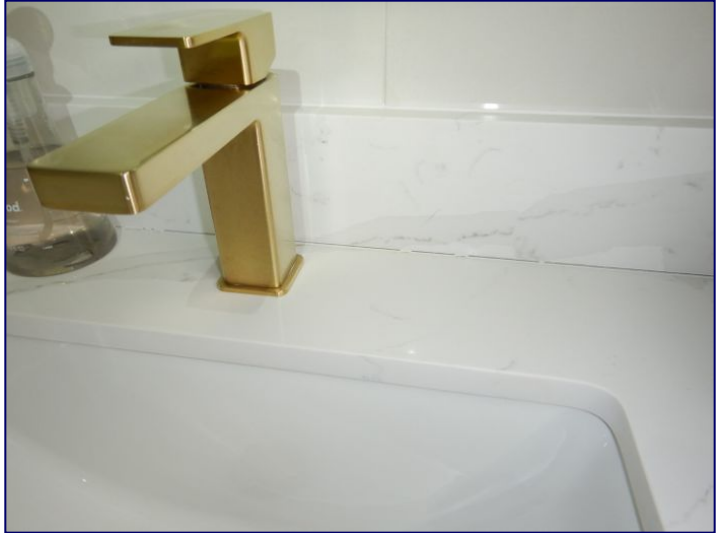
• Vanity top/ back splash needs caulk/ grout repair to prevent moisture intrusion into or behind the cabinetry below which may cause damage to the cabinetry and or indoor air quality issues.

Vanity top/ back splash needs caulk/ grout repair to prevent moisture intrusion into or behind the cabinetry below which may cause damage to the cabinetry and or indoor air quality issues.

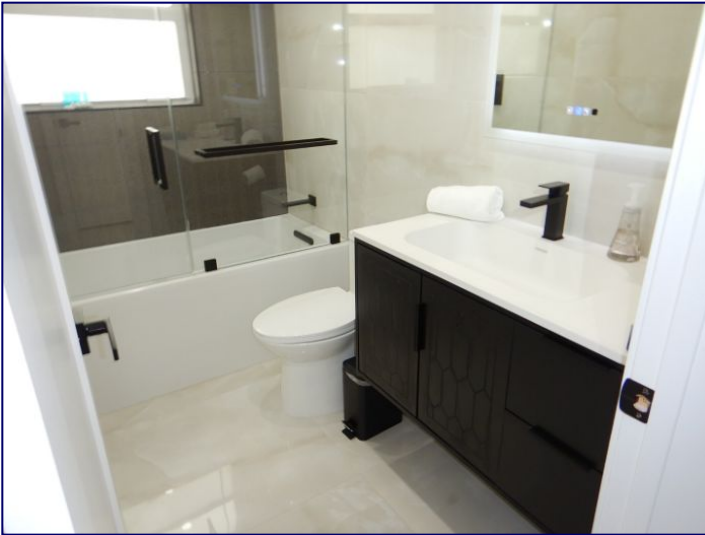
• Corrugated P-trap and or tail piece noted at the sink(s). This type of plumbing is considered to be substandard due to the ease in which they clog, smell and the difficulty in clearing clogged drain lines. Replacement(s) with smooth plumbing lines are highly recommended.

Corrugated P-trap and or tail piece noted at the sink(s). This type of plumbing is considered to be substandard due to the ease in which they clog, smell and the difficulty in clearing clogged drain lines. Replacement(s) with smooth plumbing lines are highly recommended.

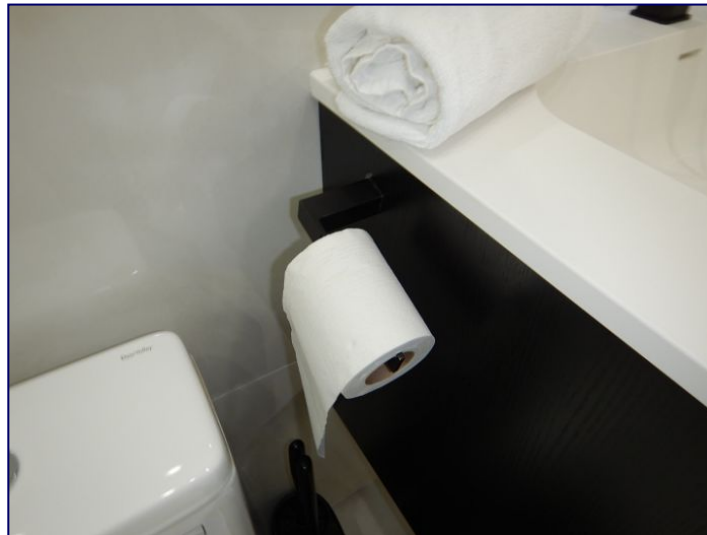
• Toilet paper holder is loose adjustments will be needed for proper operation.

Toilet paper holder is loose adjustments will be needed for proper operation.

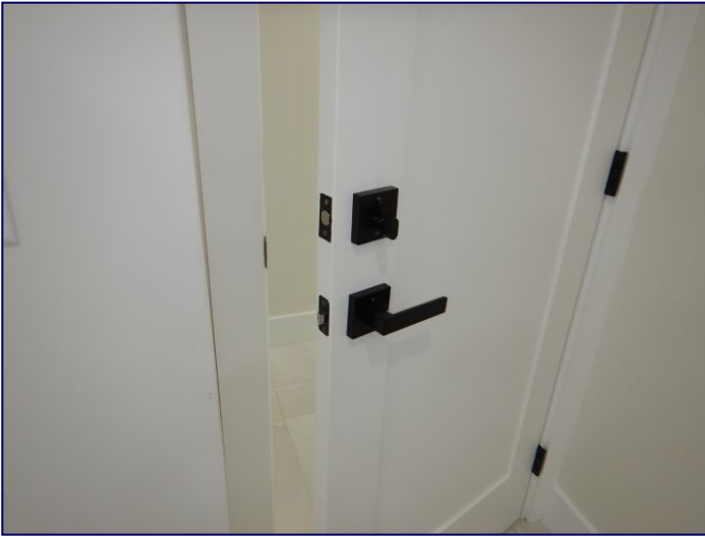
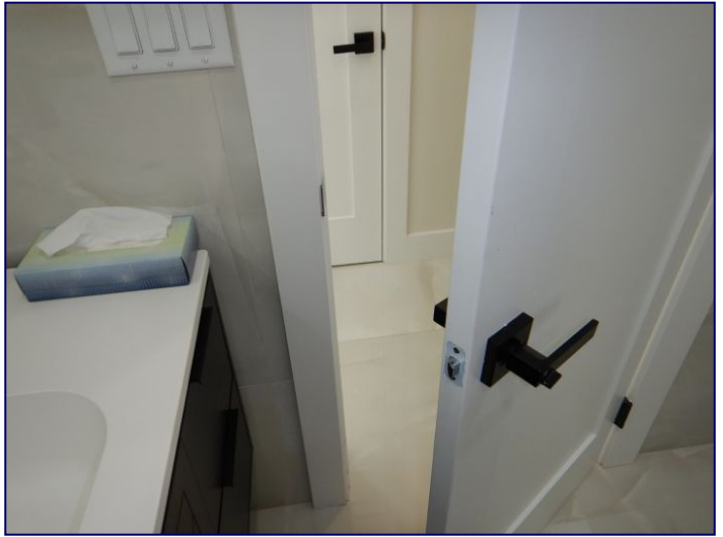
- Master Bedroom and guest bathroom doors do not latch properly. Minor adjustments will be needed for proper operation and privacy.

Master Bedroom and guest bathroom doors do not latch properly. Minor adjustments will be needed for proper operation and privacy.

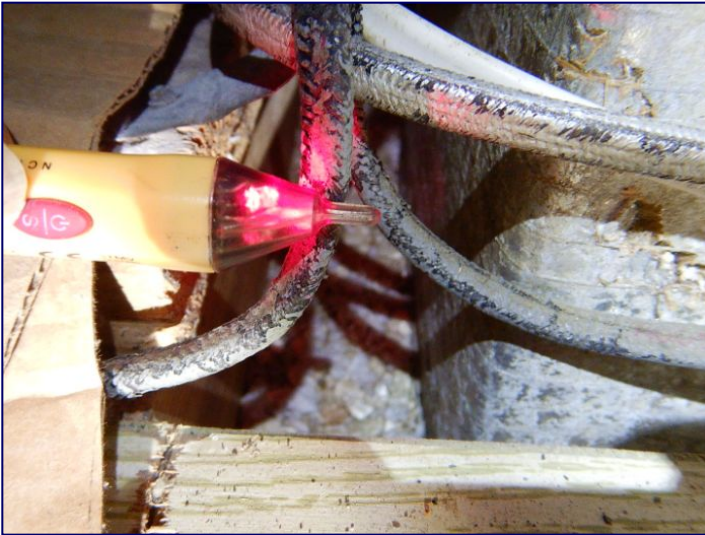
- Cloth wiring noted in the attic. Cloth wiring was used between the 1920s through the 1960s. Cloth covered wire conductors will either be copper, tinned copper or aluminum. Aluminum wiring was used in homes between the early 1960s through the mid 70s due to a worldwide copper shortage between these years. Aluminum wiring is considered to be unsafe due to the fact that as aluminum expands and contracts as the wiring heats and cools under load. Over time expansion and contractions may cause connections to become loose. Loose connections can lead to overheating and arcing and create fire hazards at these connections. At Beacon Home Inspection Services you and your family's health and safety as well as protection of your investment is our top priority, and we make every effort to determine and identify unsafe conditions. Due to conditions of limited accessibility, safety and or liability concerns as well as techniques that fall well outside the scope of a home inspection, if cloth covered wiring is observed whether copper, tinned copper or aluminum wiring is or is not identified a further more invasive inspection by a licensed electrician is highly recommended as all cloth wiring is now considered to be nearing or past its serviceable life expectancy of 50 years. Cracks/ deterioration of the cloth insulator which cannot be seen during a visual inspection can also be an electrocution/ fire hazard. For homes built between 1960 and 1976 aluminum wiring or remnants of aluminum wiring may be present in the home that can not be visually detected. Identification of the types of conductors is limited to the main electrical panel inspection only and all types of conductors observed at the main panel will be listed under the main electrical section of the report.

Cloth wiring noted in the attic. Cloth wiring was used between the 1920s through the 1960s. Cloth covered wire conductors will either be copper, tinned copper or aluminum. Aluminum wiring was used in homes between the early 1960s through the mid 70s due to a worldwide copper shortage between these years. Aluminum wiring is considered to be unsafe due to the fact that as aluminum expands and contracts as the wiring heats and cools under load. Over time expansion and contractions may cause connections to become loose. Loose connections can lead to overheating and arcing and create fire hazards at these connections. At Beacon Home inspection Services you and your family's health and safety as well as protection of your investment is our top priority, and we make every effort to determine and identify unsafe conditions. Due to conditions of limited accessibility, safety and or liability concerns as well as techniques that fall well outside the scope of a home inspection, if cloth covered wiring is observed whether copper, tinned copper or aluminum wiring is or is not identified a further more invasive inspection by a licensed electrician is highly recommended as all cloth wiring is now considered to be nearing or past its serviceable life expectancy of 50 years. Cracks/ deterioration of the cloth insulator which cannot be seen during a visual inspection can also be an electrocution/ fire hazard. For homes built between 1960 and 1976 aluminum wiring or remnants of aluminum wiring may be present in the home that can not be visually detected. Identification of the types of conductors is limited to the main electrical panel inspection only and all types of conductors observed at the main panel will be listed under the main electrical section of the report.

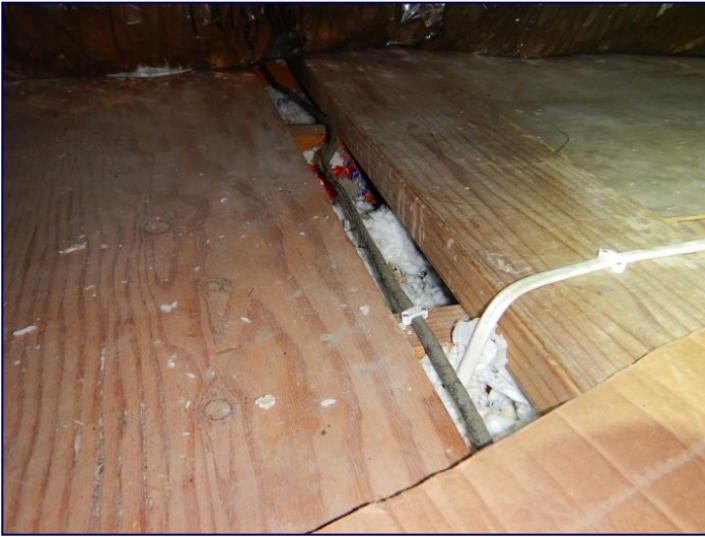
- Some areas of insulation have been disturbed or removed by tradesmen. Redistribution or installation of more insulation is recommended to improve energy efficiency and prevent deterioration of indoor air quality.

Some areas of insulation have been disturbed or removed by tradesmen. Redistribution or installation of more insulation is recommended to improve energy efficiency and prevent deterioration of indoor air quality.

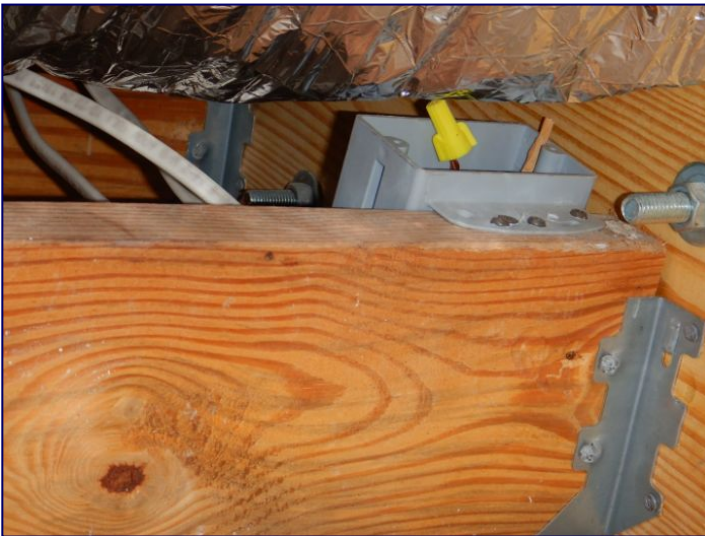
- **ELECTRICAL:**
  - Electrical Box Covers noted as missing or damaged in the attic which is a potential shock or electrocution hazard. Recommend installing [proper cover(s)].

Electrical Box Covers noted as missing or damaged in the attic which is a potential shock or electrocution hazard. Recommend installing [roper cover(s)].

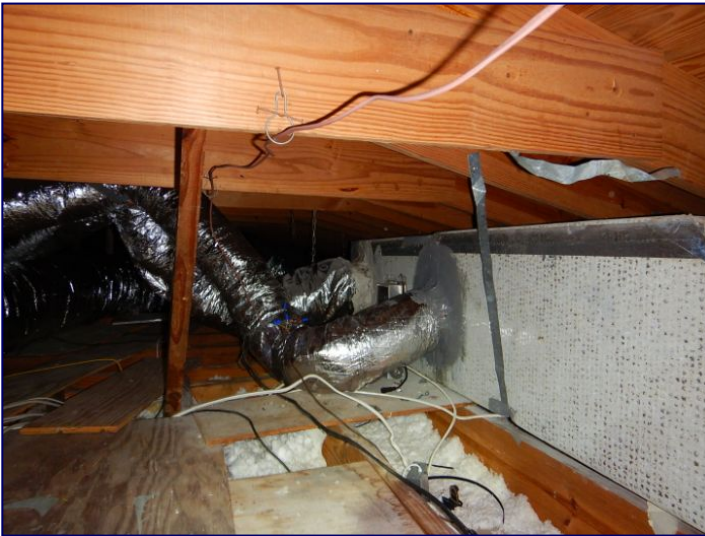
- **\*Not enough insulation. Insulation throughout the attic is aged, degraded, matted down or disturbed to the point where insulation should be added or replaced. Contact FP&L, they sometimes perform free energy audits and will add insulation at no cost to the owner. 1-800-DIAL-FPL (1-800-342-5375.**

\*Not enough insulation. Insulation throughout the attic is aged, degraded, matted down or disturbed to the point where insulation should be added or replaced. Contact FP&L, they sometimes perform free energy audits and will add insulation at no cost to the owner. 1-800-DIAL-FPL (1-800-342-5375).

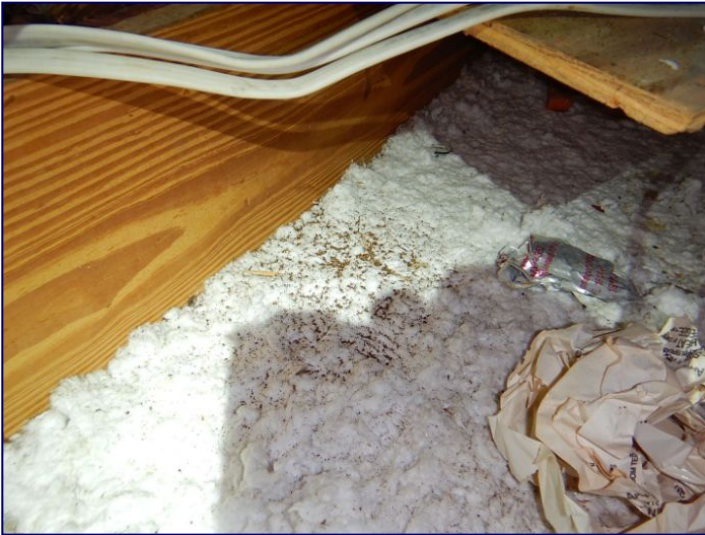
- **INSECT/ WDO ACTIVITY:**
  - Insect damage or activity noted in the form of **drywood termite pellets**, galleries and or shed wings. I would highly recommend checking with the seller to see when the last termite inspection/ treatment was performed and if there are any warranties or termite bonds on the property. If no proof can be provided in writing that service was performed within the last six months further evaluation and treatment options by a licensed pest control company is highly recommended. See environmental section of the report for more information on termites.

Insect damage or activity noted in the form of drywood termite pellets, galleries and or shed wings. I would highly recommend checking with the seller to see when the last termite inspection/ treatment was performed and if there are any warranties or termite bonds on the property. If no proof can be provided in writing that service was performed within the last six months further evaluation and treatment options by a licensed pest control company is highly recommended. See environmental section of the report for more information on termites.

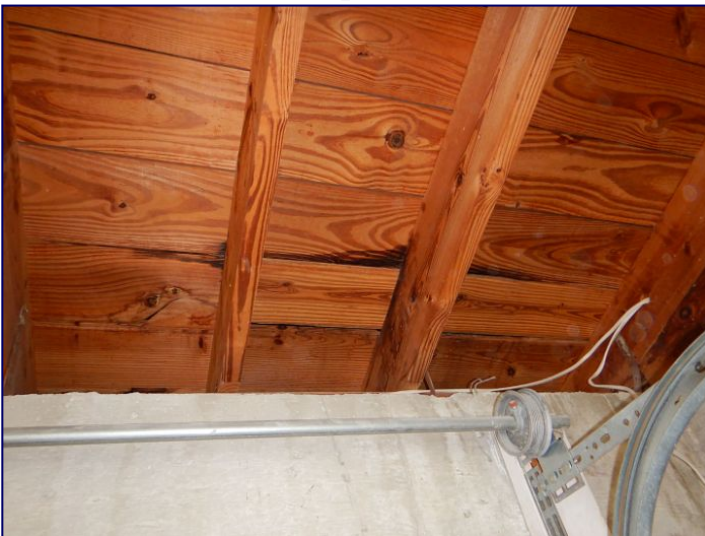
- Water stains or previous repairs noted at garage ceiling. See Photo(s) These areas were scanned with infrared technology and found to be dry at the time of inspection. I would recommend speaking to the seller regarding these repairs and their origins. Any roof repairs should be documented in writing and you should check to see if there are any transferable warranties for the repairs. Monitor for the redevelopment of leaks.

Water stains or previous repairs noted at garage ceiling. See Photo(s) These areas were scanned with infrared technology and found to be dry at the time of inspection. I would recommend speaking to the seller regarding these repairs and their origins. Any roof repairs should be documented in writing and you should check to see if there are any transferable warranties for the repairs. Monitor for the redevelopment of leaks.

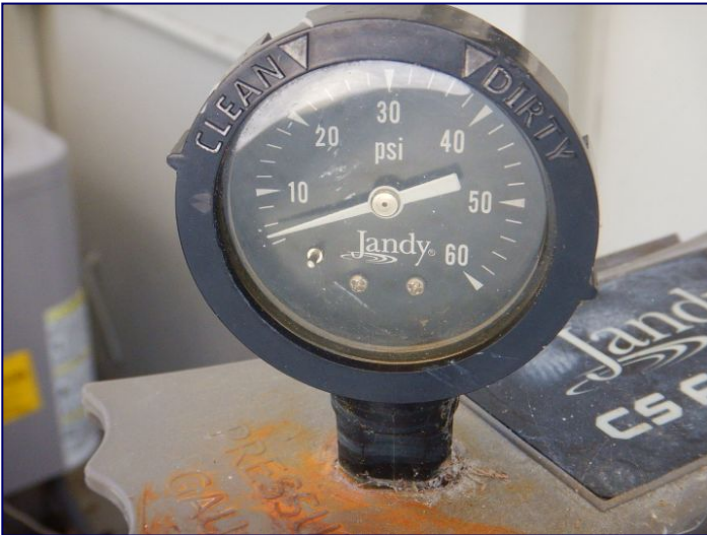
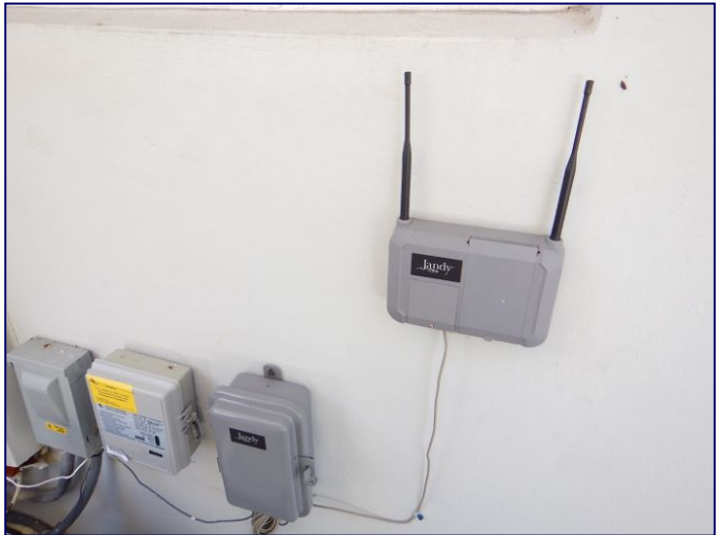
The pool heater controls are locked and the heater appears to be controlled by an Aqualink type remote control system. Heater could not be evaluated for operations. Have seller demonstrate operations prior to closing.

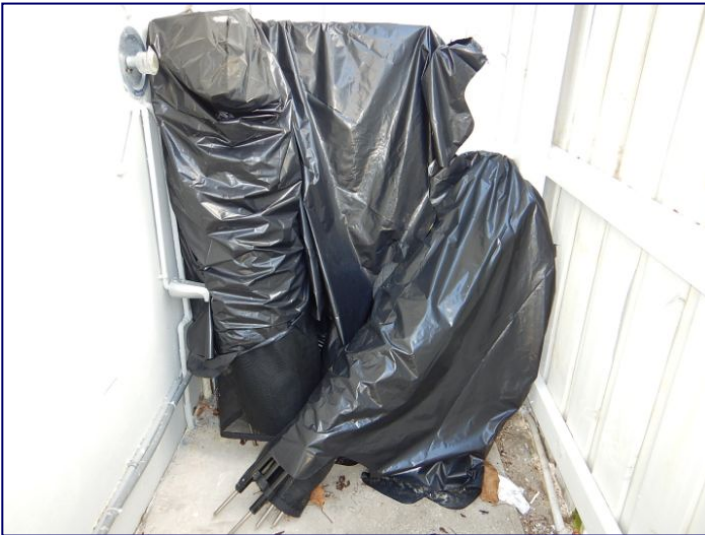
Safety netting was located rear of the home.

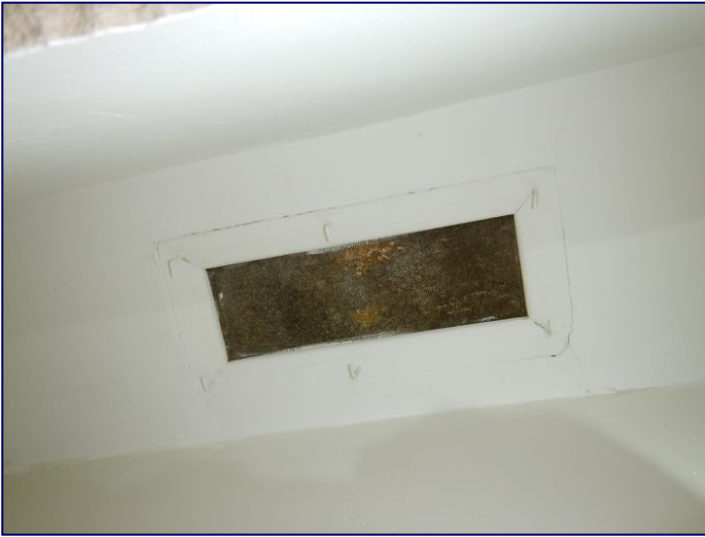
Potential Conditions Conducive to Mold Growth: Attic ventilation openings were observed in the ceilings of multiple interior closets, creating a direct pathway between the attic and the closet spaces. The attic contains potential vermiculite insulation and loose-fill fiberglass insulation, while the closets are not directly conditioned and are equipped with solid doors, limiting air circulation. This configuration may allow heat, humidity, and insulation particulates to enter the closets, creating conditions conducive to microbial growth.

Although no visible organic or biological growth was observed during the inspection or under UV light, the freshly painted surfaces may conceal evidence of previous moisture intrusion or microbial growth. Recommendation: Seal the attic ventilation openings and improve closet ventilation by installing louvered doors or providing conditioned air through the HVAC system.

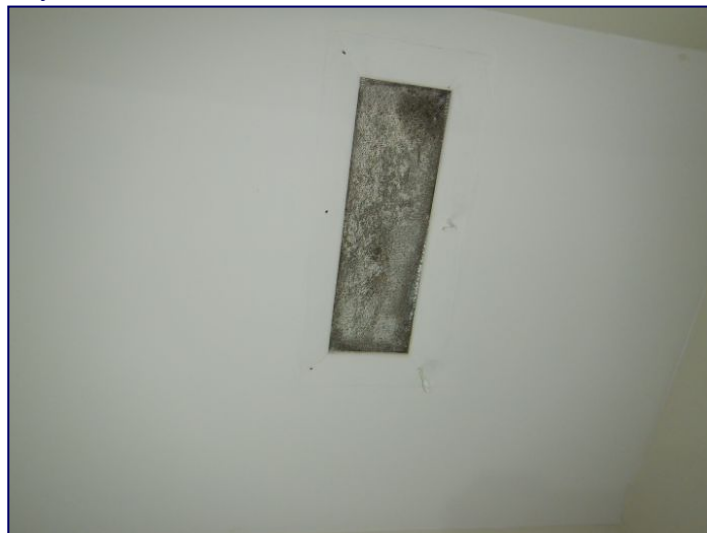
- **Potential Conditions Conducive to Mold Growth:** The laundry room, adjacent half bathroom, and three

Moisture content testing of the accessible wall surfaces within the laundry room was performed and found

was observed during the inspection or under UV light, the freshly painted surfaces may conceal evidence

of previous moisture intrusion or microbial growth.

**Recommendation:** Consider extending the home's HVAC system to condition the laundry room and adjoining closet areas to improve temperature and humidity control and reduce conditions conducive to future microbial growth.

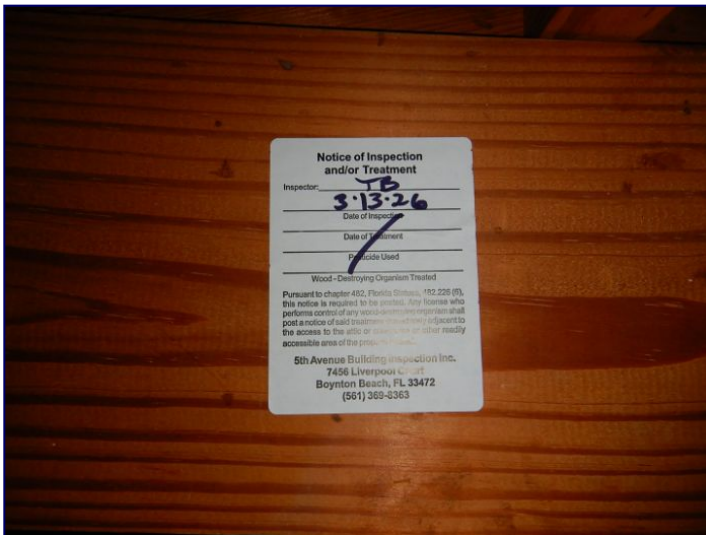
**There is a notification tag at the attic that indicates that a WDO inspection was recently performed by a licensed pest control company. The tag indicates that no active WDO activity was noted and no treatment was performed. You should still check with the seller on any findings and or recommendations that were made. I would also check on any warranties or WDO bonds that may be applicable to the property. If these cannot be provided in writing you may also want to check with the pest control company for any available information.**

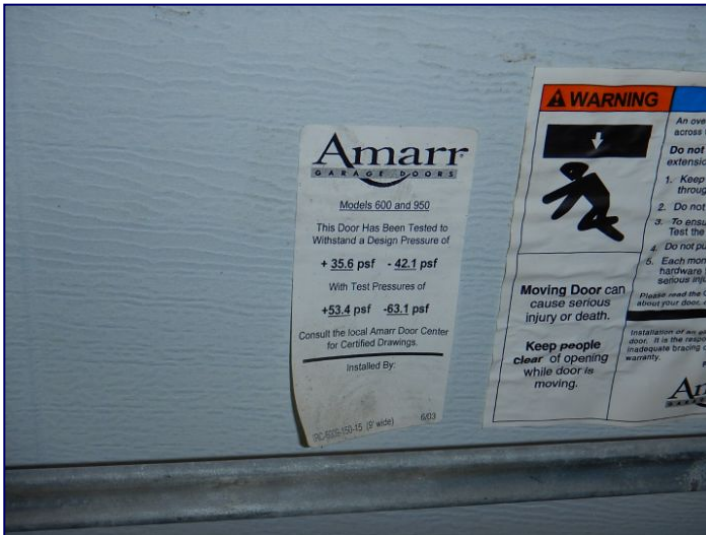
Your garage door is wind rated but not impact rated. You will receive a partial credit for your wind rated garage door but can save on your insurance rates by updating to an impact rated garage door. Check with your underwriter to see if upgrading would be cost effective.

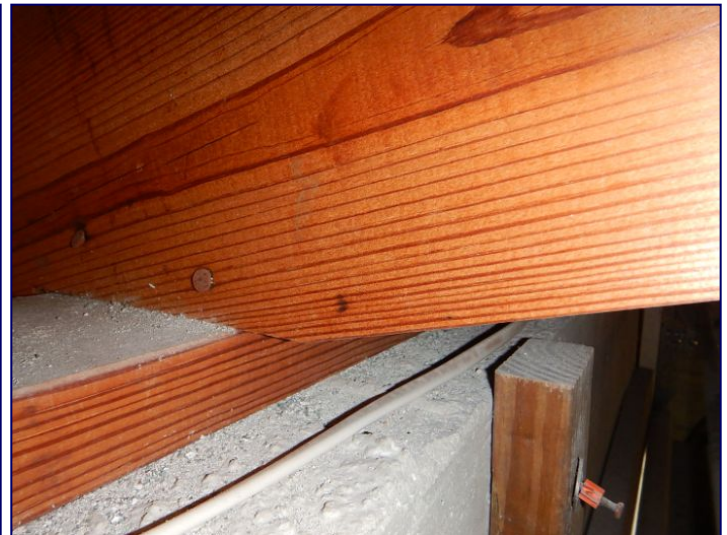
Toenails are defined in the 2002 FBC as a nail or nails driven through the roofing truss into the wall top plate or metal attachments that do not meet minimum roof to wall attachment requirements for the 1802 Wind Mitigation Form.

Roof to wall attachments are by far the largest credit you will receive from your insurance company.

Updating the roof to wall attachments to meet minimum 2002 FBC code is highly recommended. Check with your underwriter to see if updating would be cost effective.
